Council Memorandum

Re: 311 10th Street Building Feasibility Study Review

Golden Civic Center: Feasibility Study

Final Due Diligence Report

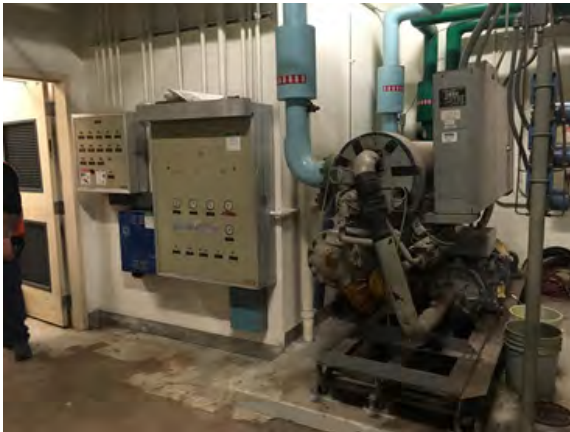
Fig. M-3 – Small Abandoned Chiller

There are a total of three chillers in the main mechanical room; however, the smallest one is abandoned. Of the two larger Carrier units, only the largest and newest unit was operational during site visits. The second chiller is said to be a backup unit, but it is estimated to be past its equipment life expectancy. Heat rejection is managed by a two-cell cooling tower on the east side of the building. Each cell appears to be paired with a VFD condenser water pump. These pumps were operating at 100% during site visits. Given the full load operation of the condenser water pumps, and the single operable chiller, it is recommended that the older Carrier chiller unit be replaced, and the two chillers to operate lead/lag, distributing run-time between them. It is also recommended that the abandoned chiller be removed at this time. The new Police Department

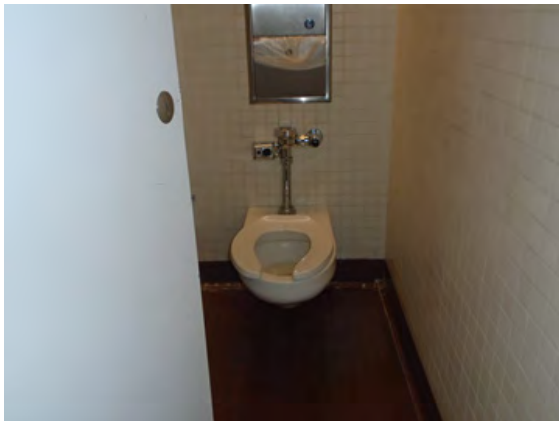
The Due Diligence Report recommended that all core restrooms be renovated, and fixtures be replaced with appropriate accessories. Additionally, an anticipated seventeen water closets will be added throughout the building with an estimated fourteen lavatories. It is anticipated that new breakroom sinks will be added throughout the building, each with a new small electric water heater. The largest anticipated plumbing change will be the addition of two locker rooms for the Police Department on the third floor. This will require an additional or upsized domestic water heat exchanger for the hot water load from the showers. Based on preliminary calculations, the domestic water supply and waste piping will not need to be upsized to meet the increased demand. However, it was recommended in the Due Diligence report that the sanitary line be scoped with a camera and the grease trap be cleaned.

Fig. P-1 – Typical Wall Mounted Water Closet

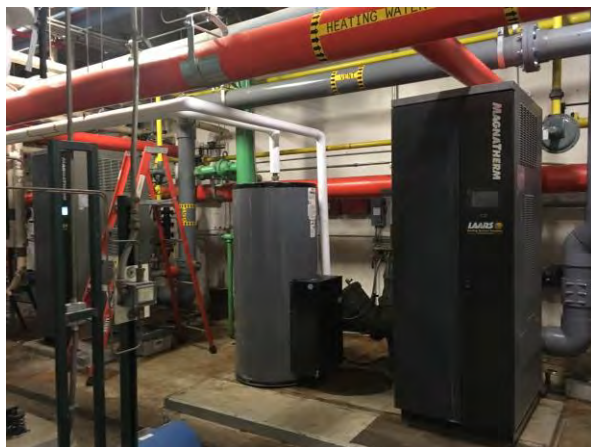
The existing building contains two 2,500,00 BTUH gas fired boilers. The boilers were installed in 2015 and are in good condition. At the time of the boiler replacement, the heating water pumps were also replaced and VFDs (Variable Frequency Drives) were included for energy efficient operation of the pumps. The building was originally served by steam from the adjacent brewery and when the steam was removed, the boilers were installed. The boilers also provide domestic hot water via a heat exchanger located in the basement. During the second site visit, one boiler was operating and the other one was turned off. The heating water setpoint was displayed at 190°F and with an inlet temperature of 152°F and an outlet temperature of 191°F. The boilers are piped in a primary-secondary configuration.

Fig. M-1 – Boilers shown on left and right of photo.

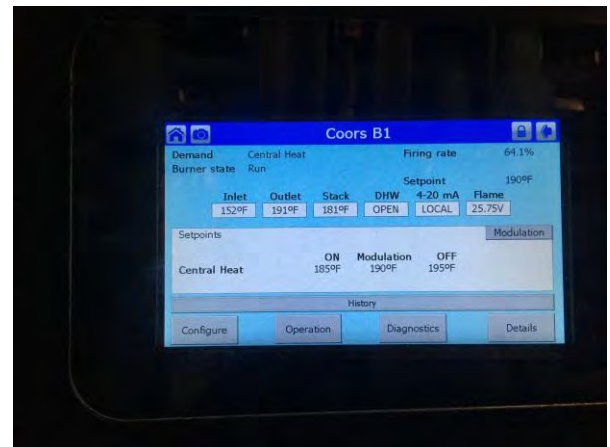
Fig. M-2 – Boiler operating conditions during second site visit.

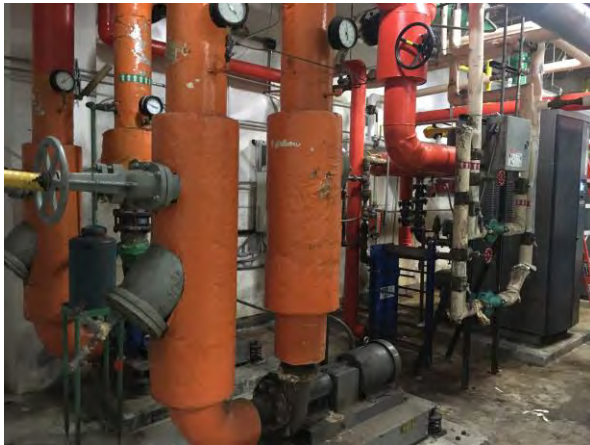
Fig. M-3 – Heating water secondary pumps shown in the lower left of photo and one of the boilers shown on the right side.

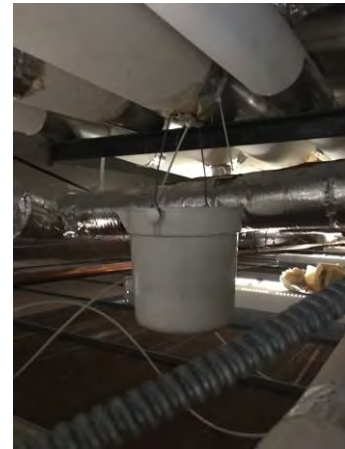
Fig. M-4 – Bucket found hanging below heating water pipe in the southwest corner of the second floor office space. This is evidence of leaking heating water piping.

It has been reported that the building has experienced leaking heating water pipes when heating water pumps are turned off or modulate to lower speeds. The current solution to this issue is to operate the secondary heating pumps at or near full speed all the time regardless of heating demand to maintain pressure in the pipes, which it seems has mostly worked. Not only is this operating method not practical in the long term, as the system will inevitably require a shutdown at some point, it is wasteful from an energy standpoint. It is recommended that all heating pipe mains (4" and larger) be replaced with a construction that will mitigate leaks at all times, even when system is operating at partial load conditions or not operating at all.

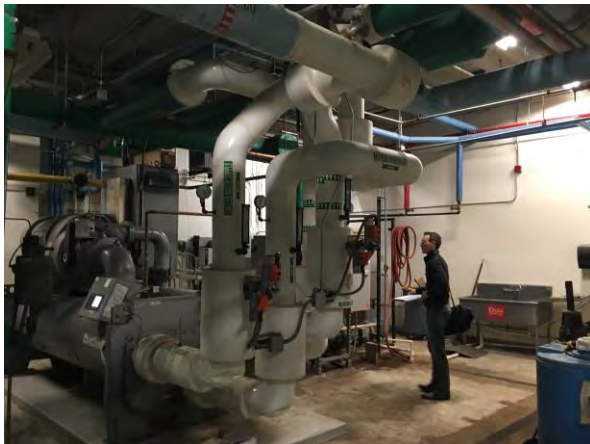
Fig. M-5 – 2011 Carrier chiller in operation.

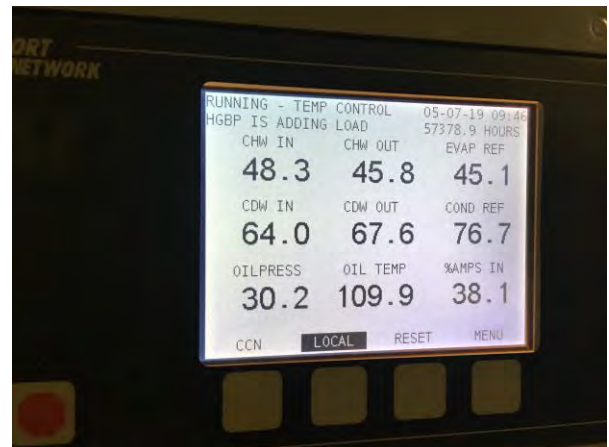
Fig. M-8 – Chiller operating conditions during second site visit.

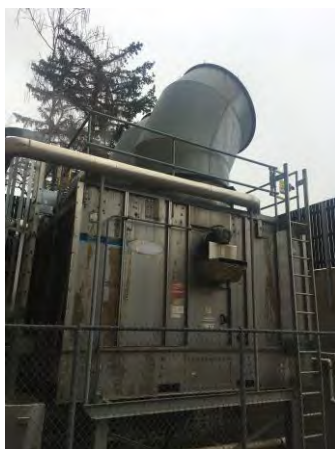
Fig. M-9 – Two-cell cooling tower located on the east side of the building.

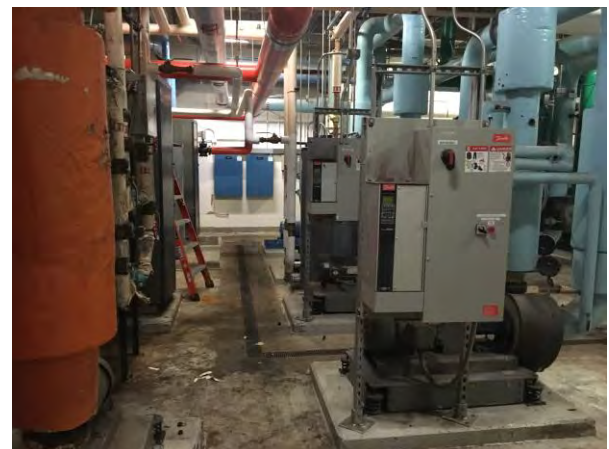
Fig. M-10 – Secondary chilled water pumps with VFDs.

Although the cooling plant is currently running sufficiently utilizing a single chiller, the backup chiller is estimated to be past its equipment life expectancy. If the primary chiller has an unexpected failure, and the backup chiller cannot reliably operate, this could leave the building without cooling for possibly an extended period of time while repairs are made. It is therefore recommended that the older Carrier chiller be replaced, and the two chillers operate lead/lag, distributing run-time between them. It might also be prudent to remove the abandoned chiller at this time.

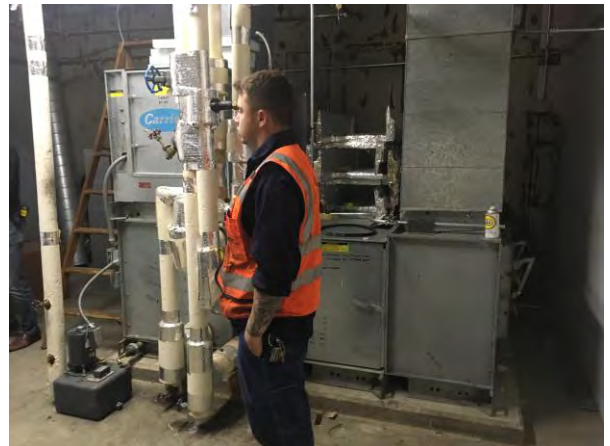
Fig. M-14 – Air handling unit serving recording studio.

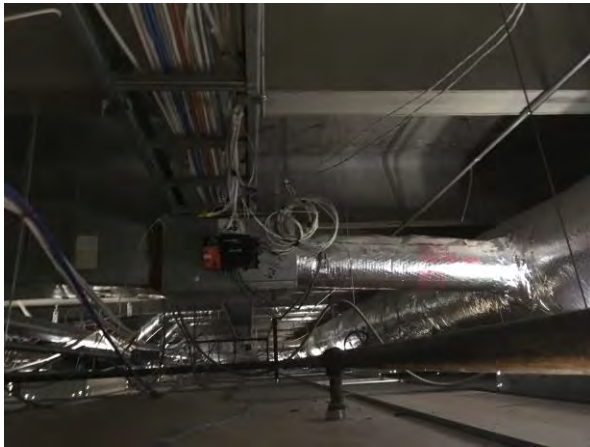
Fig. M-15 – Typical cooling only VAV box above ceiling.

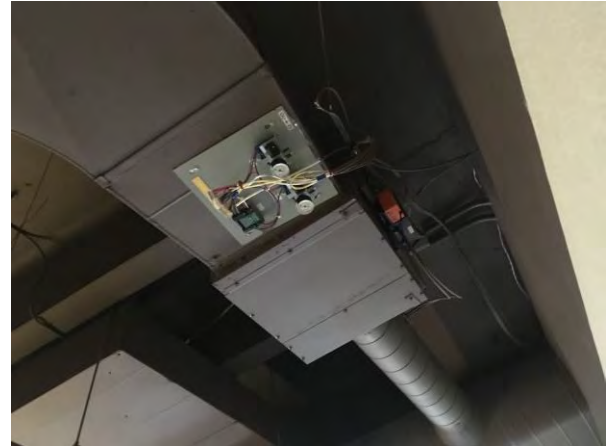
Fig. M-20 – Example of pneumatic-to-electric controls on VAV box.

It is recommended that all existing pneumatic controls be replaced with DDC. This would include all VAV boxes, control valves, damper actuators, etc. This would increase comfort, decrease burden on facility staff, and improve energy efficiency.

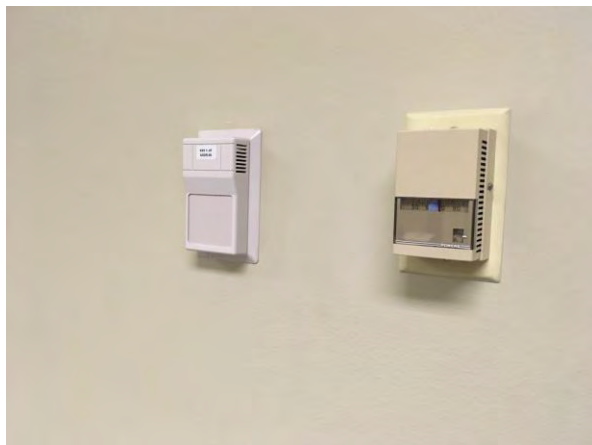
Fig. M-21 – Pneumatic thermostat alongside DDC zone sensor on wall of first floor conference room.

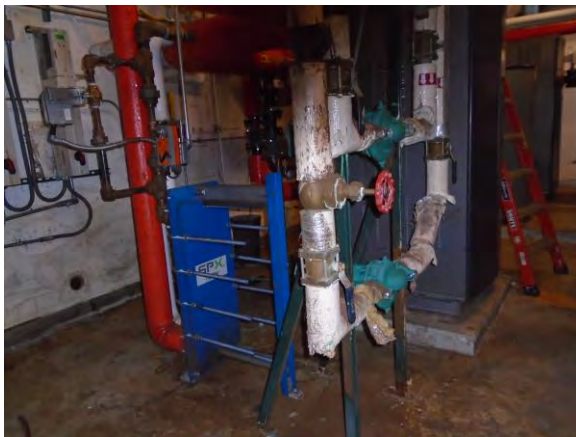
Fig. P-4 – Domestic hot water flat plate heat exchanger

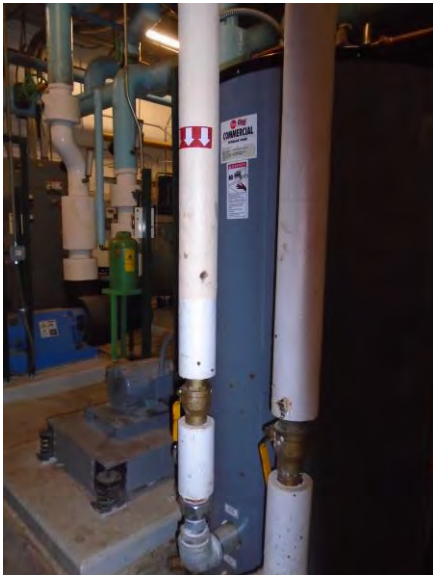
Fig. P-6 – Domestic hot water storage tank

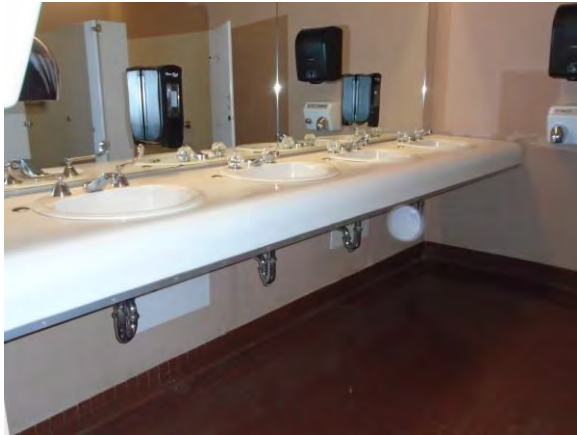
The core restrooms are in fair to poor condition. The restrooms are operable, but there are signs that the lavatories in each of the restrooms has issues with waste line draining. Hot water was present at the lavatories tested. The Women's restroom consisted of five (5) water closets and (4) lavatories. The Men's restroom consisted of (3) water closets, (2) urinals, and (4) lavatories. The water closets are wall mounted flush valve style. There are floor drains in each restroom for ease of cleaning. The restrooms were not checked for full ADA compliance however, the lack of insulation under the sink to protect a person from the hot water line and drain line is not present.

Fig. P-7 – Typical lavatories in restrooms

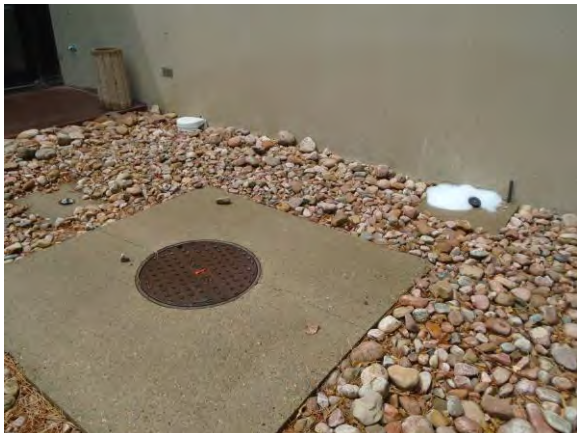
The commercial kitchen on the 1st floor has a grease interceptor located directly south of the kitchen area. The grease interceptor has had issues with backing up in the past, but when put on a quarterly cleaning schedule the backups were mitigated.

Fig. P-30 – Manhole cover for grease interceptor

It is recommended that the sanitary line be scoped with a camera to verify if there are any issues with the integrity of the pipe for long term use. Based on site conversations, the main sanitary line is in good condition.

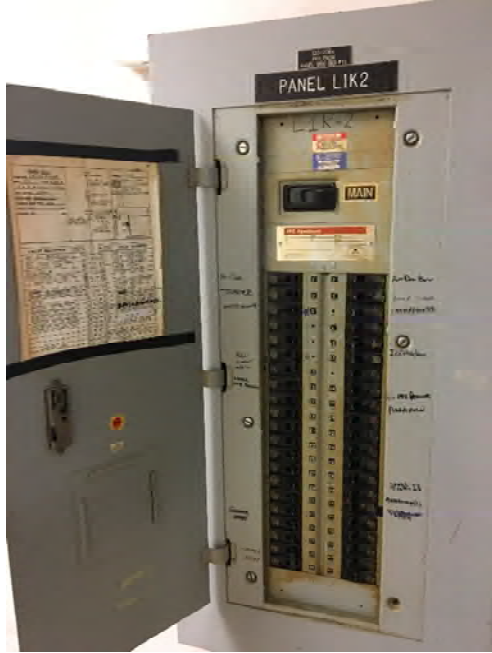
Photo #1: Kitchen Panel potentially requiring replacement.

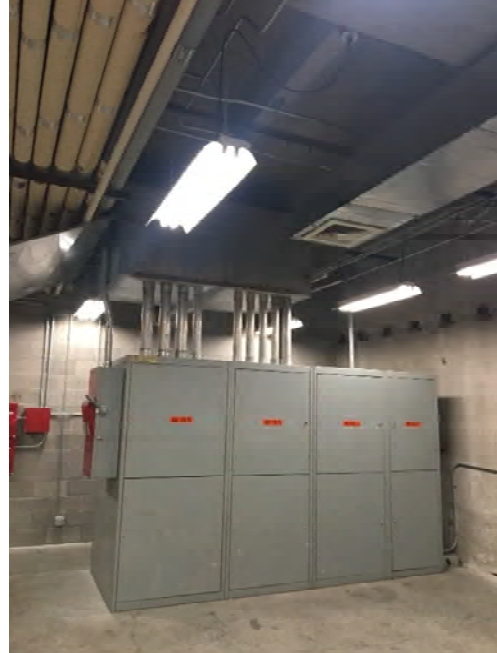
Photo #2: Main Electrical Room and MDC
