CITY OF GOLDEN

Public Art Assessment – 2020

October 2, 2020

Prepared by
Alison Leard
Pacific Coast Conservation
2334 Colorado Blvd
Denver, CO 80207
310-383-4710
www.pacificcoastconservation.com

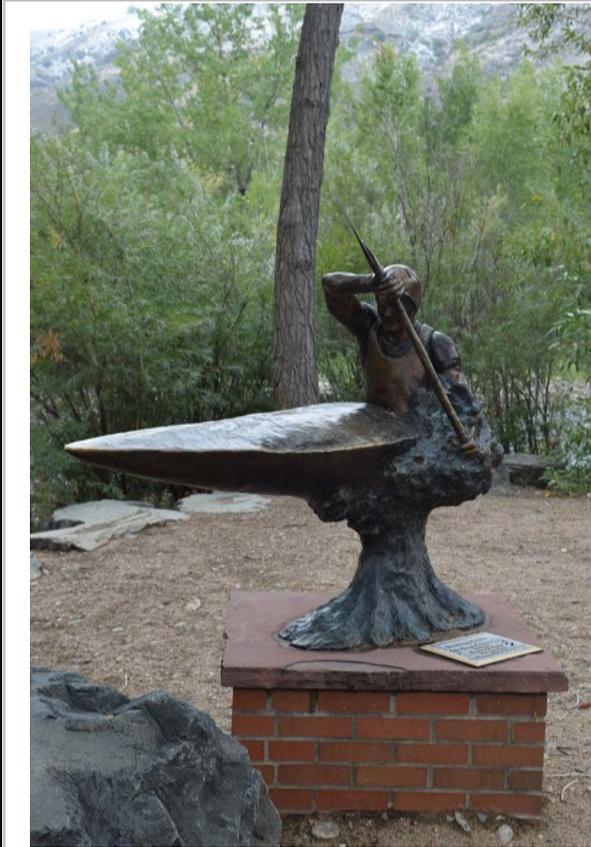
Visually good structural condition, no hands-on verification possible. There is worn patina along the top of the kayak, paddle and waves. There is soiling overall, concentrated where the statue is mounted to the base. On the side of the kayak there is streaking which is possibly soiling or staining.

Optional: integrate appearance by repatinating or applying tinted wax to areas of worn patina.

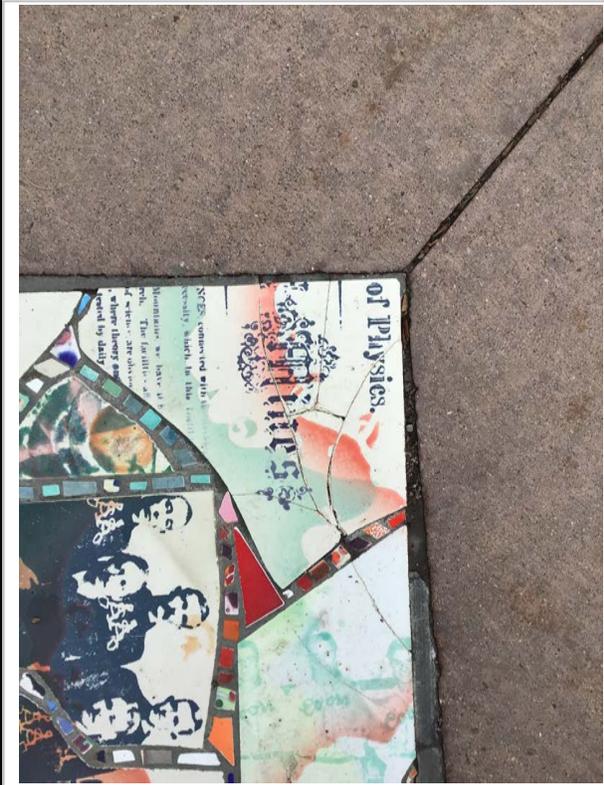
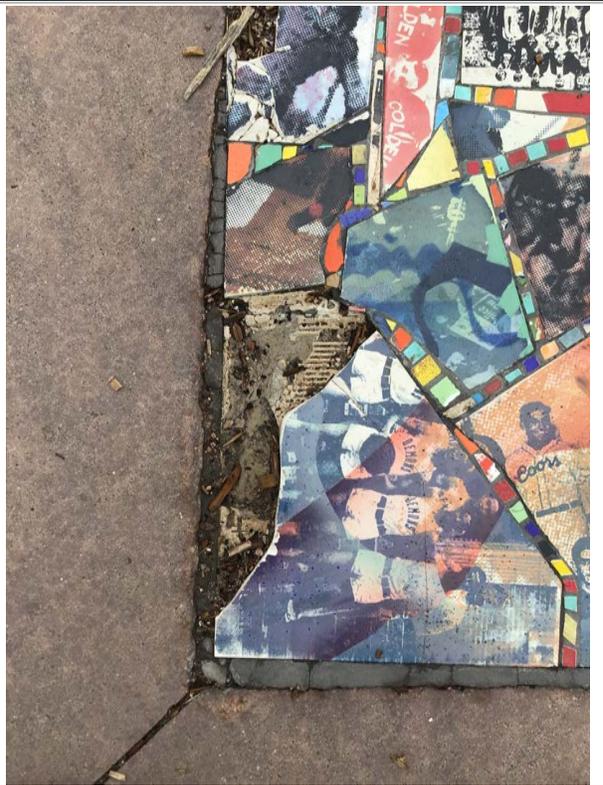
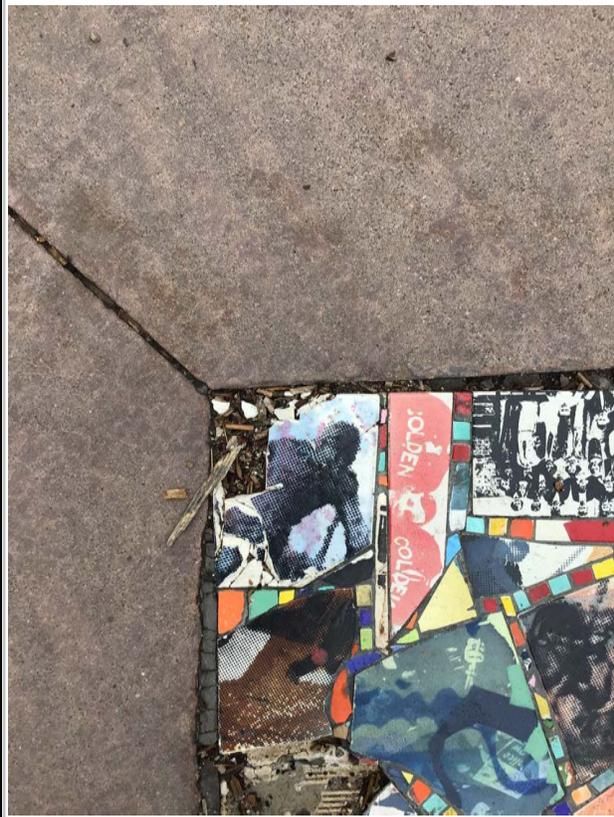
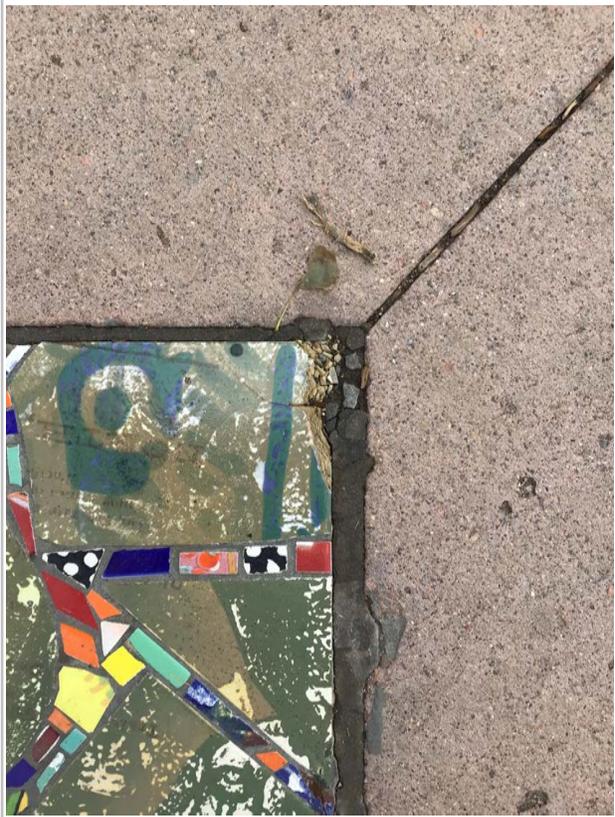
The tiles are in varying condition. Most are stable with only minor cracks, chips and/or losses. One of the medallions has a significant loss and associated instability.

Repair loose/missing mortar, securing loose tiles. Contact artist to determine if replacing missing tile with a matching piece is possible. If not, match with a in kind replacement.

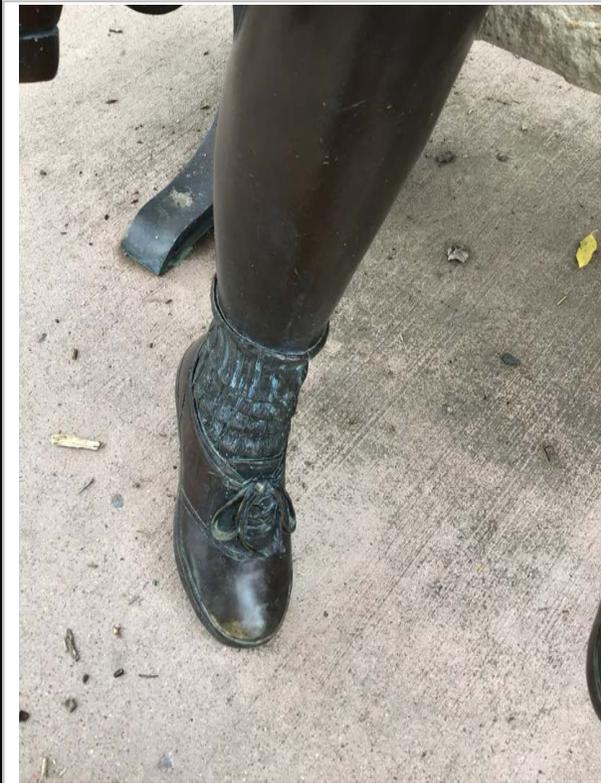
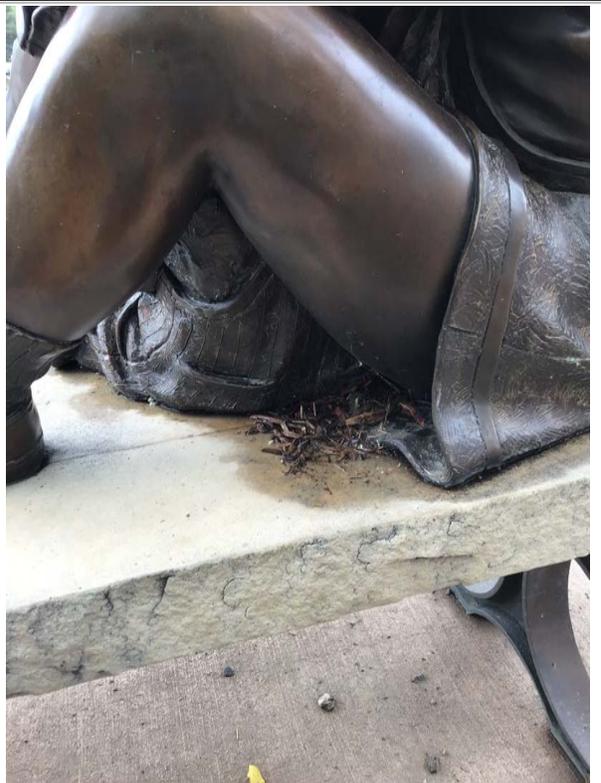
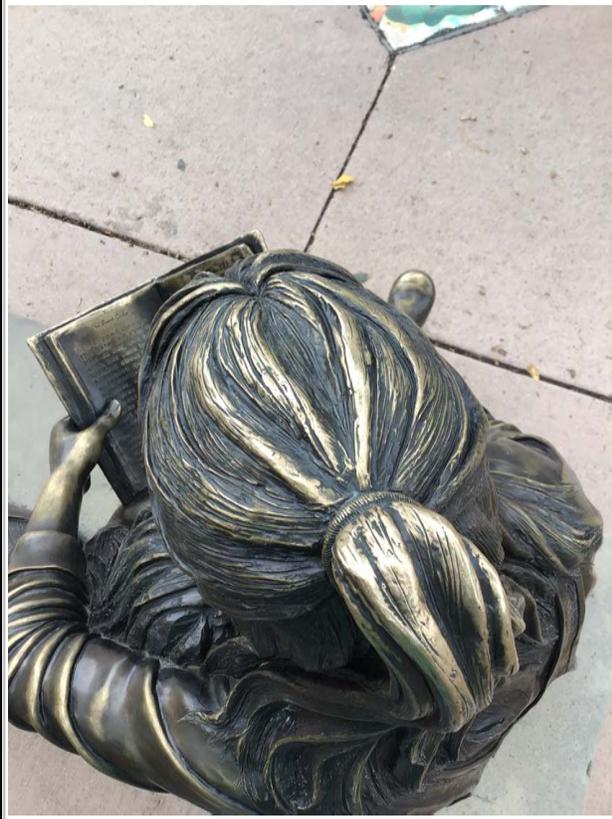
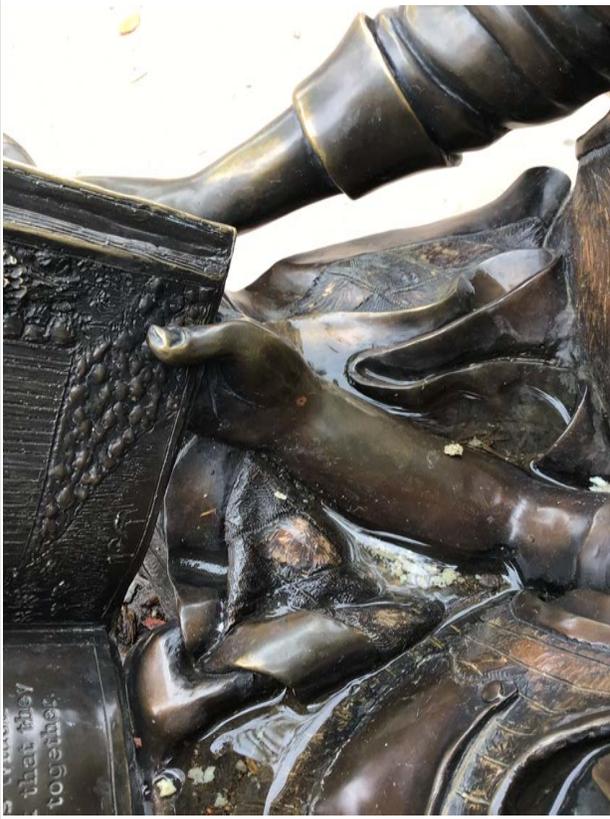
Copper alloy sculpture of two girls on stone and metal bench. The sculpture is in good structural condition. There is surface corrosion concentrated on the proper right (PR) foot of the older girl figure, and around a casting flaw hole on the PR arm of the same figure. The patina has worn in areas that are frequently touched, particularly the open pages of the book. There is soiling overall and debris caught in areas where water is pooling on the bench. There is a failed wax coating overall with wax built-up in areas of detail. May want to add weep holes in areas of pooling water. Review during maintenance.

Reduce surface corrosion on the PR foot, and any other locations as needed. Apply a protective coating of hot wax, followed by a second cold wax coating. Buff wax coats when set with a soft cloth. Add weep hole(s) as necessary.

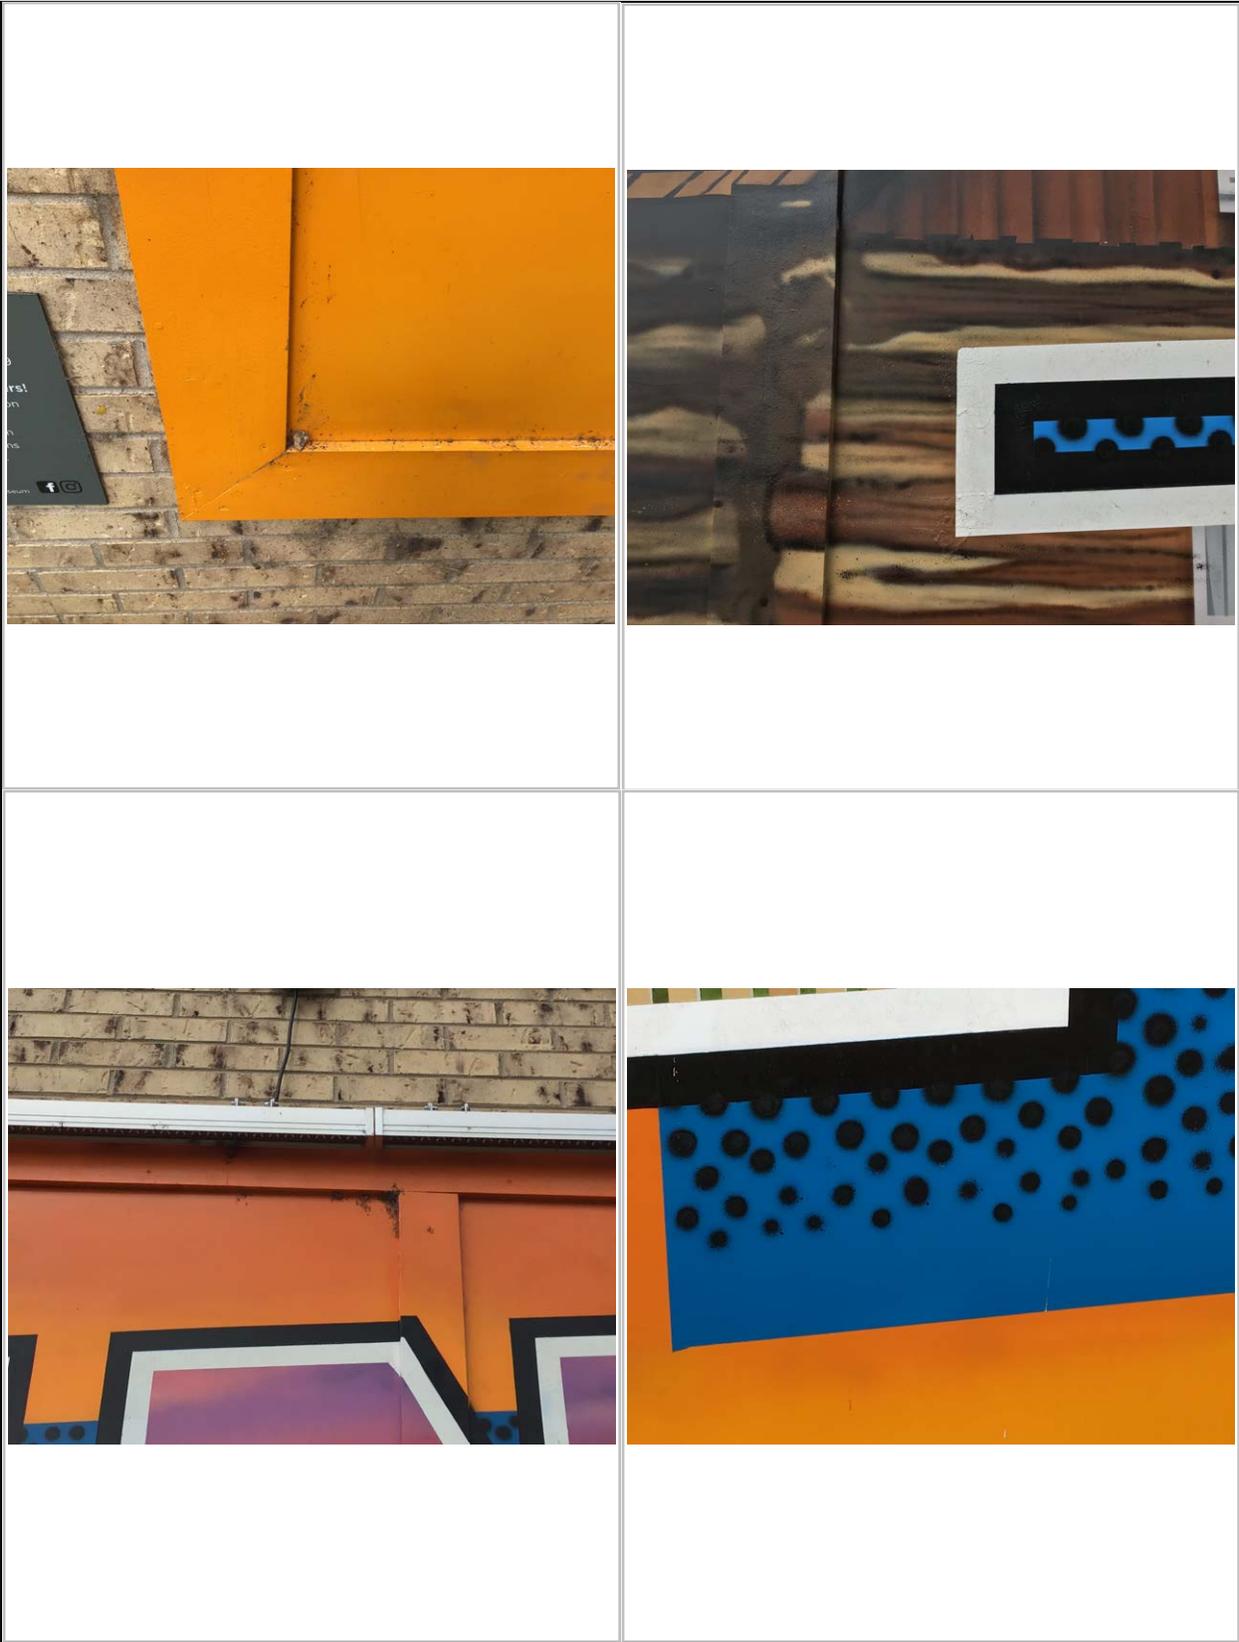
The mural is in structurally sound condition. There is bubbling paint in the "E", but no paint loss. There are scratches and surface soiling overall. There is insect activity in the upper corners of the mural.

Selectively clean areas of soiling and insect activity with a soft brush or soft cloth and water.
Inspect annually to track condition of the paint.

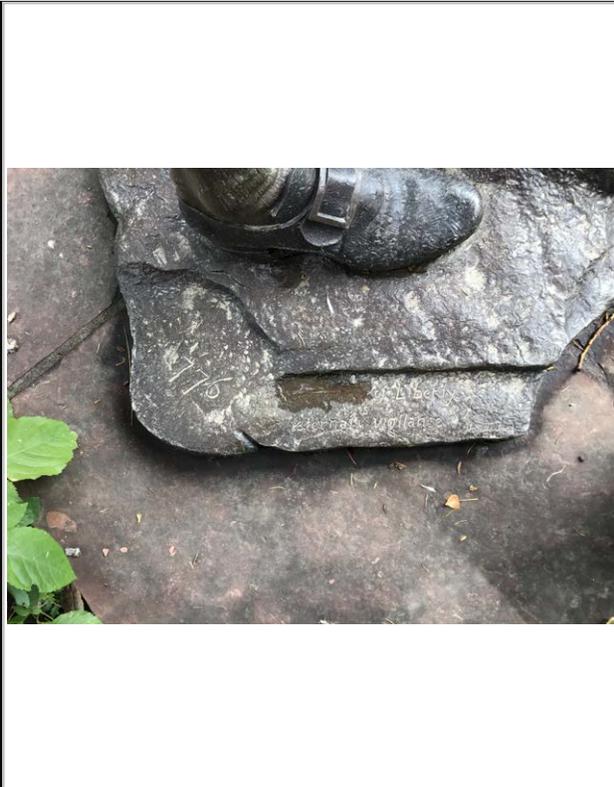
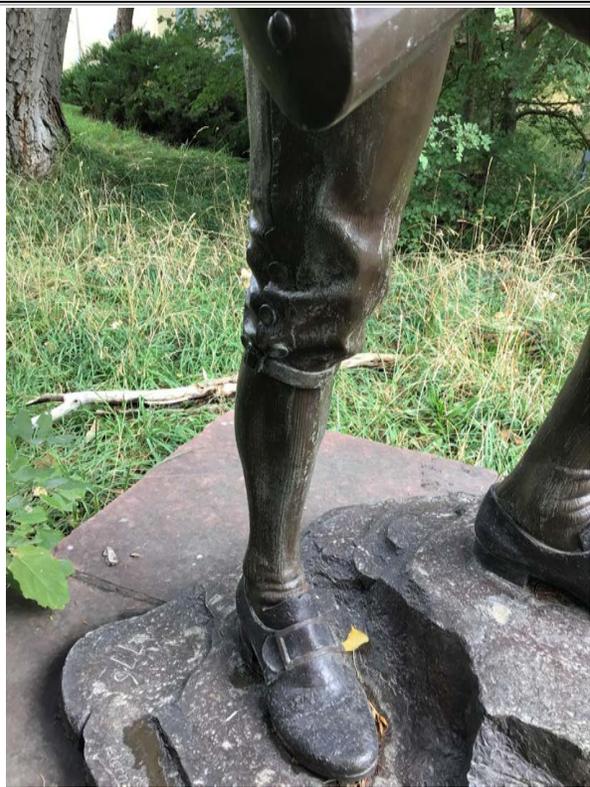
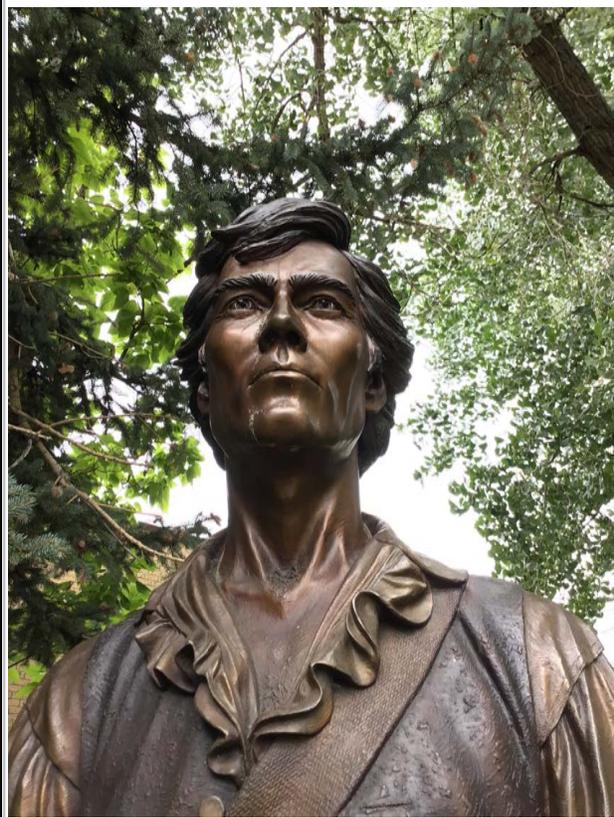
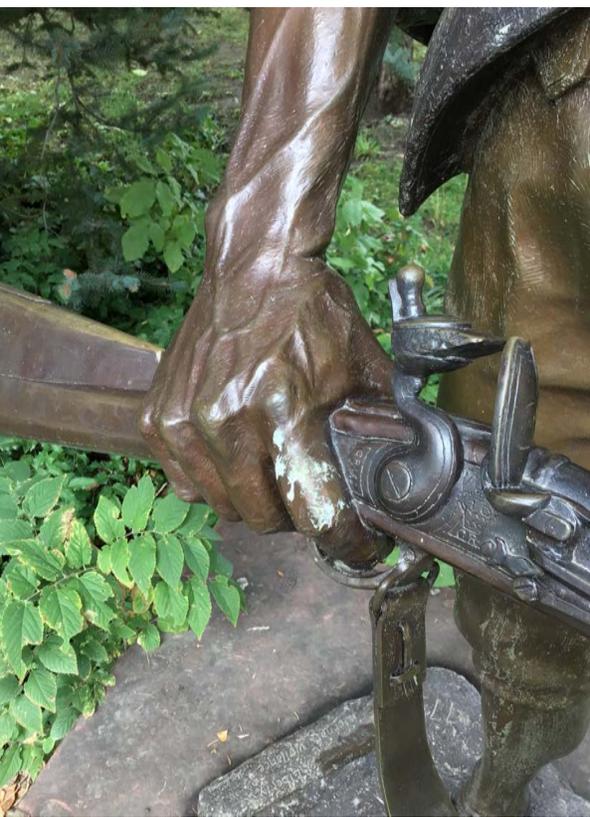
The bronze sculpture is in good condition. Water pools on the base near the feet. There are bird droppings present on the proper right hand and head. There is grime and wax buildup overall.

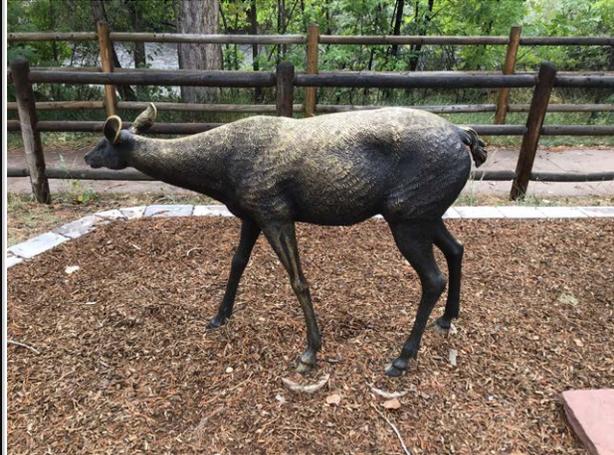
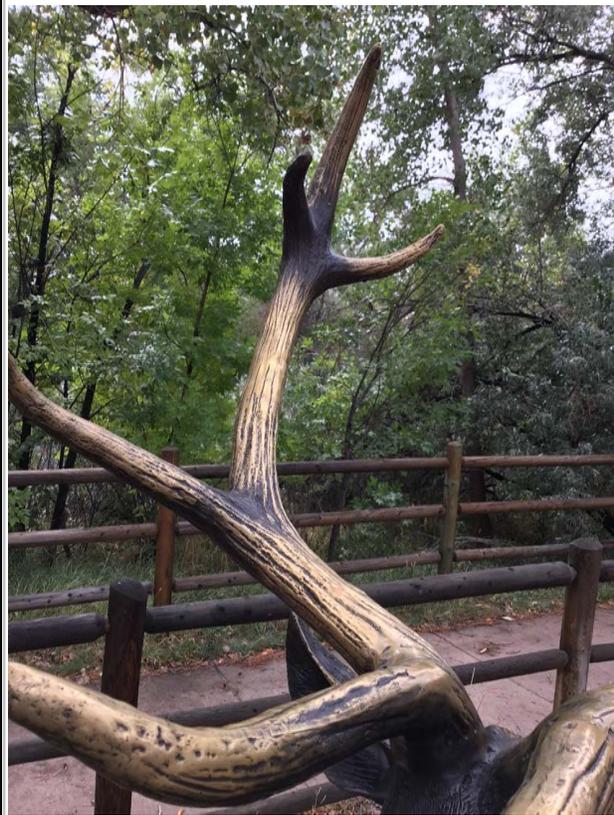
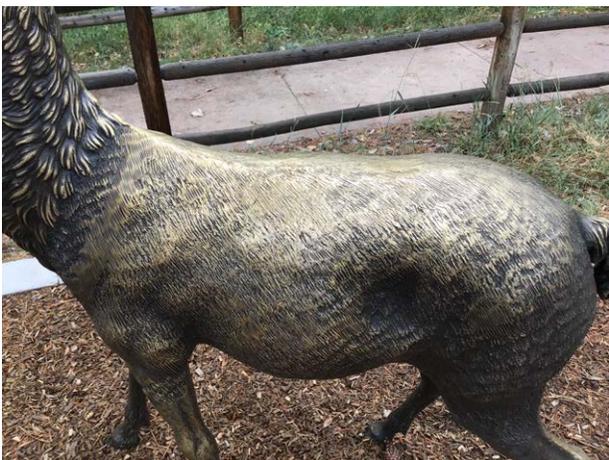
These bronze sculptures are in good structural condition overall. However, the patina on both sculptures is heavily worn, exposing the bare bronze beneath. There is grime and wax buildup overall.

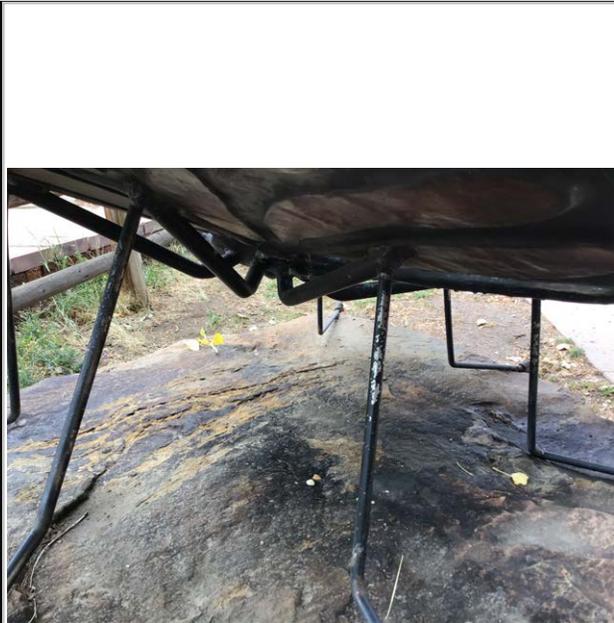
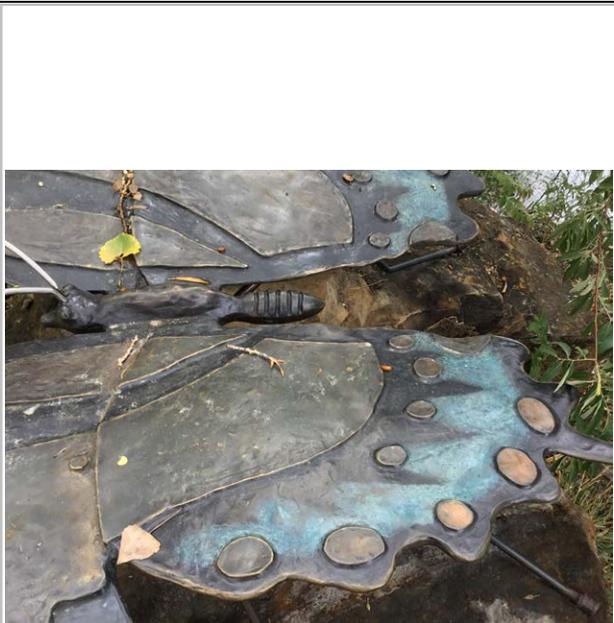
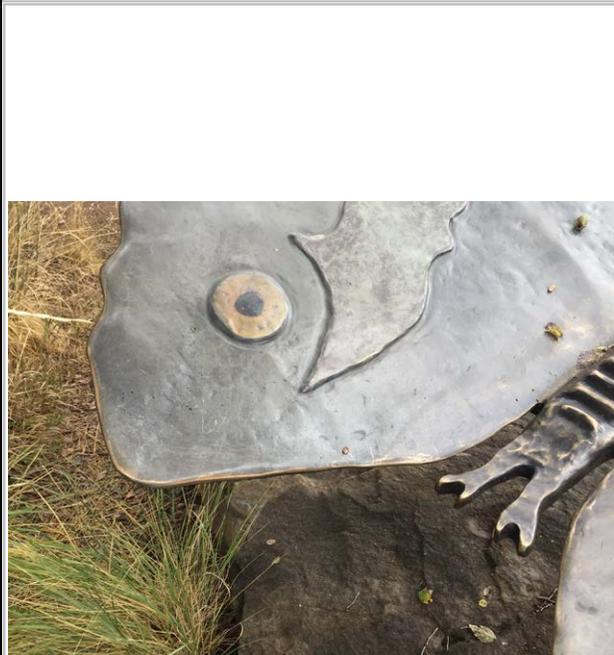
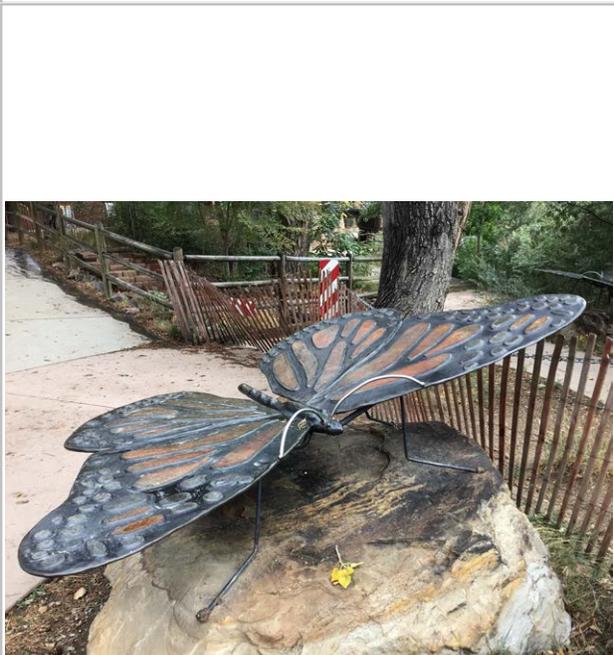
These three sculptures are in good structural condition overall. However, the black paint on the leg elements is flaking, exposing the non-ferrous metal beneath. Green corrosion is present on the wings of one butterfly nearest to the creek. This is likely due to the patina failing in this area. The patina is worn on all three sculptures. Grime, insect debris, and plant debris has accumulated overall on each sculpture.

Address failing patina on butterfly nearest to creek. Re-paint and seal legs overall.

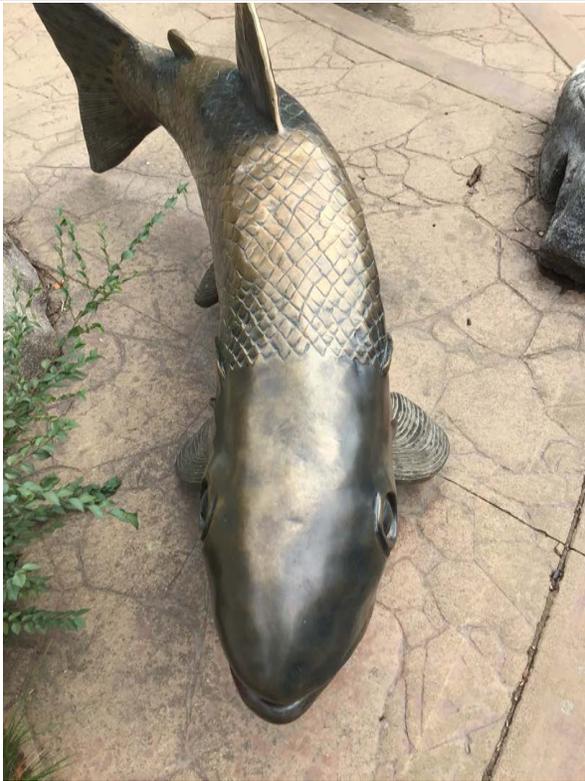
All elements are in good structural condition. The patina is heavily worn overall, exposing the bare bronze underneath. Minor corrosion products are present on the sides closest to the creek. Grime and wax buildup is present overall.

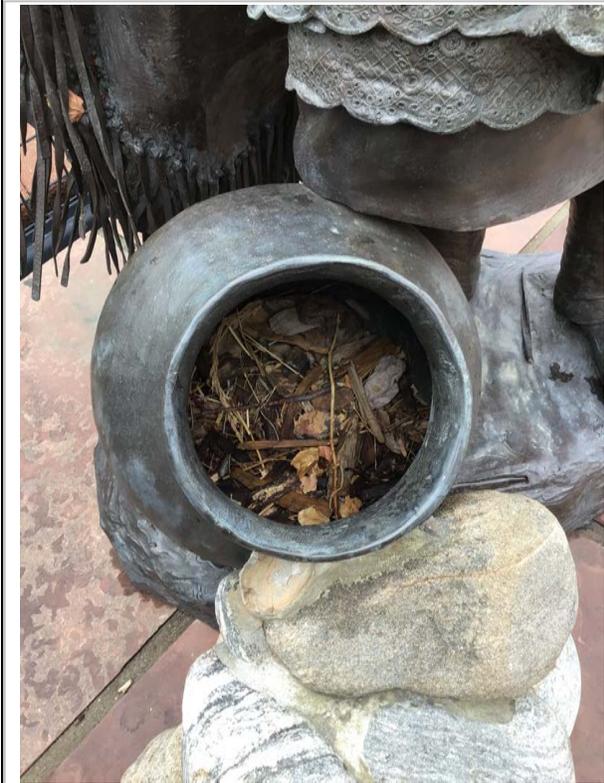
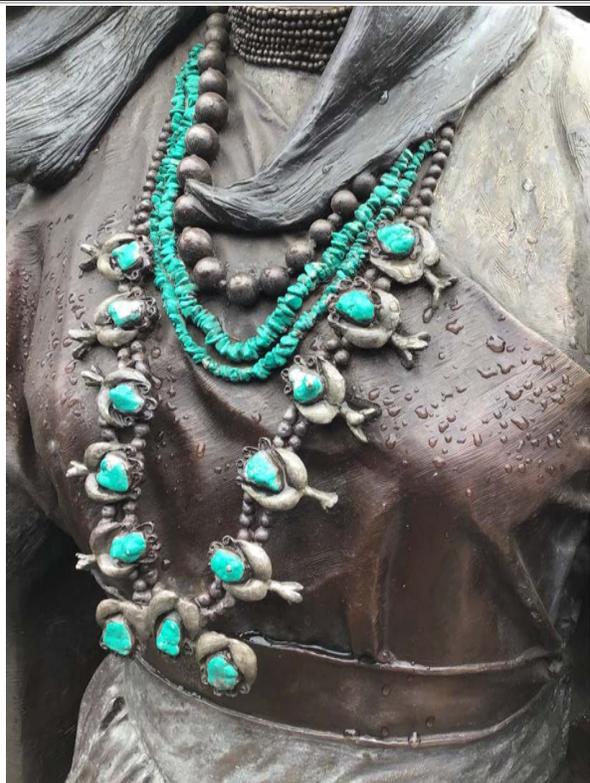
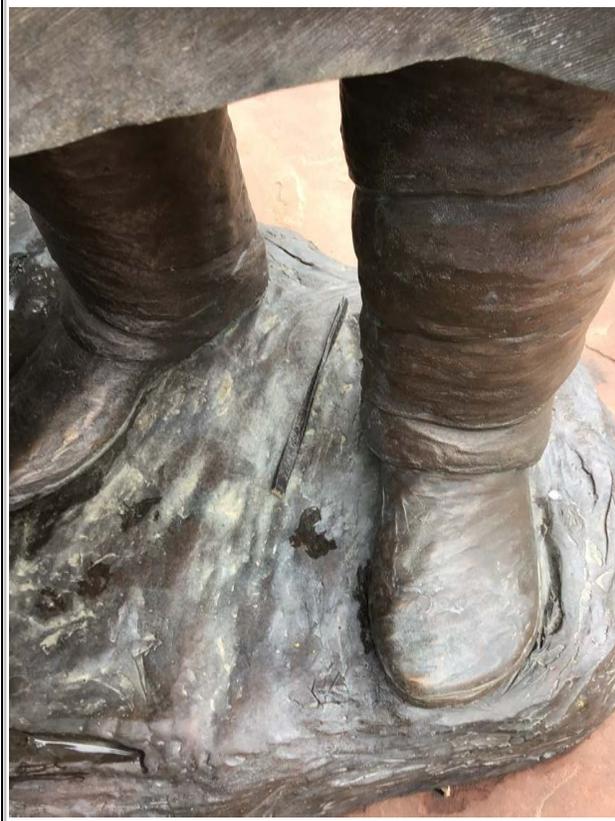
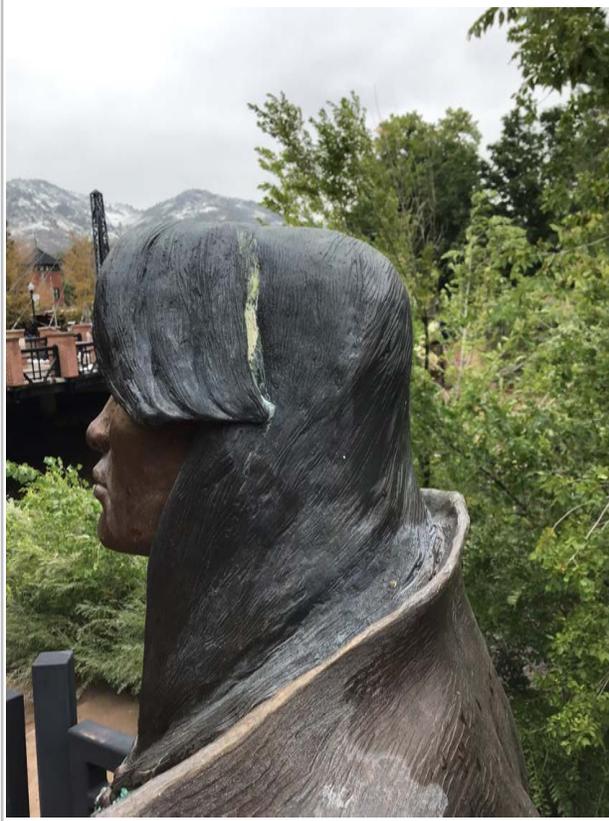
This sculpture is in fair condition overall. A broken tassel element was observed near the figure's feet. Blue paint on the figure's jewelry is flaking and chipped. Pooling water near the feet and associated corrosion products was observed. Foliage inside the pot near the figure's feet is trapping moisture and will likely lead to further corrosion. Bird droppings, grime, and wax buildup are present overall. Bird droppings have caused corrosion to the head and face.

Remove loose plant material. Wash overall with a non-ionic detergent and soft brush. Scrub with a stiff brush to remove loose corrosion. Rinse with water. Use solvent to remove excess and dirty wax. Apply a hot wax coating overall and buff when set with a soft brush. Apply a cold wax coating to the feet and pot,

Repair broken element, if possible. Mitigate corrosion products. Cover mouth of pot (possibly with mesh) to prevent accumulation of foliage and other debris. Inpaint losses to blue in jewelry and seal painted elements overall.
