CERTIFICATE OF APPROPRIATENESS APPLICATION

Heritage Square

Re: Heritage Square Application for Certificate of Appropriateness for Demolition

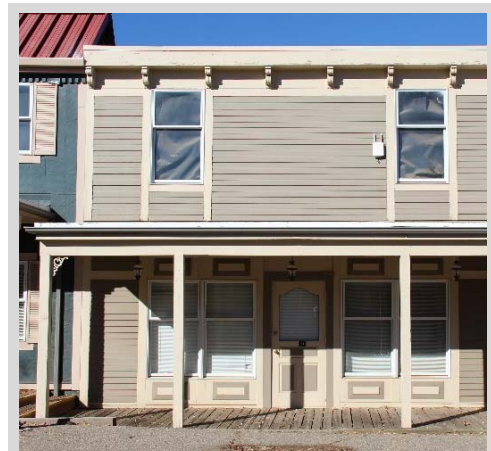
This façade from Building T is a typical example of the lack of detailing in these 1980s structures

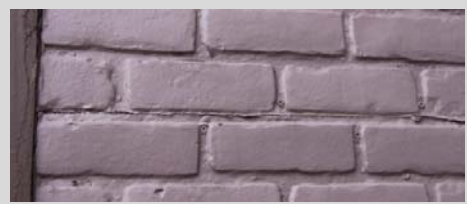
This detail of Building B shows a painted brick façade, with closer review revealing the screws that fasten the plastic bricks to the wood structure

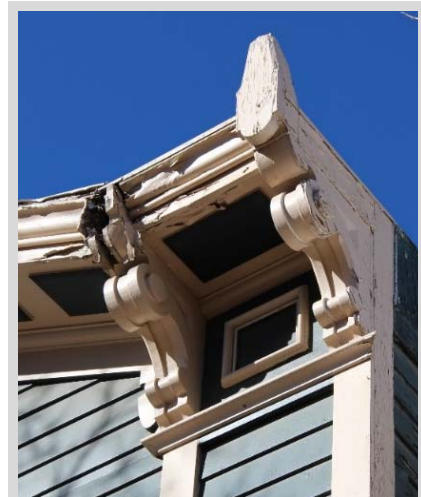
Detail photograph showing deteriorated wood cornice
