2007 Vidler Tunnel Repairs

Flossie Vein Collapse Area

East Portal Rebuild

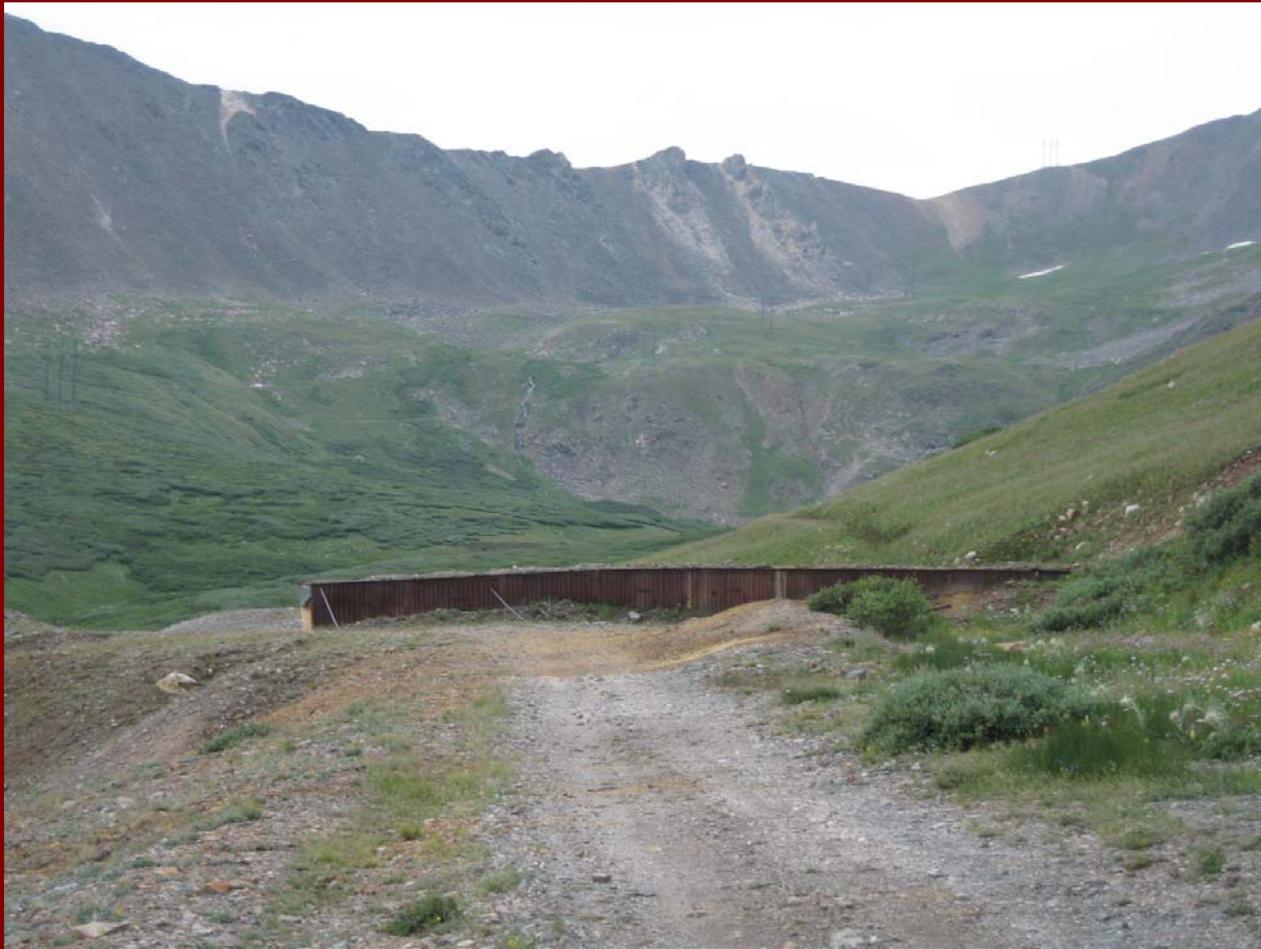
The old east portal structure viewed from the north

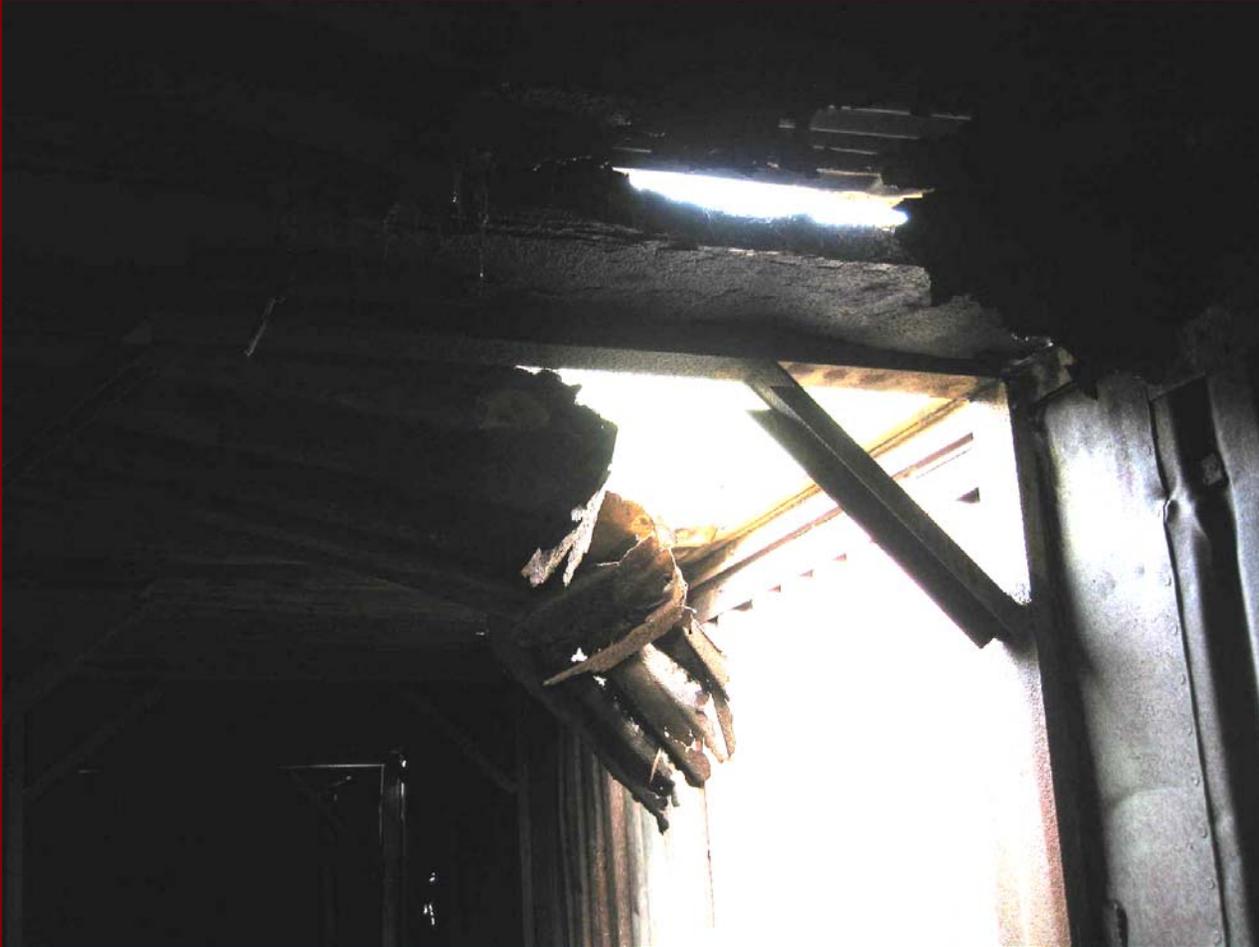
The roof of the east portal was made of boxcar side panels and was collapsing, allowing vandals to enter and presenting a danger to City workers.

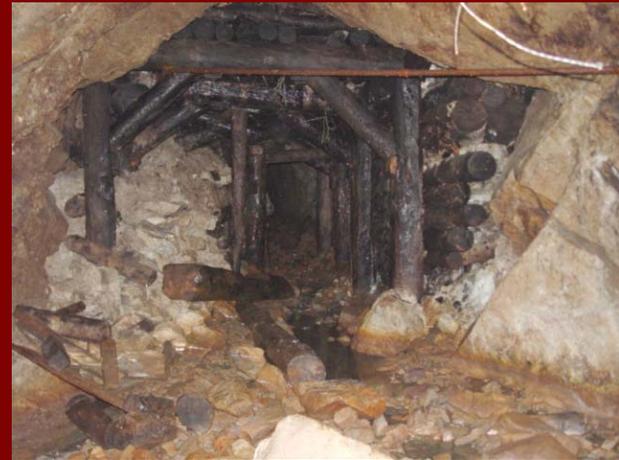
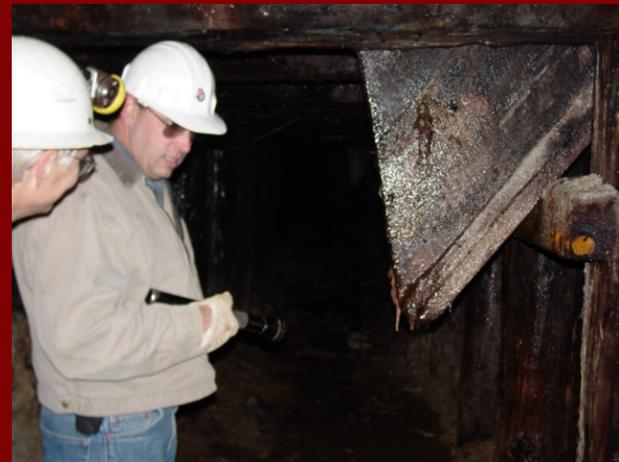
The Flossie Vein crosses the Vidler Tunnel at an angle of about 45 degrees at approximately 800 feet from the East Portal

- Mining was performed up to 90 feet above the main bore, 140 feet to the left and 160 feet to the right. The area where the mining was done was shored up with timber in the late 1800s.(Photo in 2003)
The wooden chutes are where the silver ore was dropped into mine carts.

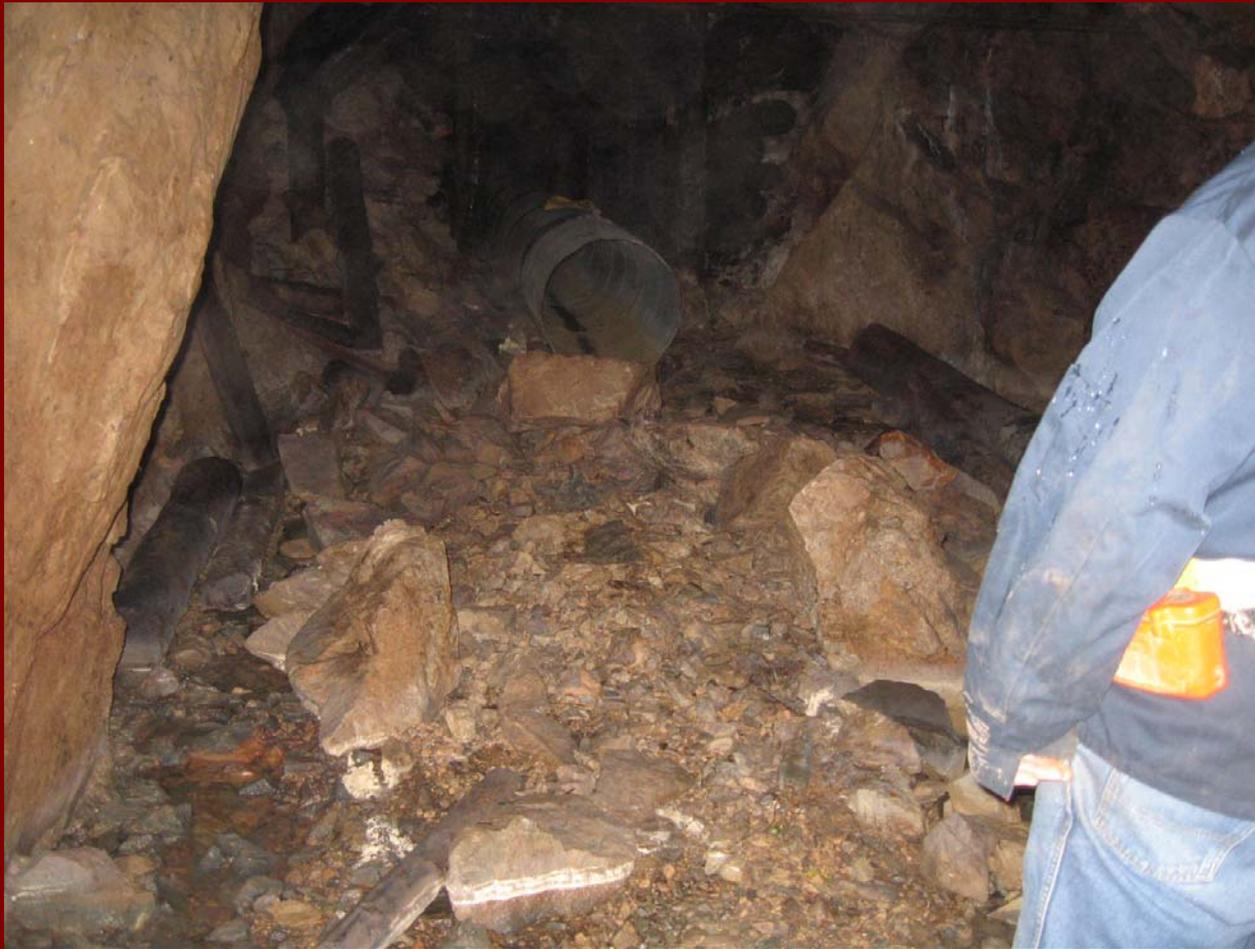
In the Fall of 2006 we installed a 30" pipe through the Flossie Vein intersection to allow water to flow in case of a collapse and the following winter the roof began to come down.

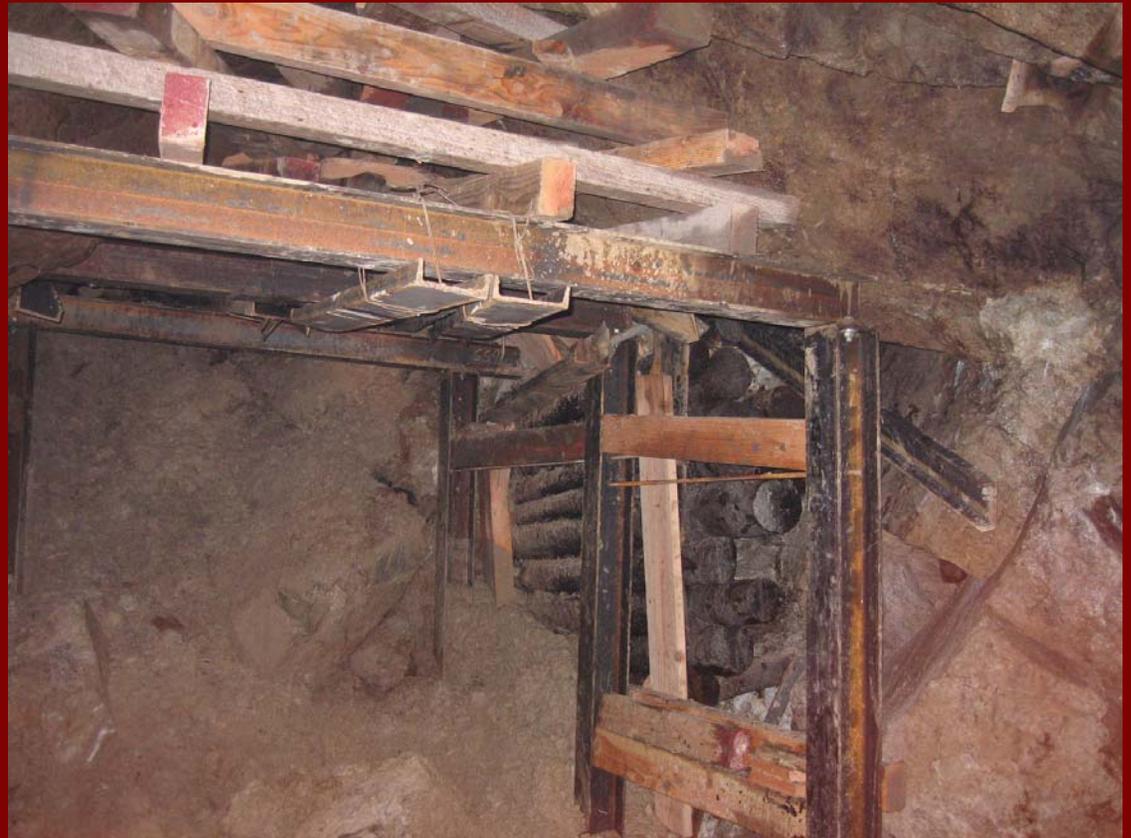
Material coming in from above

- After installing the first 3 steel sets to allow removal of debris from the tunnel floor, material (referred to as “muck”) began sloughing in from the roof and right side.
- Over 100 tons of material had to be removed before the next steel set could be placed.

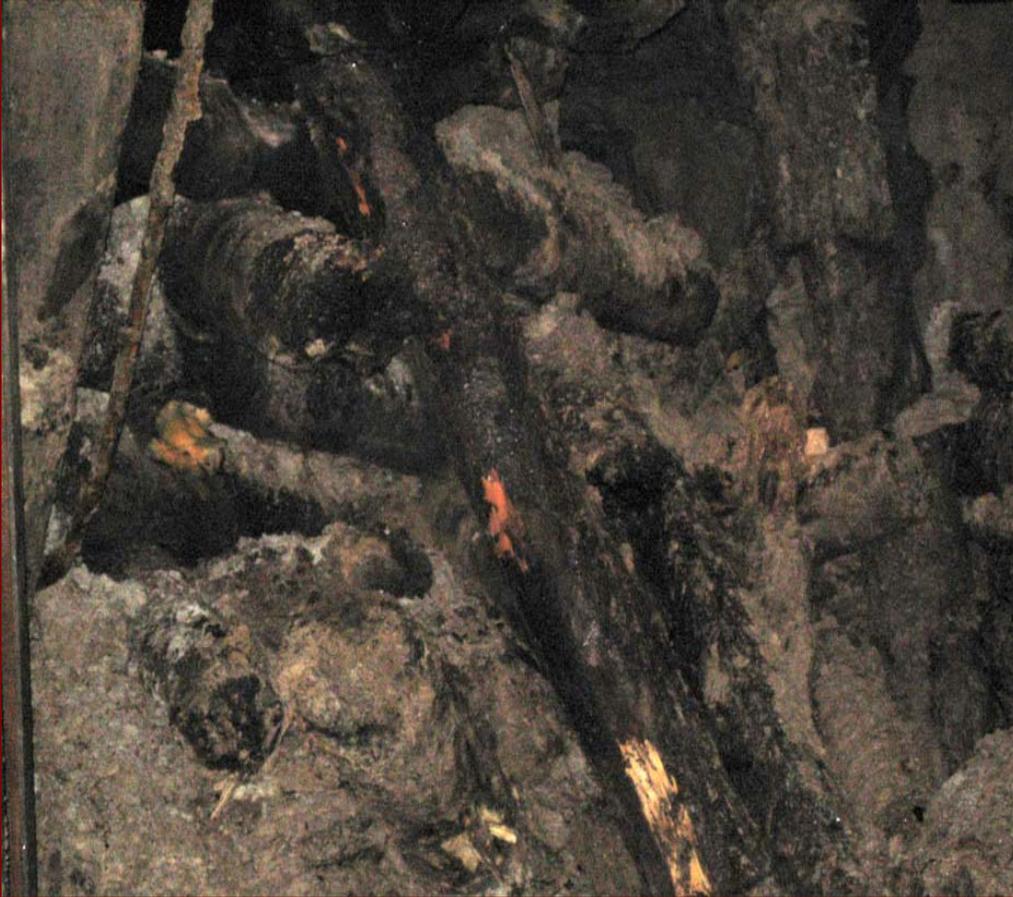
First Muck and then Timber

- After removing the muck which had come in from the right another steel set was placed and timber started coming in from above.

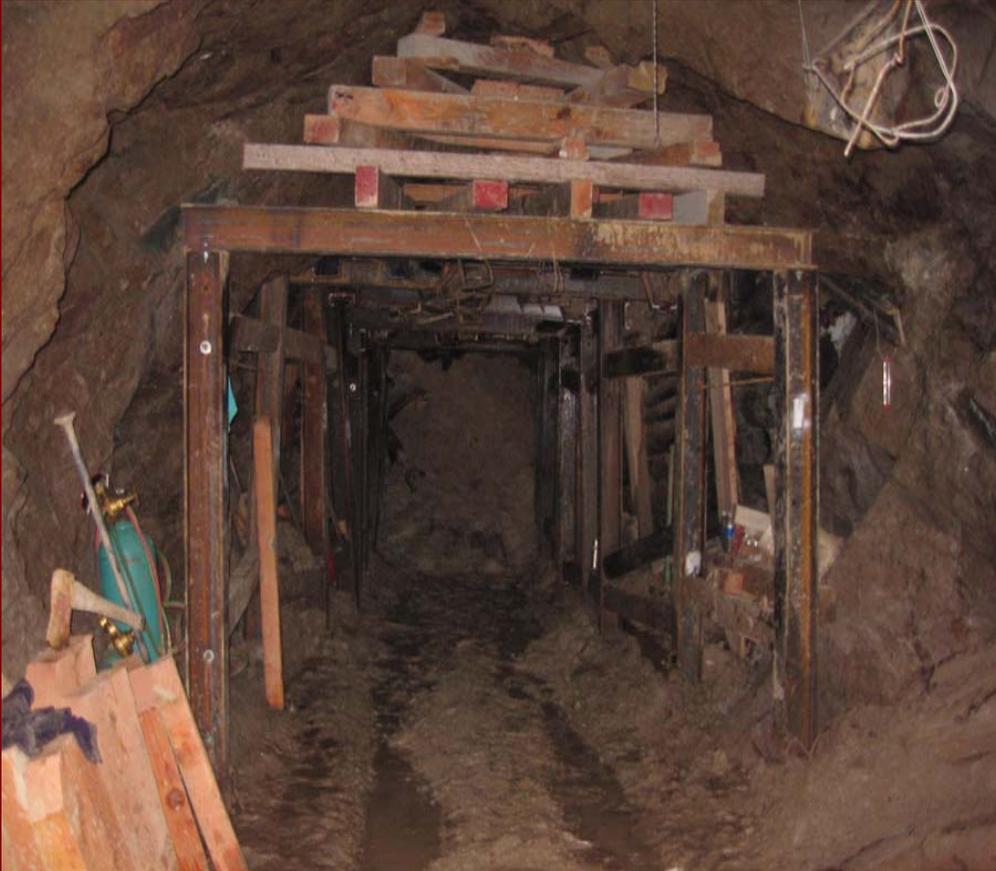
The timber and then more muck

- The timber was removed and three more steel sets were placed when the muck started coming in from the left.
- Another 100 tons

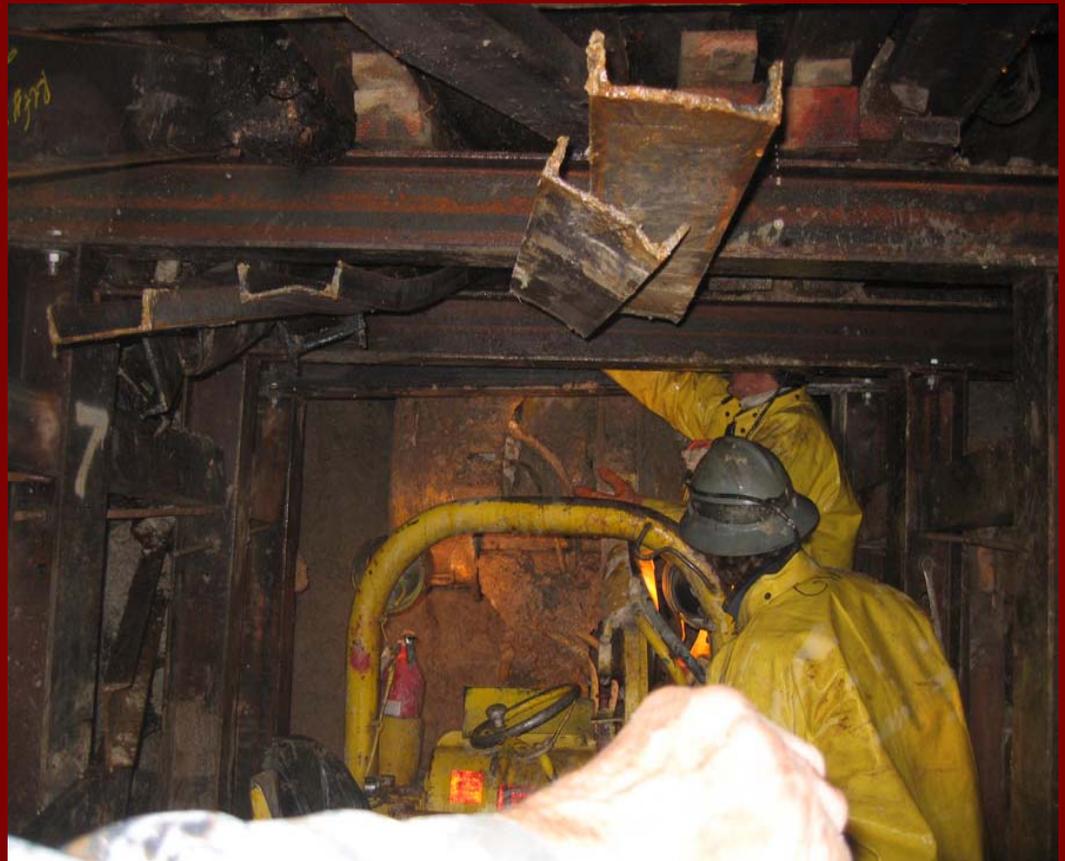
Nearing the end with steel sets

- The last few steel sets were put in place on September 18, 2007. Notice the smaller steel channels bending
