COLORADO CULTURAL RESOURCE SURVEY

## Architectural Inventory Form

1. Resource Number: 5JF.3267
2. Temporary Resource Number: N/A
- Parcel Number: 30-273-05-009
- SHF/CLG Grant Number: N/A
- Temp. Survey Number: 2
3. County: Jefferson
4. City: Golden
5. Historic Building Name:
- Boutwell/Rehkov/Satterfield House
6. Current Building Name:
- Aegis Professional Realty

7. Building Address: 514 9th Street, Golden
8. Owner Name and Address: John S. Jordan, 514 9th Street, Golden, Colorado 80401

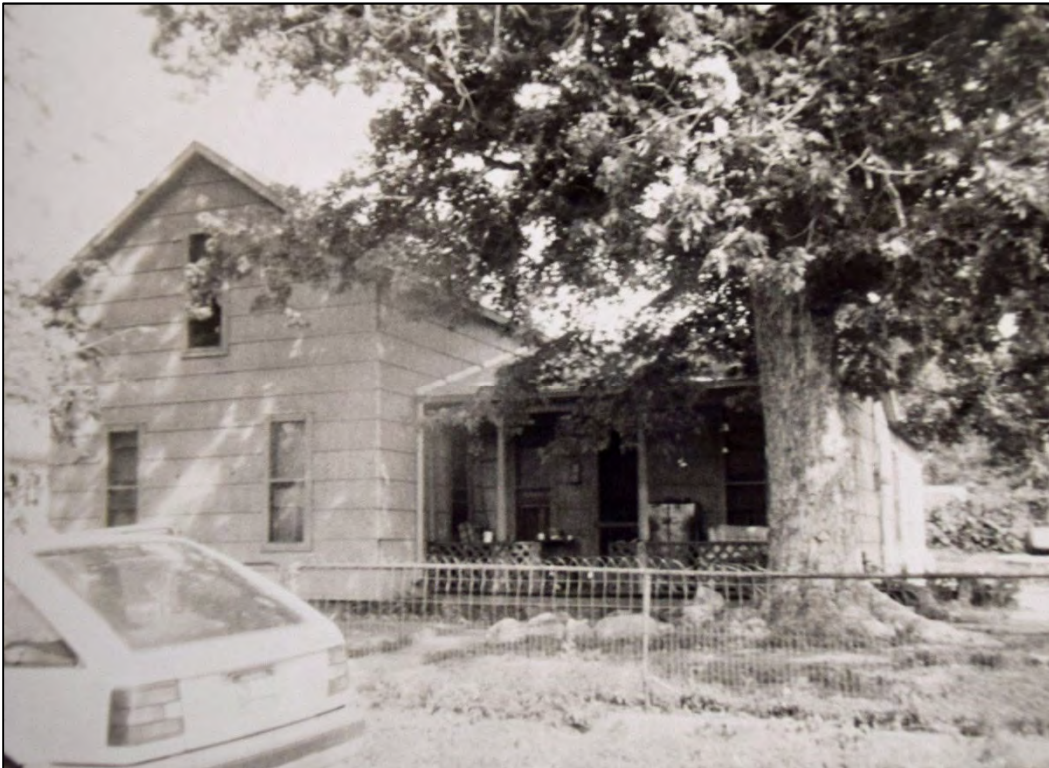
5JF3267. The front and east wall of the house are shown in this ca. 1980s assessor appraisal card photograph. SOURCE: Jefferson County Assessor, appraisal card, in the files of the Jefferson County Archives, Golden, Colorado.

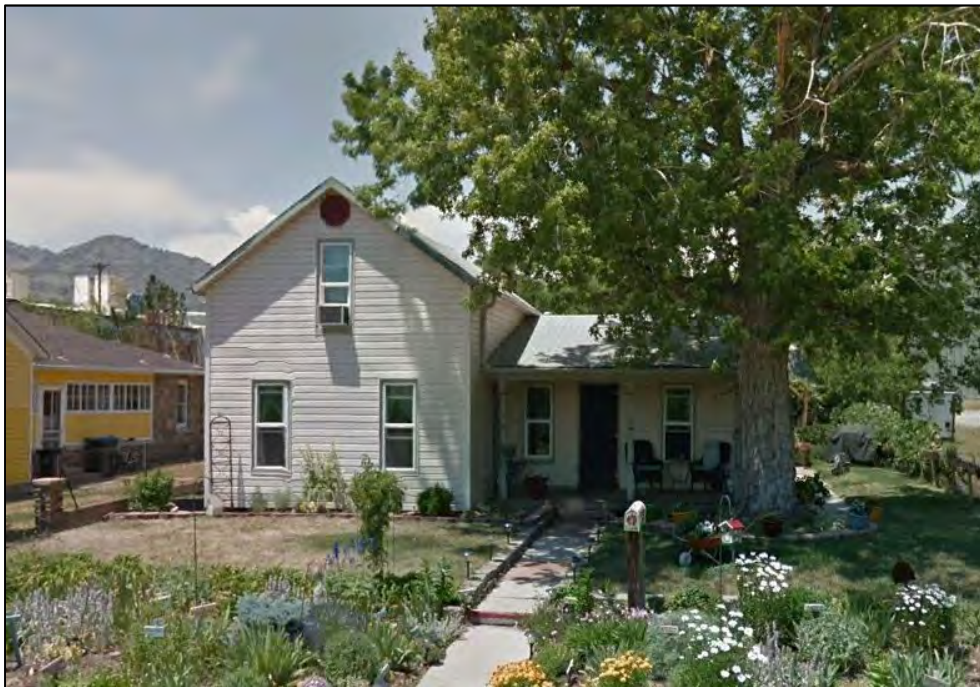
5JF3267. The front of the house are shown in this June 2017 Google Street image, prior to fenestration changes and construction of a front pergola. SOURCE: Google Street image, June 2017.

Originally a dwelling, this building now is used as an office. The 1882 birds-eye-view map shows it with the one-and-a-half-story section to the west and the intersecting one-story wing to the east with a rear wing. The building displays substantial changes in recent years based on a 2012 Google Street image, including recladding of the front (the remaining walls already had vinyl siding then); addition of doors and pergola to the first story of the front gable; installation of the decorative vergeboard on the front gable; and installation of the current door and windows on the front of the one-story east-west wing. The roof slope of the east-west wing had been extended by 2012; the porch then displayed turned spindle supports (now replaced with thick square posts). All windows appear to be replacements.

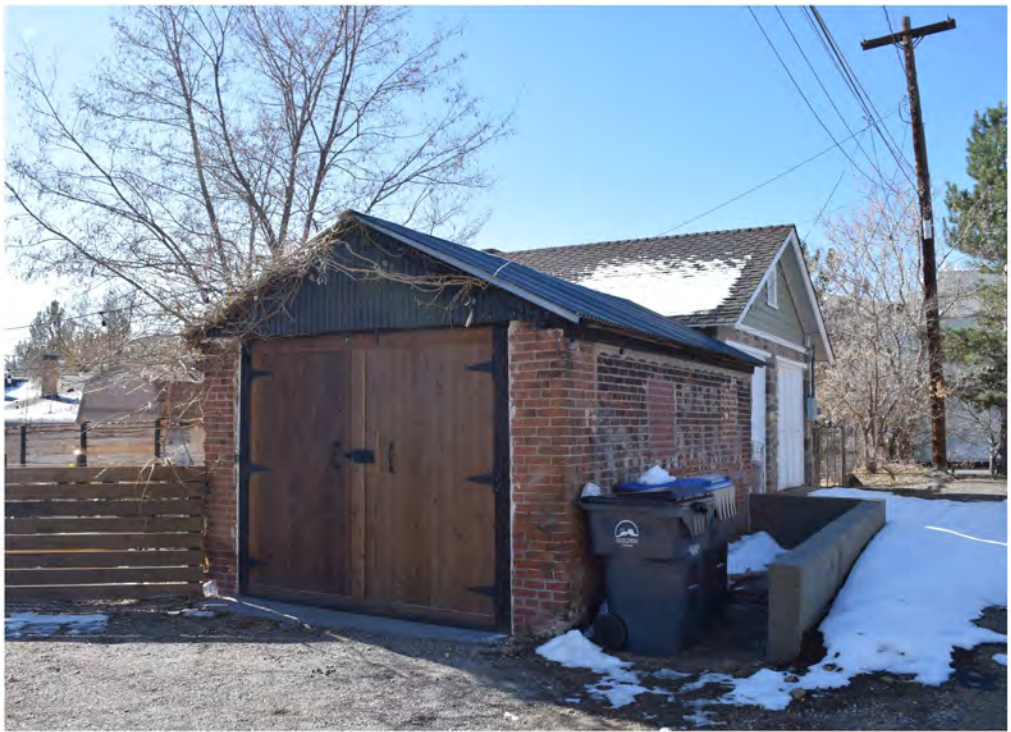
5JF.3267\_Jefferson\_Golden\_06\_514-9thSt-Res2\_THSimmons\_Nov2018\_SSW

2. Barn/Shed (ca. 1878-82, Willits map, 1878 and Stoner map, 1882). The Tour of Historic Golden provided a ca. 1882 year of construction for this barn/shed. This one-story brick front gabled roof barn/shed stands at the northwest corner of the parcel and faces east. The front contains double vertical board doors with strap hinges (recent replacements); the gable face is clad with corrugated metal panels. The south wall has an off-center paneled wood door to the west, while the west wall is not visible. The north wall (which faced active railroad tracks) contains the remnant of a ca. 1909 painted commercial wall sign in black and white for Durham tobacco, originally reading "Smoke Durham." The wall has two sections of infill brick (possible former windows). The roof has slightly overhanging eaves and is clad with corrugated metal panels.

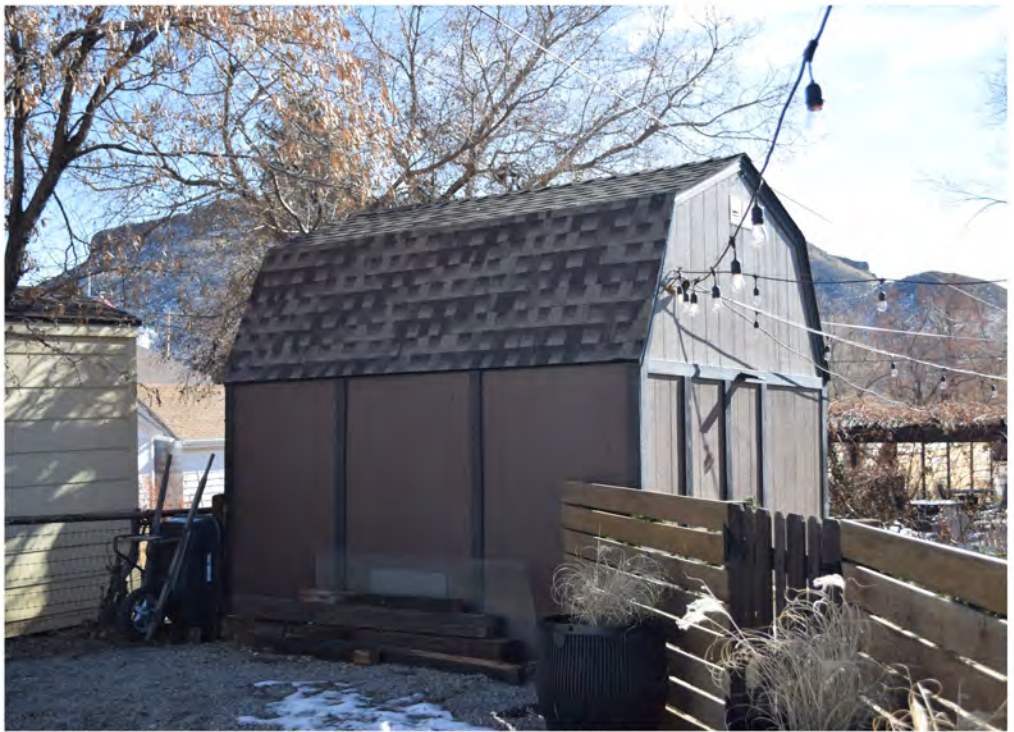
5JF.3267\_Jefferson\_Golden\_10\_514-9thSt-Res3\_THSimmons\_Nov2018\_E

3. Shed (ca. 1938-99, Sanborn map, 1938 and Google Earth aerial, 1999). This shed is not shown on the 1938 Sanborn map but appears to be present on the 1999 Google Earth aerial. Based on visible wall materials, it appears to date to the latter part of the twentieth century. The one-story side-gambrel roofed shed is located to the rear on the east property line and faces south. The walls are clad with T1-11 type wood paneling with widely spaced battens. The south wall contains off-center double doors composed of the same material. The remaining walls are unfenestrated. The roof is clad with composition shingles and has flush eaves.
