COLORADO CULTURAL RESOURCE SURVEY

Architectural Inventory Form

1. **Resource Number:** 5JF.1022
2. **Temporary Resource Number:** N/A
- Parcel Number: 30-284-17-002
- SHF/CLG Grant Number: N/A
- Temp. Survey Number: 3
3. **County:** Jefferson
4. **City:** Golden
5. **Historic Building Name:**
Schultz House, Jackson House/Rental Property
6. **Current Building Name:**
Golden Solar, Your Ashtanga Yoga

7. **Building Address:** 612-14 10th Street, Golden
8. **Owner Name and Address:** 614 10th St. LLC, 305 Lookout View Drive, Golden, Colorado 80401

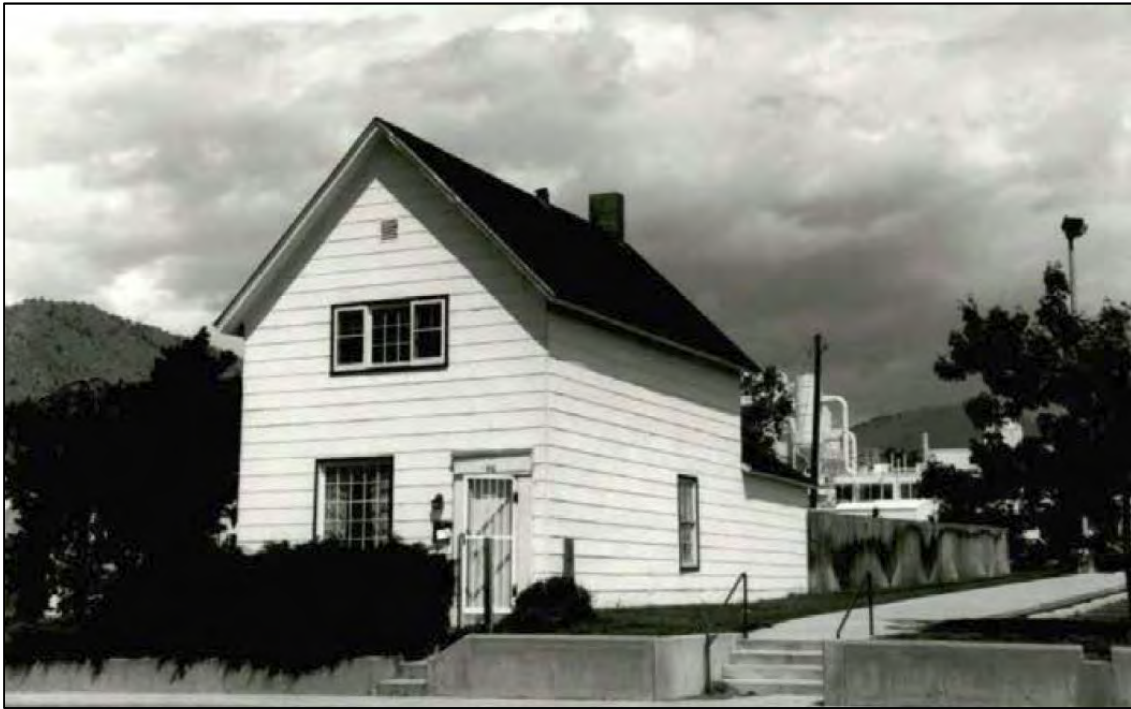
5JF1022. The front and east side of the house is shown in with wide horizontal siding and different windows from present in this 1995 survey photograph. SOURCE: C. Mehls, Historic Building Inventory Record form, 5JF.1022, 17 June 1995, in the files of the History Colorado, Denver, Colorado.

The 1890 Sanborn map shows the one-and-a-half-story part of the house extending farther south than the 1895 map. The 1938 Sanborn shows open front porches on both the one-story and one-and-a-half-story parts of the house; the latter section had a full-width porch. A 1995 survey form photograph of the one-and-a-half-story part of the building shows a considerably different appearance: wide horizontal siding; a different front door with security door; a wide multi-light window west of the door; and a short tripartite window in the gable face (nine-light flanked by one-over-one-light windows). Based on Google Street images, most of the current fenestration was in place by May 2017; the present front door and east window on the one-and-a-half-story section were added after that date. The current fenestration and cladding may better reflect the dwelling's original appearance, but this is not documented. The mural was added to the east wall in March 2018.

The integrity of the principal building is undetermined. It now has a radically different (and improved) appearance from what is shown in a 1995 survey photograph. It is unknown if the current siding is original or a recladding. Similarly it is unknown if the window and door styles and fenestration reflect the property's historic appearance or if it is speculative. It is not known if the changes were based on historic photographs or drawings or if construction followed the Secretary of Interior's standards.

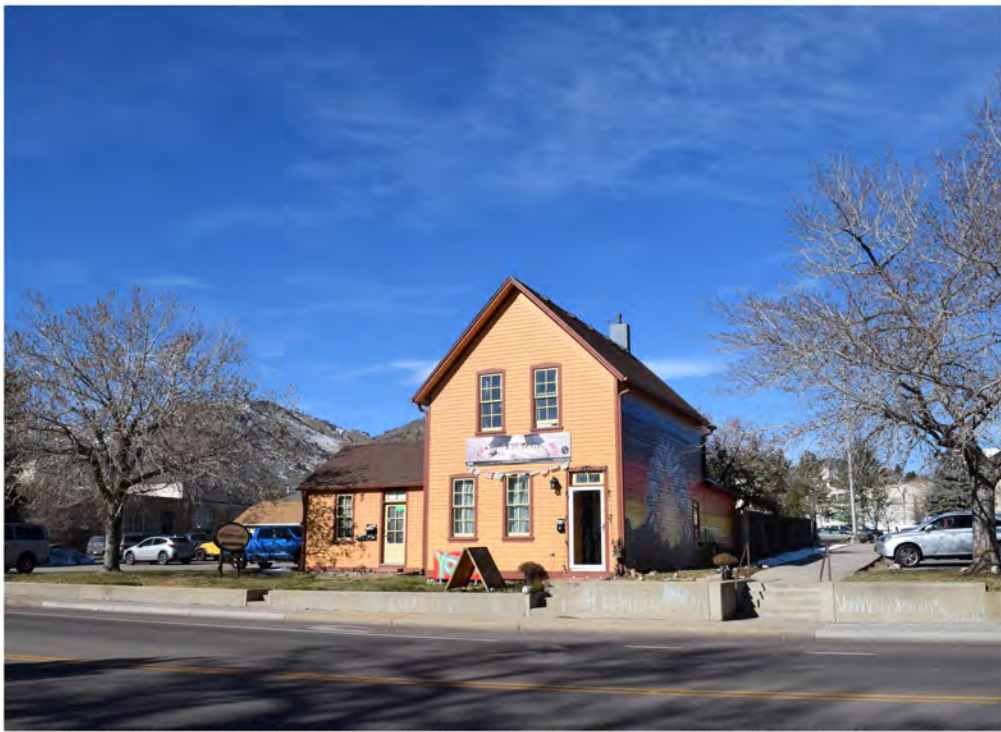
5JF.1022_Jefferson_Golden_01_612-14-10thSt_THSimmons_Nov2018_WNW

The cross-gabled roof primary building (Resource 1) is 1,267 square feet in area and consists of a one-and-a-half-story north-south component to the east and a one-story east-west wing to the west, with one-story additions to the rear. The building has a stone foundation and walls are clad with wood lap siding with a horizontal foundation board.

The front of the one-and-a-half story wing features an off-center glazed door (replacement) with a two-part transom and a lintel pediment; the door opens onto a flagstone porch. West of the entrance are two four-over-four-light wood windows with pedimented lintels; two of these windows are also in the gable face. The west wall has one of these windows. The east wall displays a large mural added in 2018 and an eight-light casement window to the north (added after May 2017). The north gable face holds two eight-light casement windows with pedimented lintels. The eaves are flush and the roof is clad with asphalt composition shingles. There is a metal clad chimney on the ridge of the one-and-a-half-story wing at the north end. Solar panels are on the west roof slope of that wing.

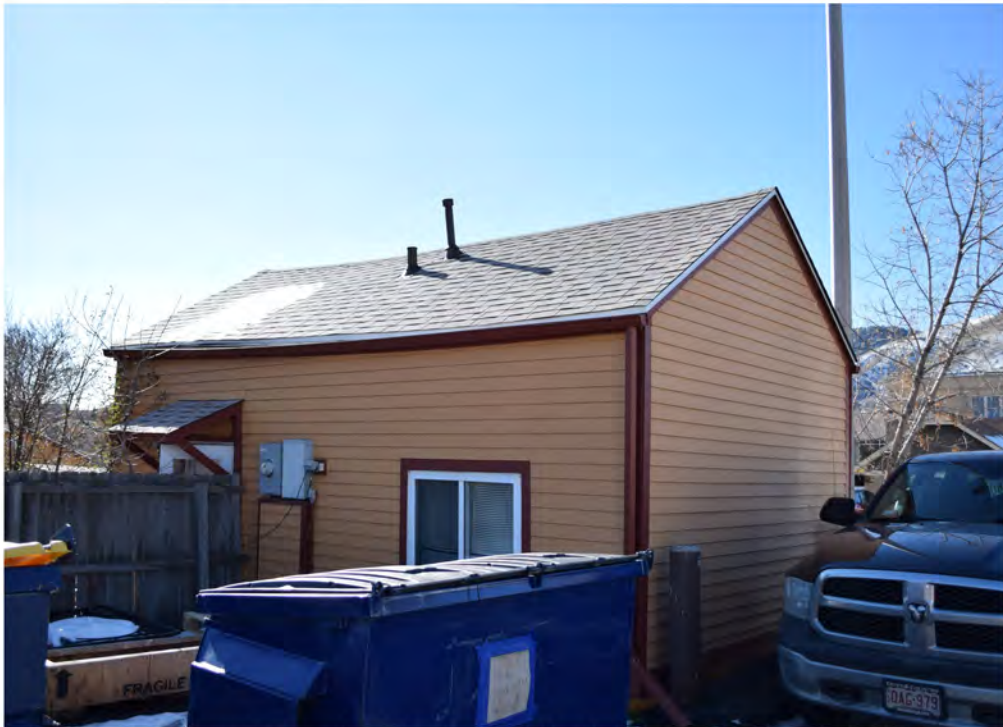
5JF.1022_Jefferson_Golden_07_612-14-10thSt-Res2_THSimmons_Nov2018_S

2. Secondary House (ca. 1890-95). Located at the northwest corner of the parcel, the side-gabled roof one-and-a-half-story building faces east. Sanborn maps and the height of the walls support the one-and-a-half-story description despite the lack of windows in the upper story. The walls are clad with horizontal wood clapboards. The front contains an off-center flush door to the south (with a pet door) sheltered by a shed hood. To the north is a two-part sliding window. The south wall has two-part vinyl sliding windows on both stories, while the west wall holds a two-part vinyl sliding window toward the south end. The north wall is unfenestrated. The roof has flush eaves and is clad with asphalt composition shingles.

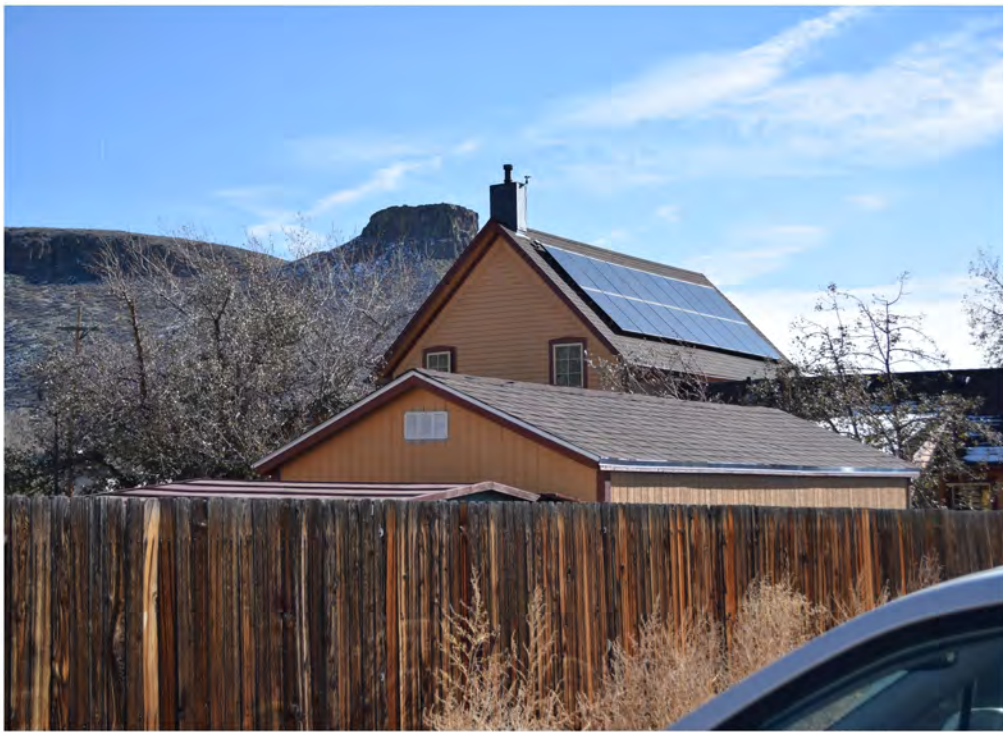
5JF.1022_Jefferson_Golden_09_612-14-10thSt-Res3_THSimmons_Nov2018_E

3. Shed (ca. 2015-17). This one-story, side-gabled roof rectangular shed abuts the west property line. The building faces east and measures about 20' x 11'. Its walls are clad with T1-11 type siding with cornerboards. The east wall contains double doors composed of the same materials as the walls. On the north there is a louver in the upper gable face. The eaves are flush and the roof is clad with asphalt composition shingles.

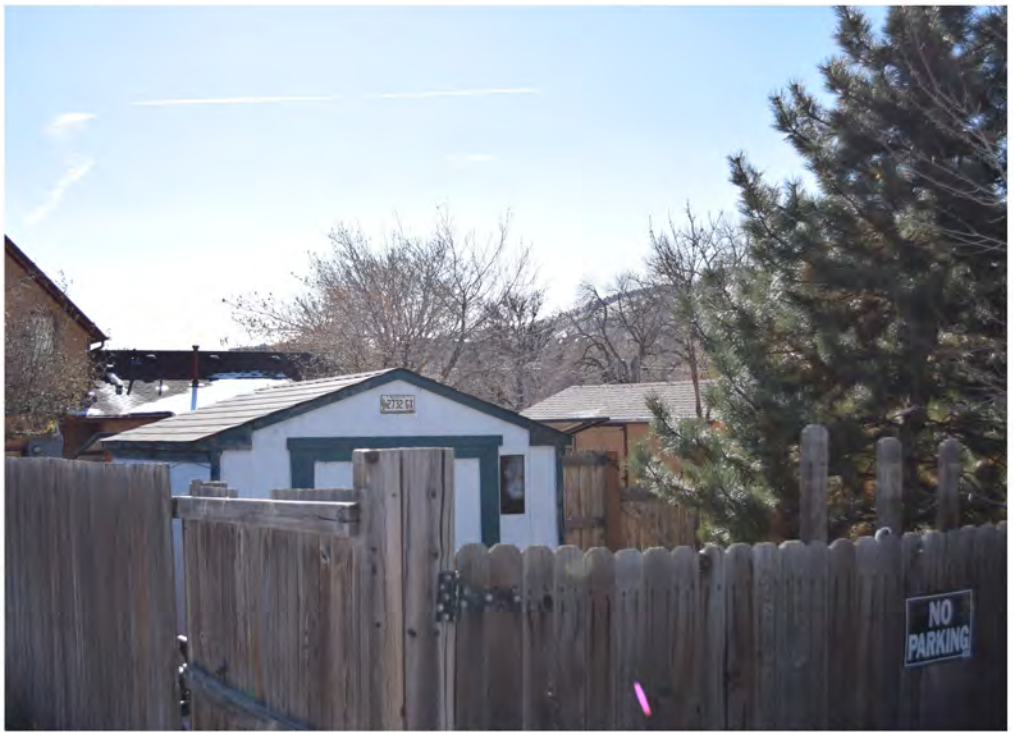
5JF.1022_Jefferson_Golden_10_612-14-10thSt-Res4_THSimmons_Nov2018_s

4. Shed (pre-1999). Located on the west property line north of Resource 3, this small (approximately 9' x 7') shed appears to face east. It has a shallow front gabled roof. The walls and roof appear to be clad with metal ribbed panels.
