BE AWARE – GIVE WILDLIFE A BRAKE!

Due to frequent vehicle/animal collisions, the Colorado Department of Transportation (CDOT) installed an at-grade wildlife crossing on US 6, between Heritage Road and 19th Street, in late 2010.

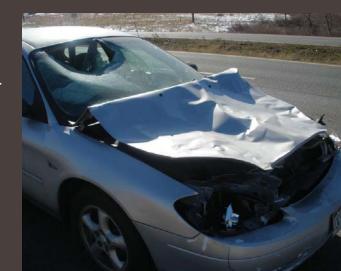
Based on collision data collected by the City between 2007 and 2014, vehicle/wildlife collisions significantly decreased in 2011, the year after the at-grade wildlife crossing was installed. In recent years, the number of collisions has begun to steadily increase.
