Council Memorandum

Re: 311 10th Street Building Feasibility Study Review

Golden Civic Center: Feasibility Study

Final Due Diligence Report

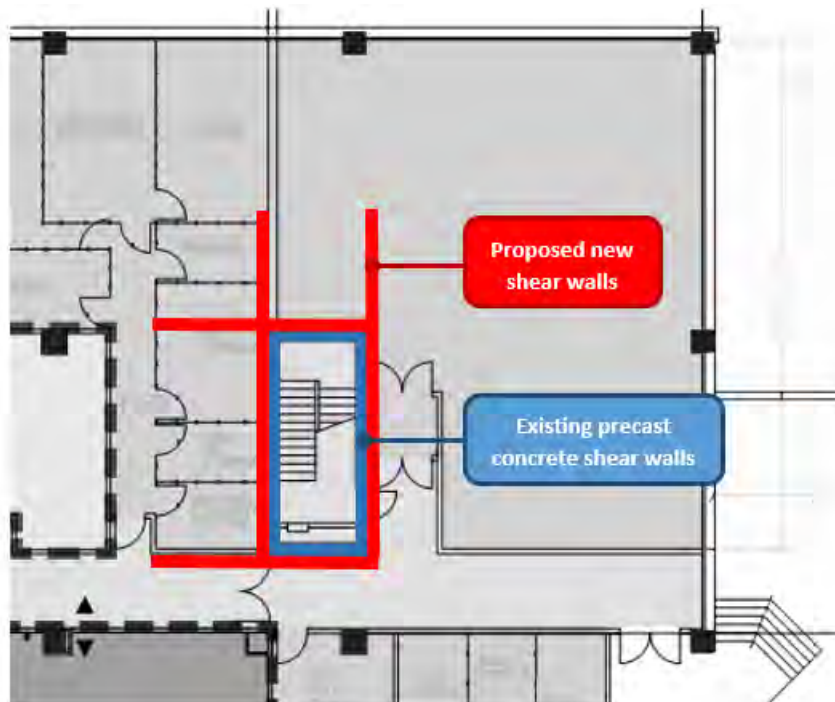
Figure 1: Proposed layout of new shear walls at each stair tower

We propose new concrete shear walls be added as extensions to the existing precast shear walls. Refer to Figure 1 for a concept level layout of proposed shear wall locations. New concrete will be formed around the existing core walls which will extend out from the cores. Adding the new walls close to existing walls will allow connection of the new walls to the existing foundations and reduce the amount of new foundation elements that will be needed. At the ends of new shear walls that do not extend to the next column, new foundations will be needed which will likely be micropiles with a pile cap. New grade beams may also be used along the wall lines to connect to adjacent drilled piers.

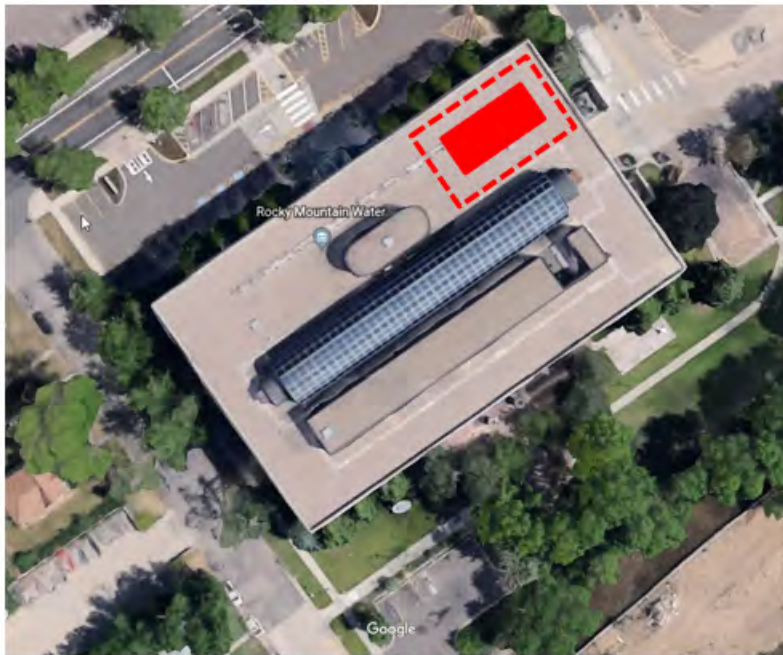
Fig. M-5 – Proposed New Rooftop Unit Location (image by Google Earth)

The new Police Department is expected to have a different occupancy schedule from all other building spaces. For this reason, a new Rooftop Unit is proposed to be installed on the north east section of the roof. This RTU will serve an estimated 15,000CFM at 20% outside air to VAV units in the Police Department. The RTU unit will have a heating coil served by the existing hot water system and a cooling coil served by the chilled water system. The new load from this unit be will accounted for in the sizing of the new chiller referenced above. A new chase will be created adjacent to the north east stairwell and a roughly 40"x30" duct will route down through the fifth and fourth floors to supply the Police Department. A corresponding 40"x36" duct will return air to the RTU. The necessary fire and smoke dampers will be installed with the new duct. The nineteen existing VAV units in this area will remain. An additional six new VAV units with heating coils will be estimated.

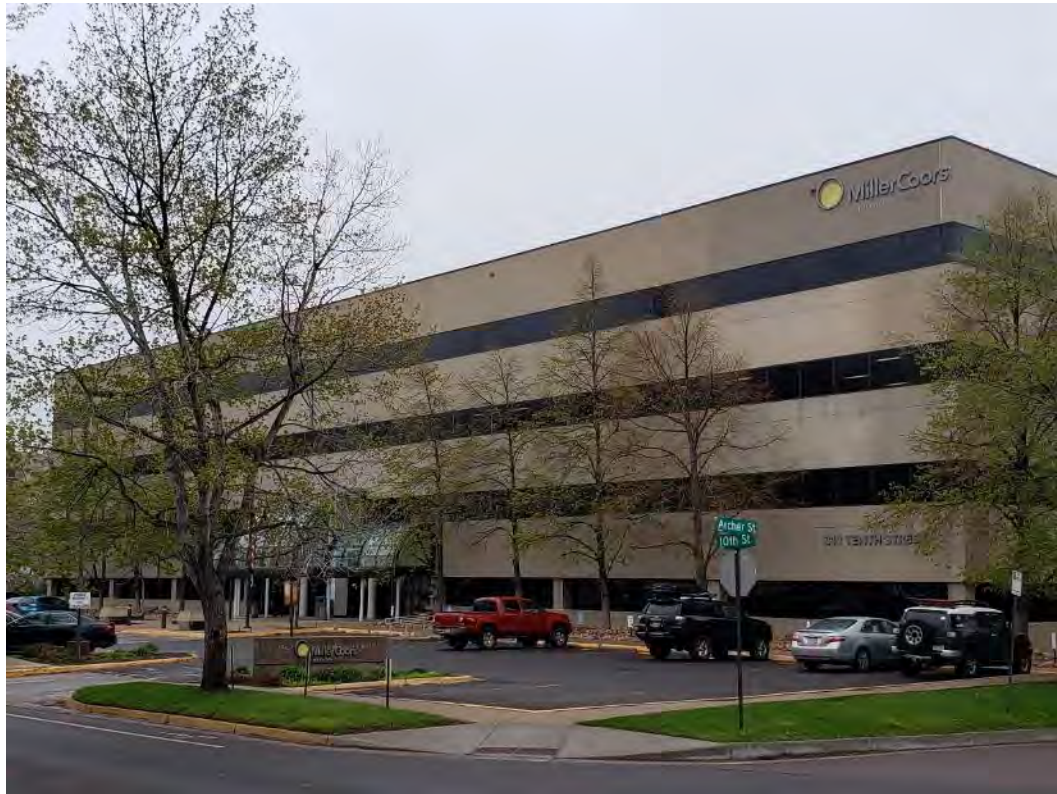
Photo 1

The property is a five-story building with approximately 170,000 square feet of office space designed in 1982 (Photo 1). The foundation system consists of 36" diameter concrete drilled piers drilled to bedrock, with 8" to 10" wide grade beams at the perimeter of the building. 24"-by-24" concrete columns extend from the tops of the drilled piers to the roof level. The floor framing at the first floor is 4" concrete slab-on-grade with 6" gravel fill below. Floor framing at the second floor through the roof consists of precast concrete double-tees supported by precast inverted-tee beams. There is also a 2 ½" (minimum) thick concrete topping slab at the floors and the penthouse floor; most of the roof does not have concrete topping. There is a large skylight at roof level that runs almost the entire length of the building. The framing of the skylight consists of hot-rolled steel angles and cold-formed metal studs. The penthouse adjacent to the skylight is framed with hot-rolled steel columns and beams. Lateral loads are resisted by cast-in-place concrete and precast concrete core walls that extend the entire height of the building.

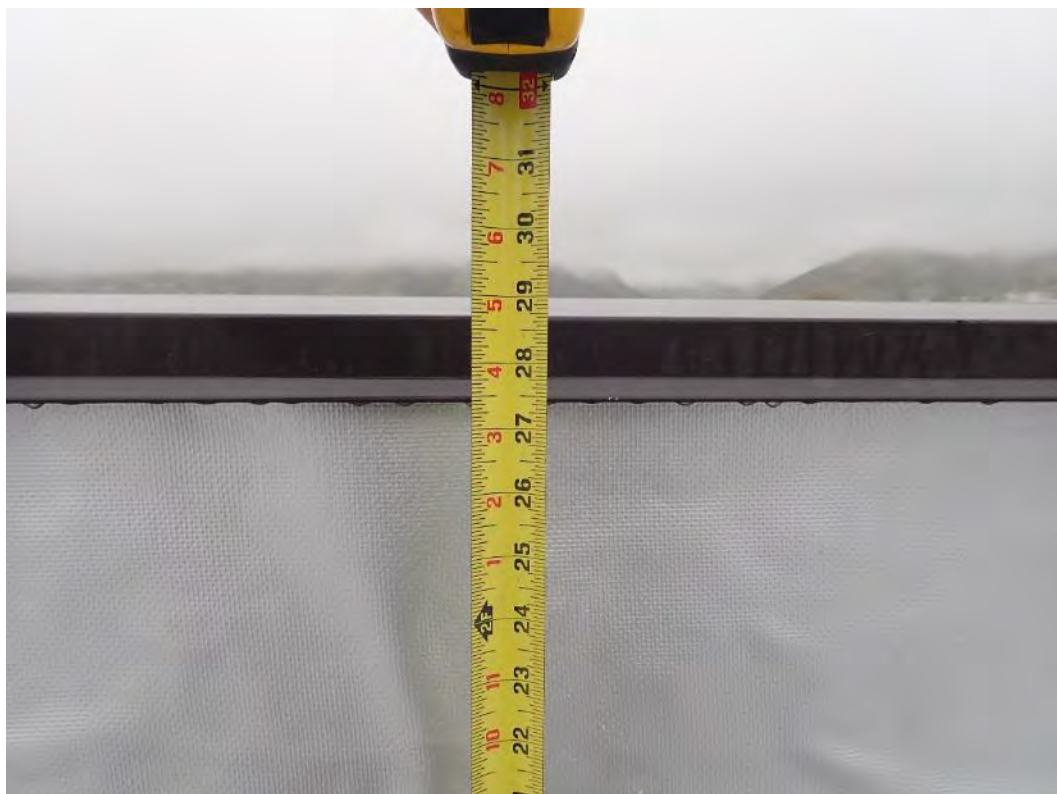
Photo 2

1. The roof is not equipped with a fall protection system and the roof parapets are not tall enough to be classified as guardrails per OSHA (Photo 2). As a result, fall protection is required on the roof when a worker is closer than 15-feet of a dangerous edge.

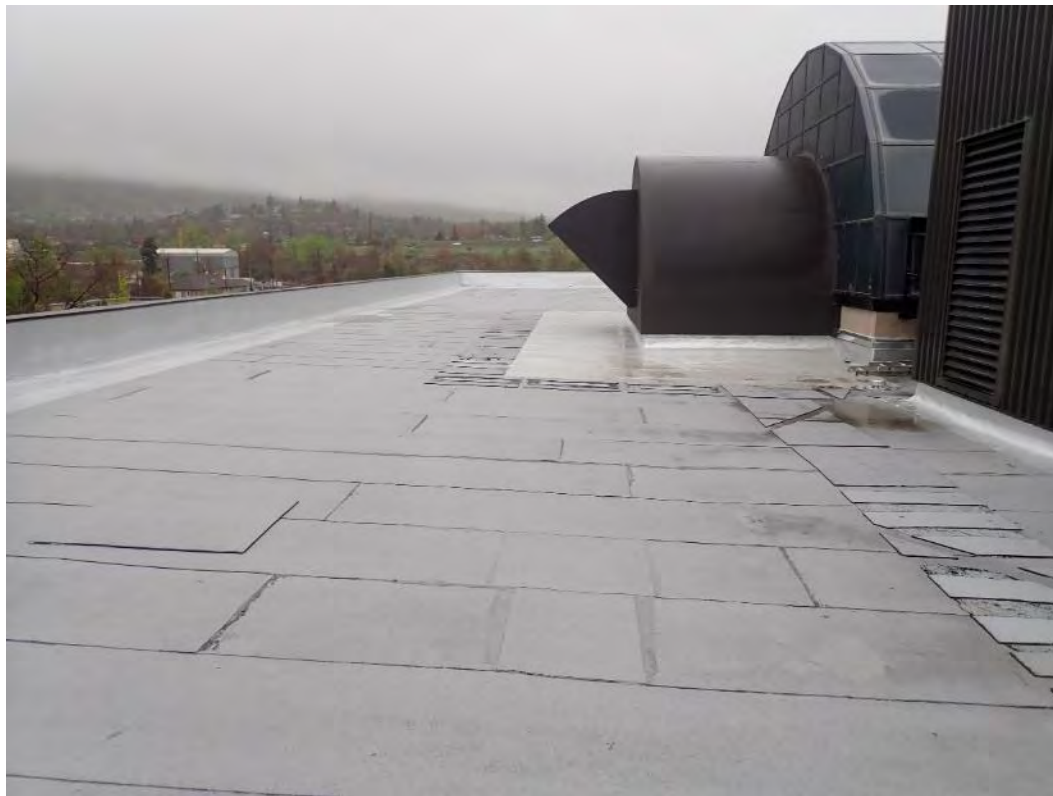
Photo 3

2. The roof is not equipped with a façade access system (roof anchors or davit bases) for window washing (Photo 3). As a result, window cleaning is performed via lifts.

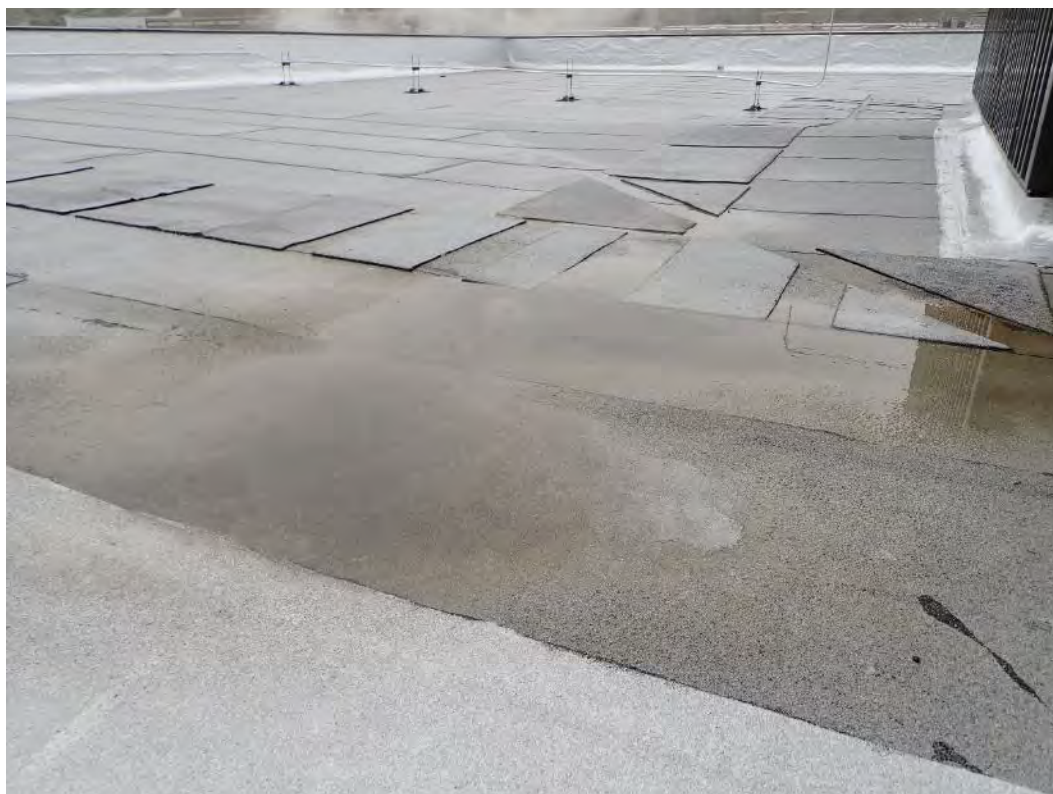
Photo 4

3. The penthouse high roof does not have fall protection.
4. Several areas of standing water were observed on the roof (Photo 4).
5. The connection of one cold-formed non-structural metal stud was broken in the mechanical penthouse (Photo 5).

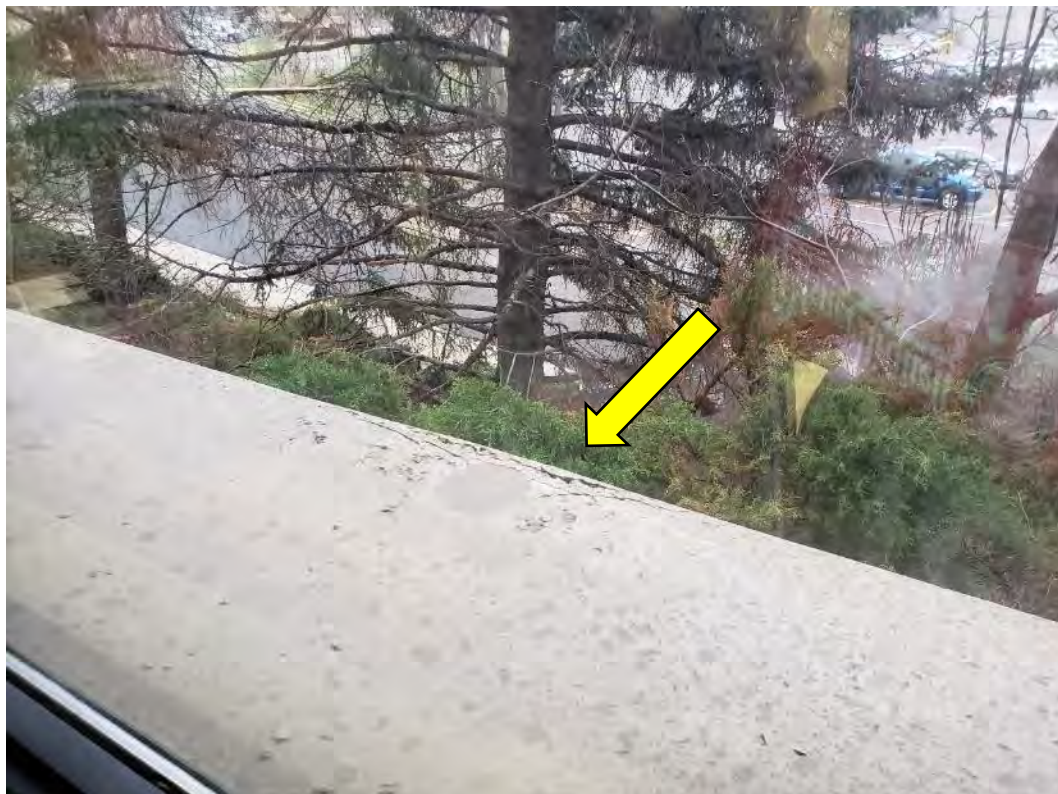
Photo 6

6. The concrete precast spandrels were spalled and deteriorated throughout the building where precipitation accumulates on top of the spandrel (Photo 6). This was generally observed at the 2nd floor spandrels where the windows are inset and in the center of the east and west faces of the buildings where the windows are inset (Photo 7).

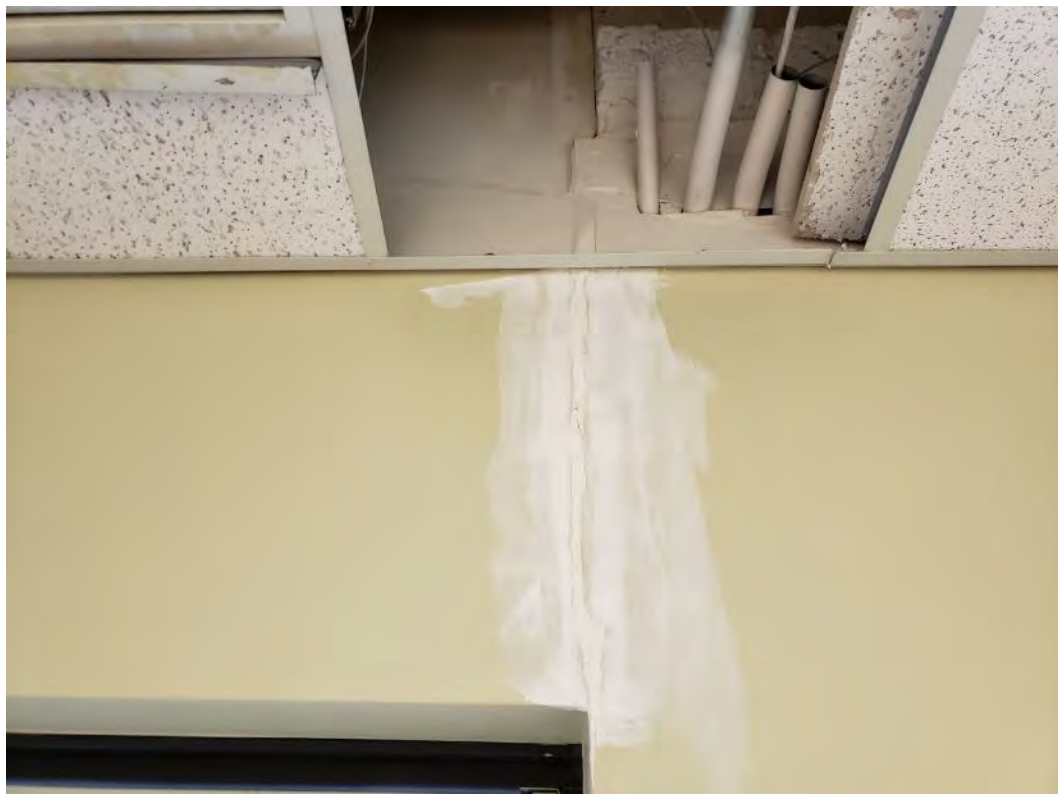
Photo 8

7. Drywall cracking was observed at the 2nd floor wall framing starting at the top of a window and extending up to one side of the column corbel supporting the 3rd floor precast inverted tee beams (Photo 8). The drywall cracking is a non-structural, cosmetic concern caused by small structural movement of the precast spandrels and/or precast columns. Drywall cracking was not observed on the other floors.

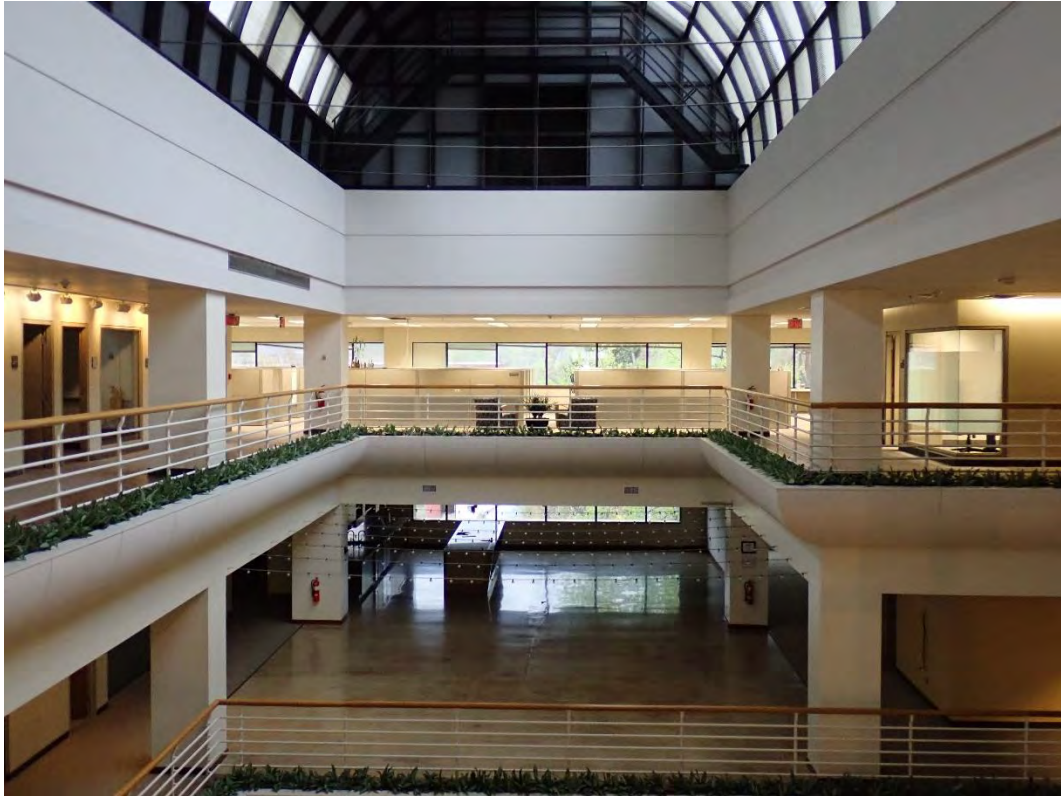
Photo 9

8. The atrium guardrails do not have the current code-required opening limitations. IBC 1015.4 specifies that the required guard rails “shall not have openings that allow passage of a sphere 4 inches in diameter from the walking surface to the required height” (Photo 9).

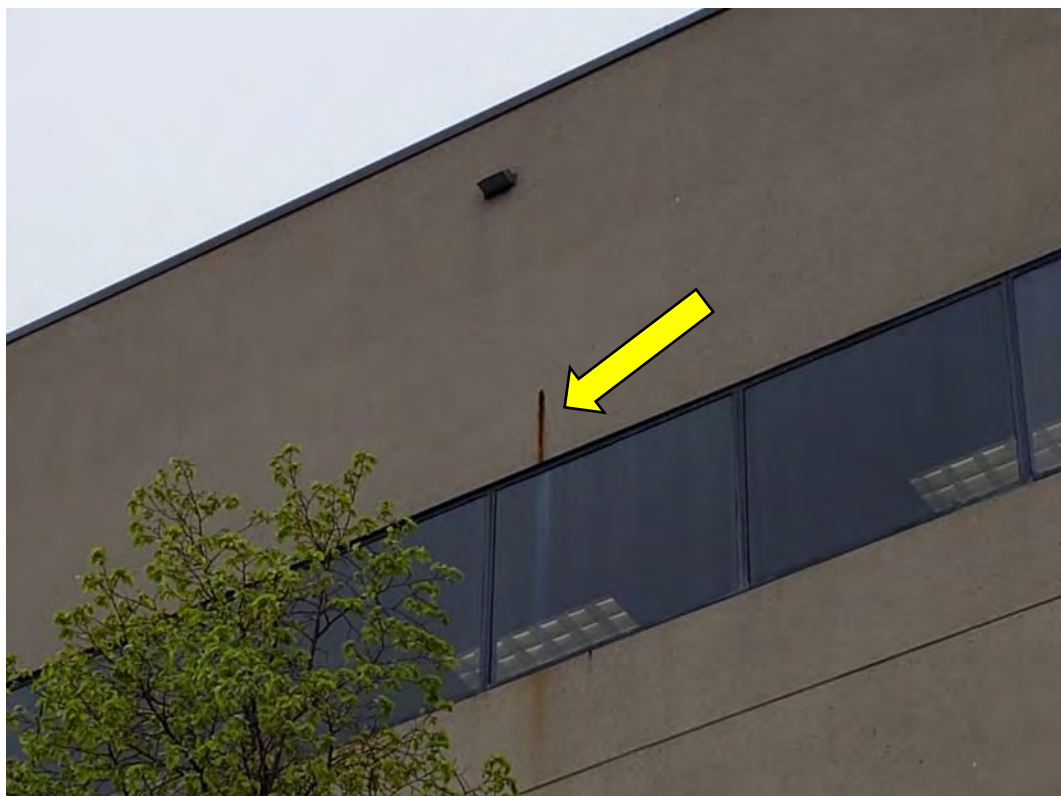
Photo 10

9. A few precast spandrels were rusted in isolated areas (Photo 10). This is likely caused by an embedded steel element located too close to the concrete surface that has rusted.

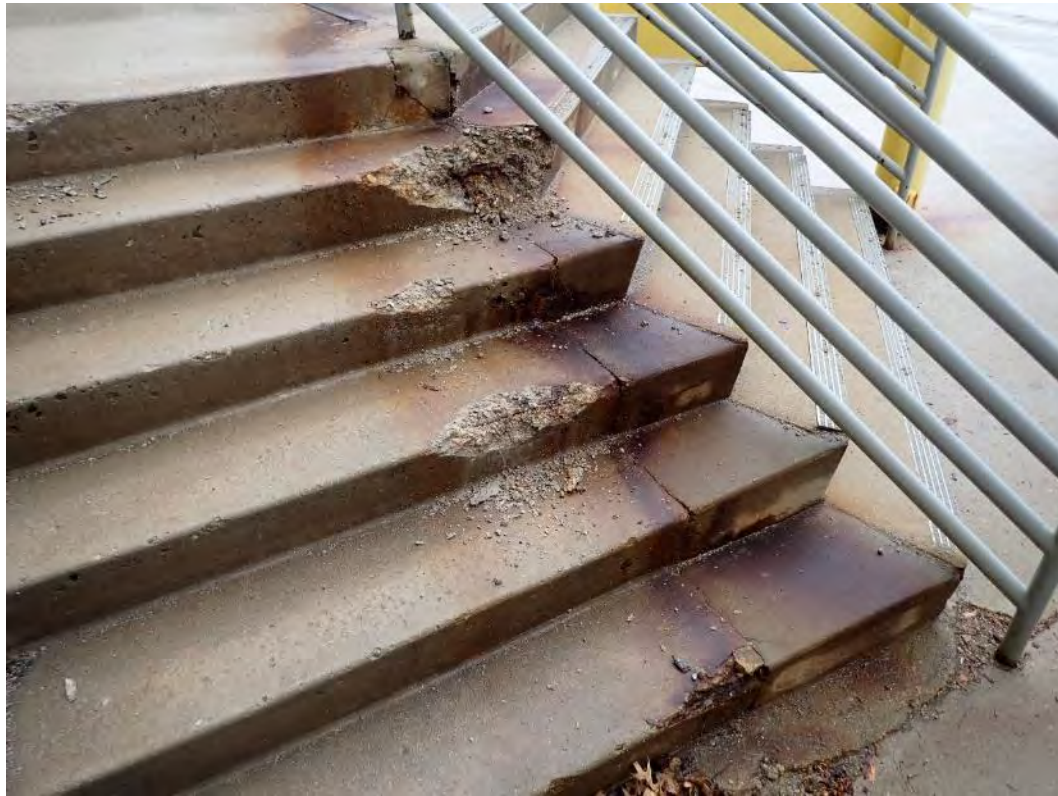
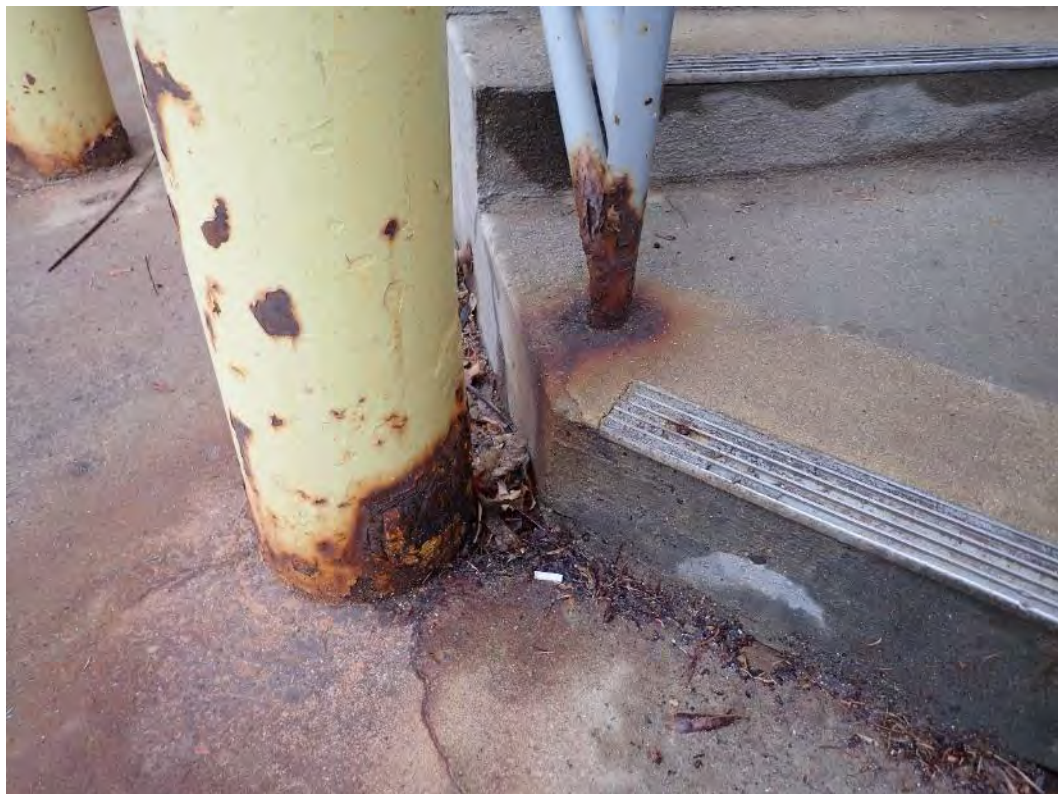
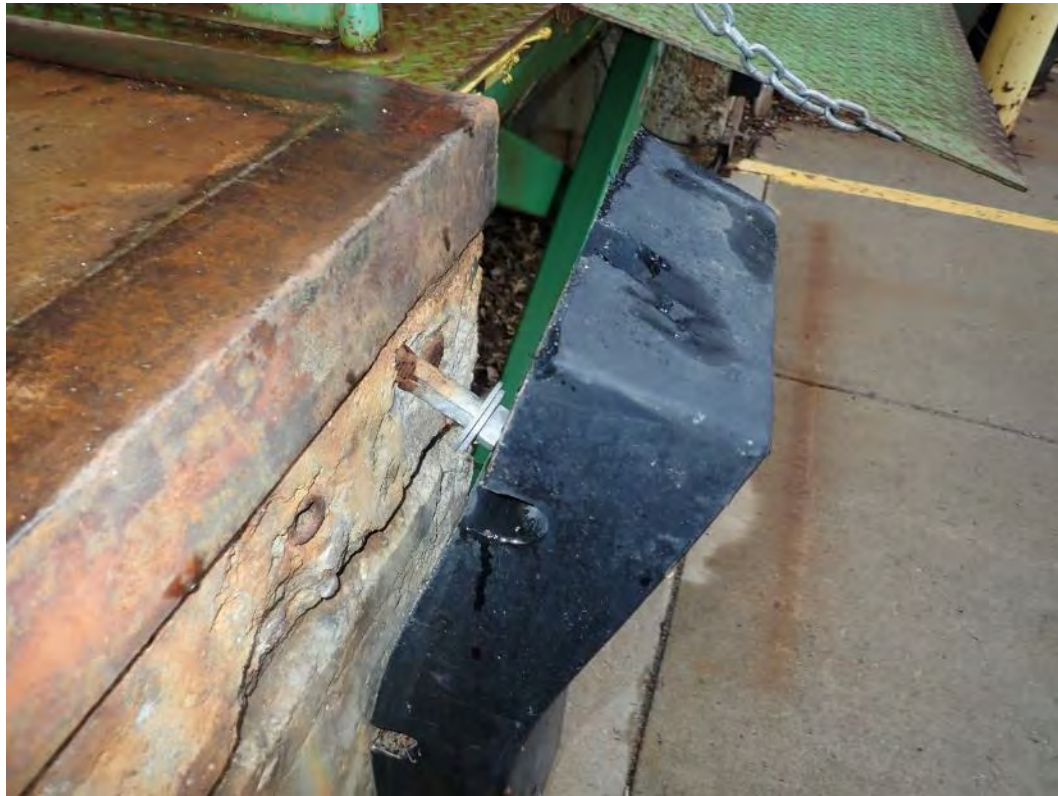
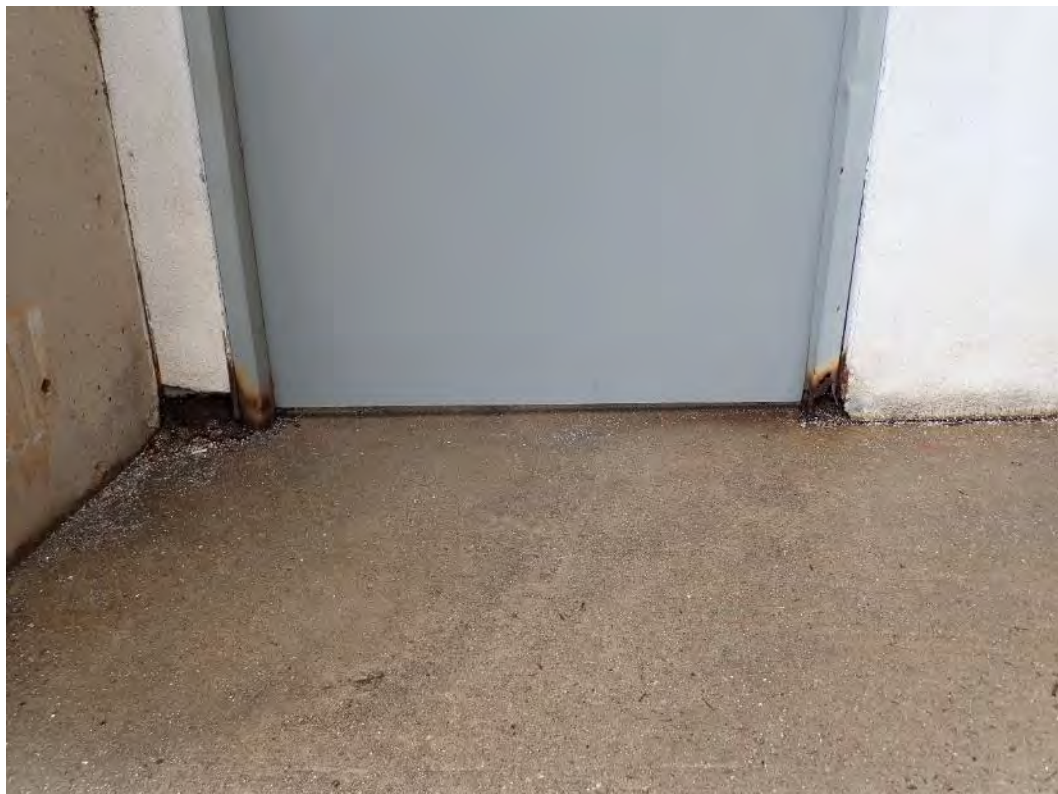
10. At the east dock, spalled, scaled, and cracked concrete, corroded handrails, corroded bollards, corroded rebar, corroded steel edge angles, a loose bumper, and a corroded door frame were observed (Photos 11, 12, 13, and 14).

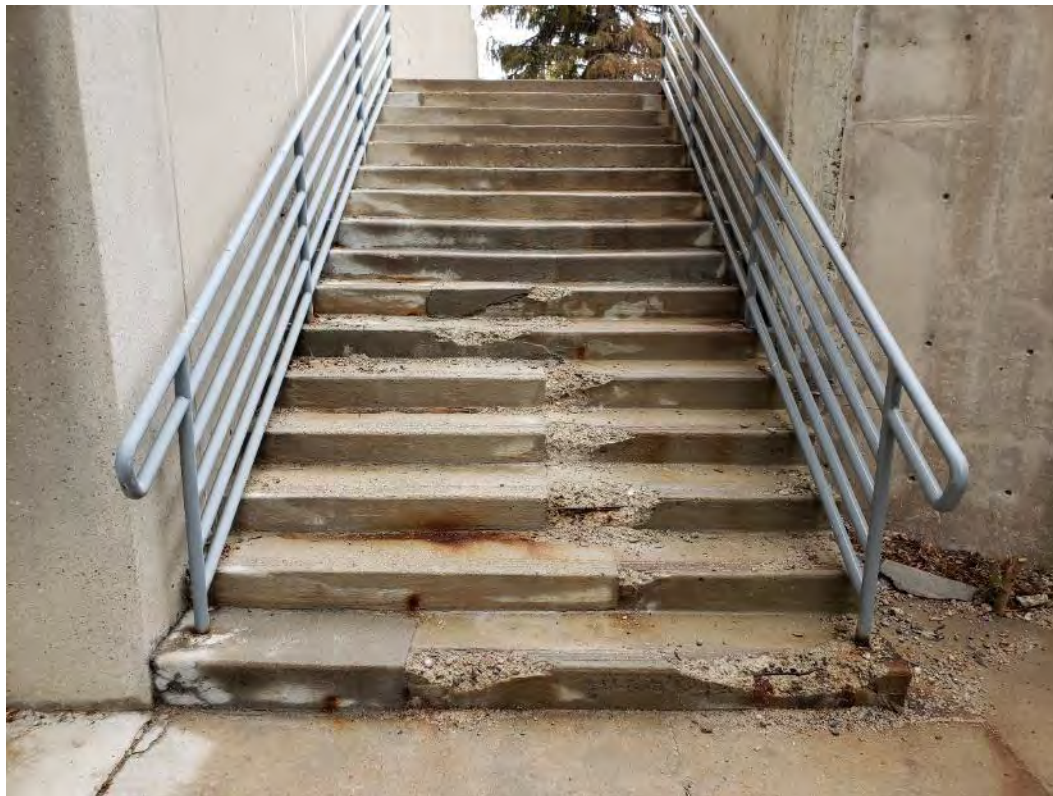
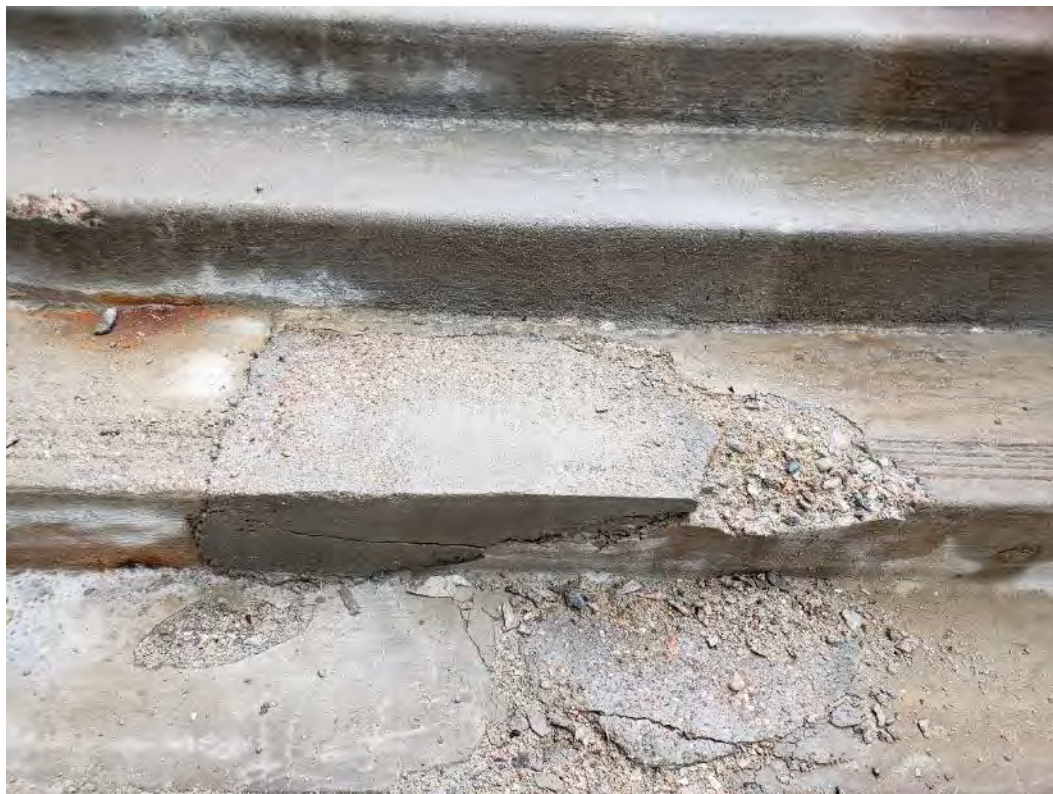
11. At the west, exterior stairs, spalled, scaled and cracked concrete, corroded handrails, corroded rebar, and concrete patches that have failed were observed (Photos 15 and 16).

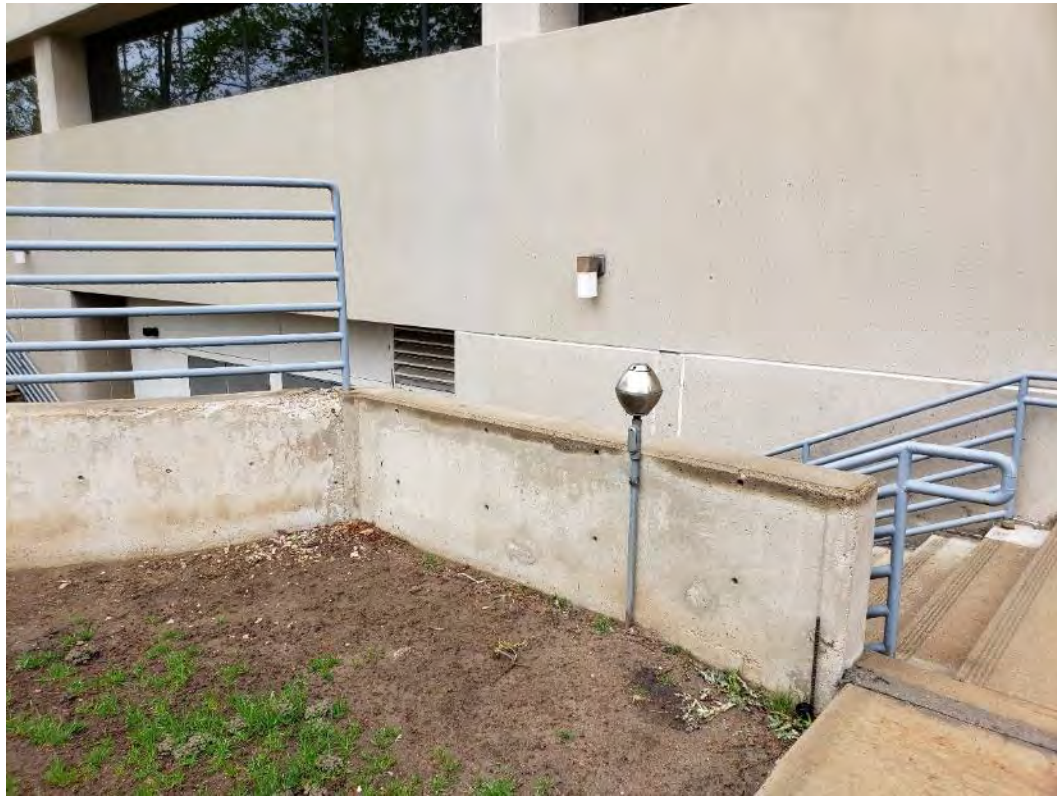
Photo 17

12. At the exterior west stairs, the southern portion of the concrete retaining wall is missing a guardrail (Photo 17). As a result, there is a fall hazard at this location.

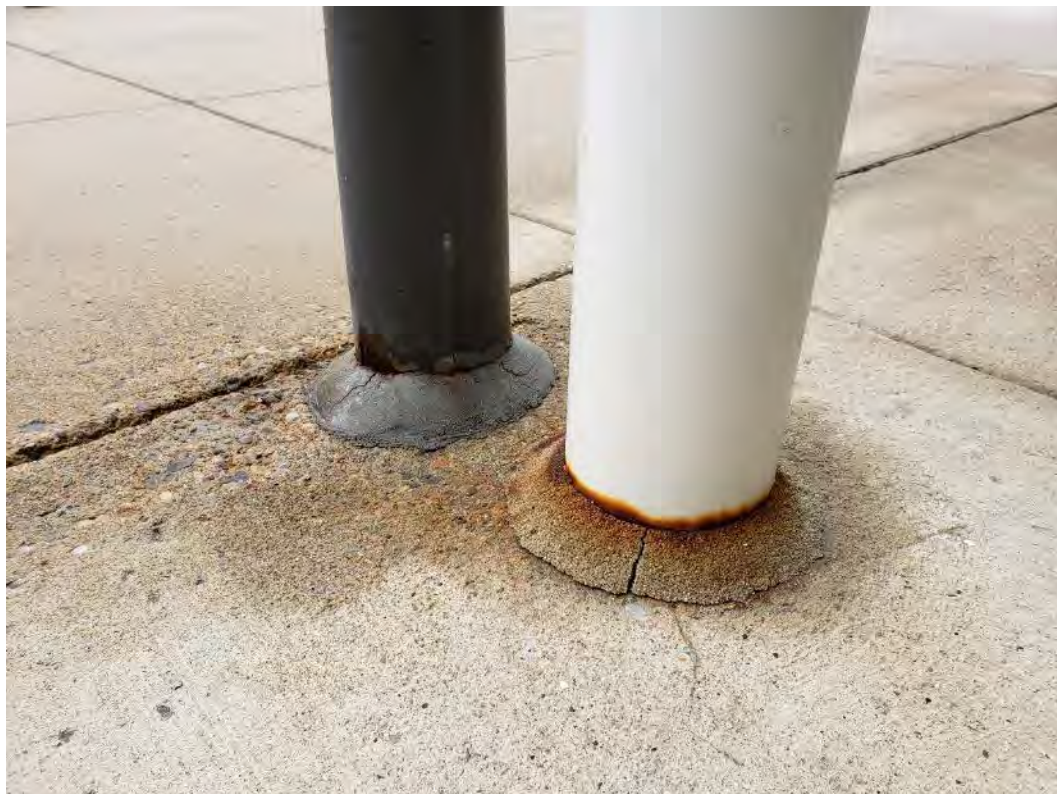
Photo 18

13. Several exterior, steel columns are corroded at the north and south entrances (Photo 18).

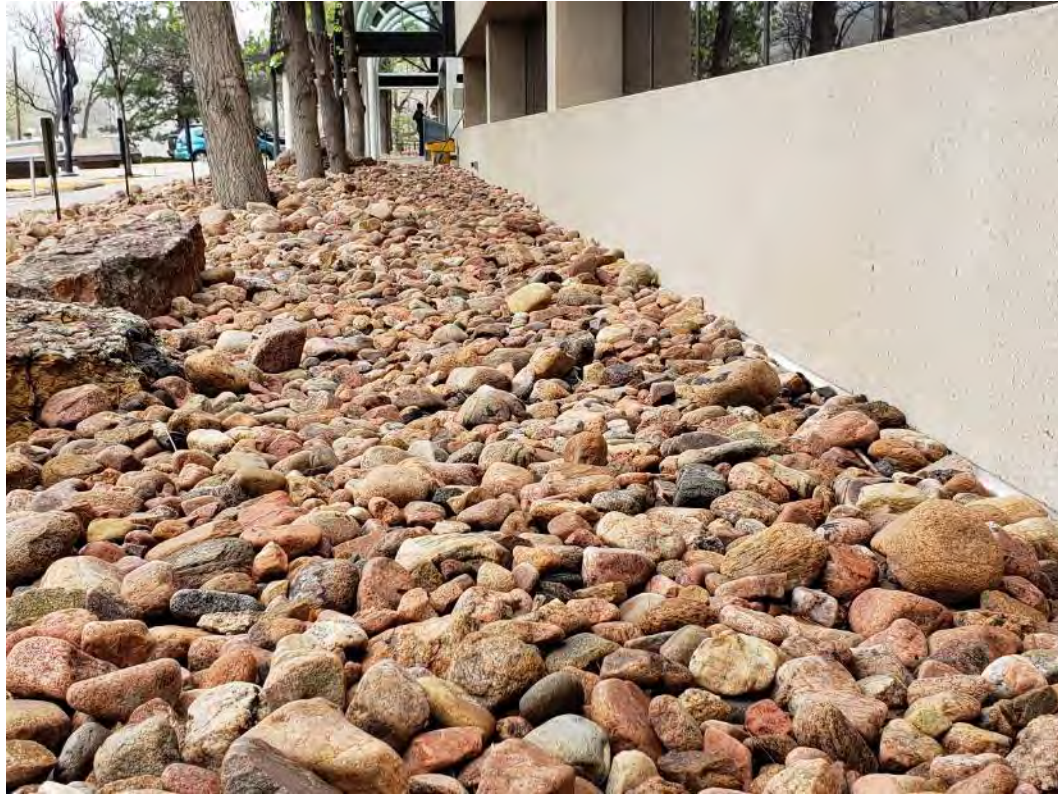
Photo 19

14. Inadequate drainage was observed where the ground abuts against the building along the north, west, and south sides of the building (Photo 19).
15. The sidewalks throughout the property are damaged and are tripping hazards (Photo 20).
16. Throughout the property, some sidewalk handrails are corroded and some of the base connections are damaged (Photo 21).

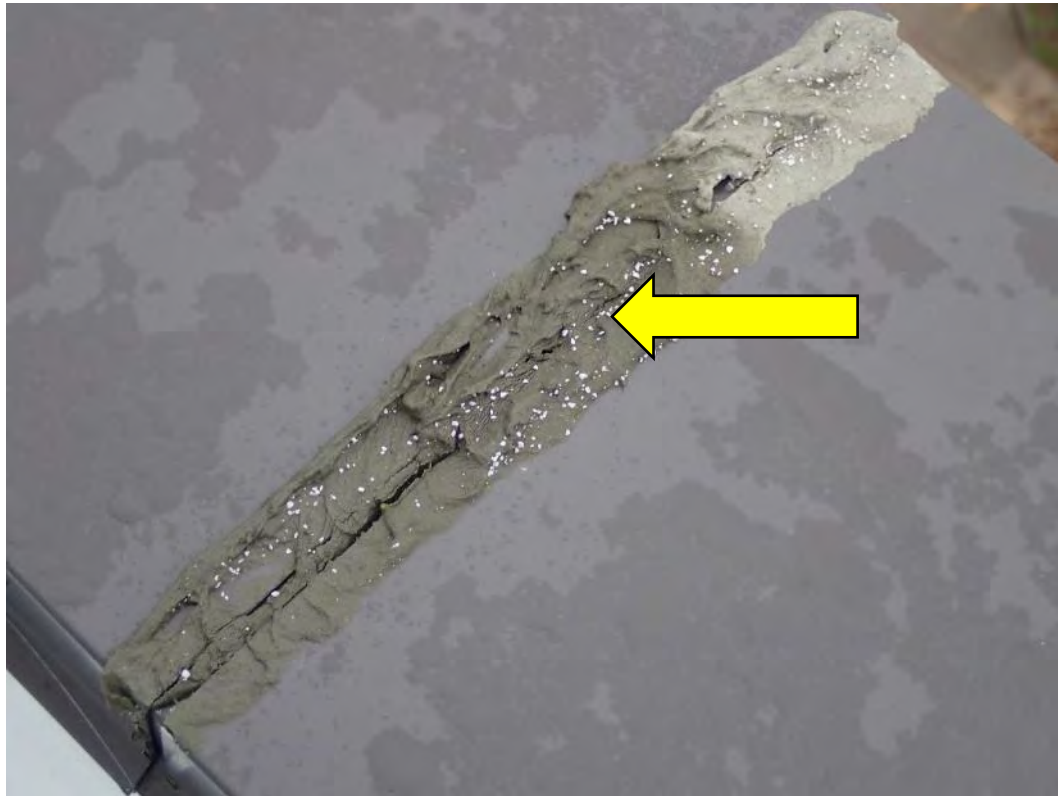
Photo A1

- A. Building Envelope – Parapet Wall and Penthouse
 - 1. Sealant installed at the cap flashing splices is deteriorated and failing (Photo A1).
 - 2. Numerous cap flashing fasteners are loose (Photo A2).

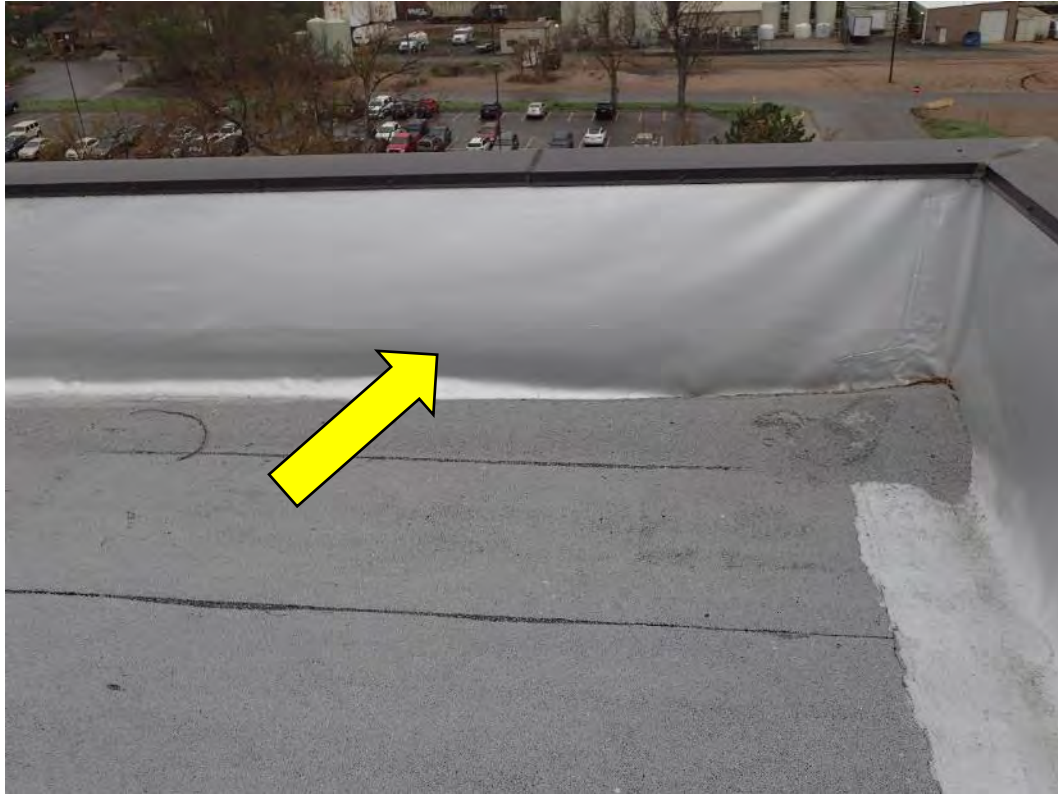
Photo A3

- 3. The roof membrane was not adhered to the sheathing at several locations on the backside of the parapet and is billowing under windy conditions (Photo A3).

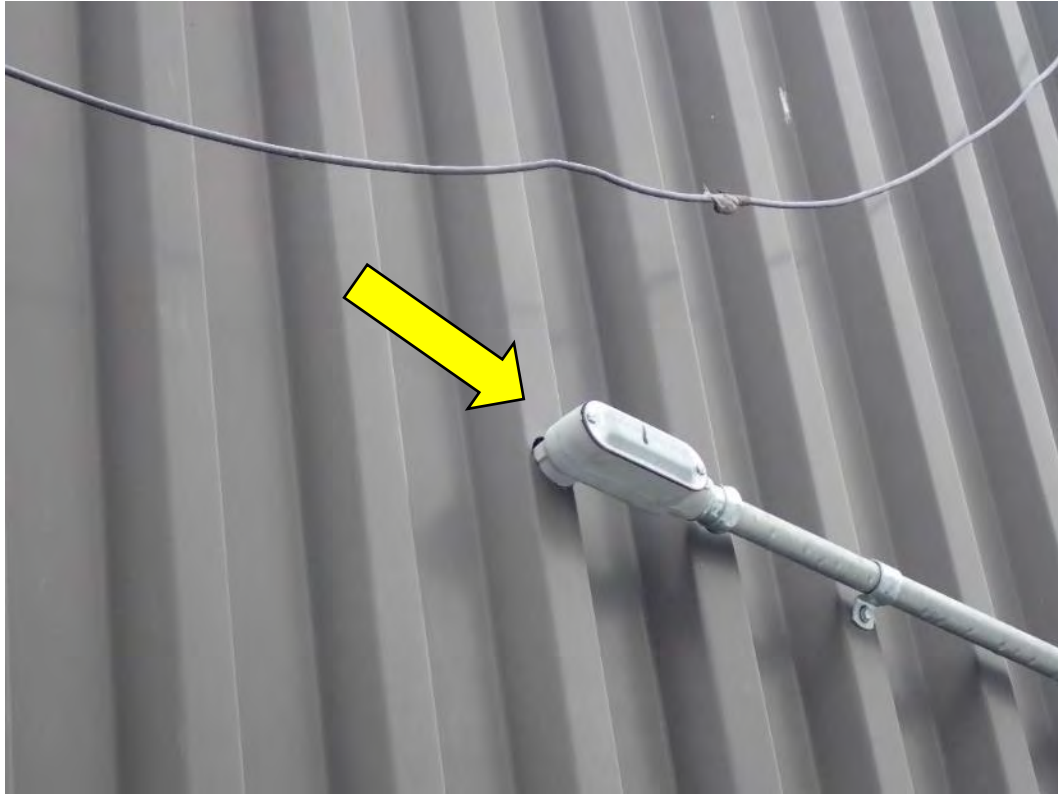
Photo A8

8. Numerous holes in the penthouse walls were not sealed (Photo A8).
9. Several metal panel screws were loose (Photo A9).

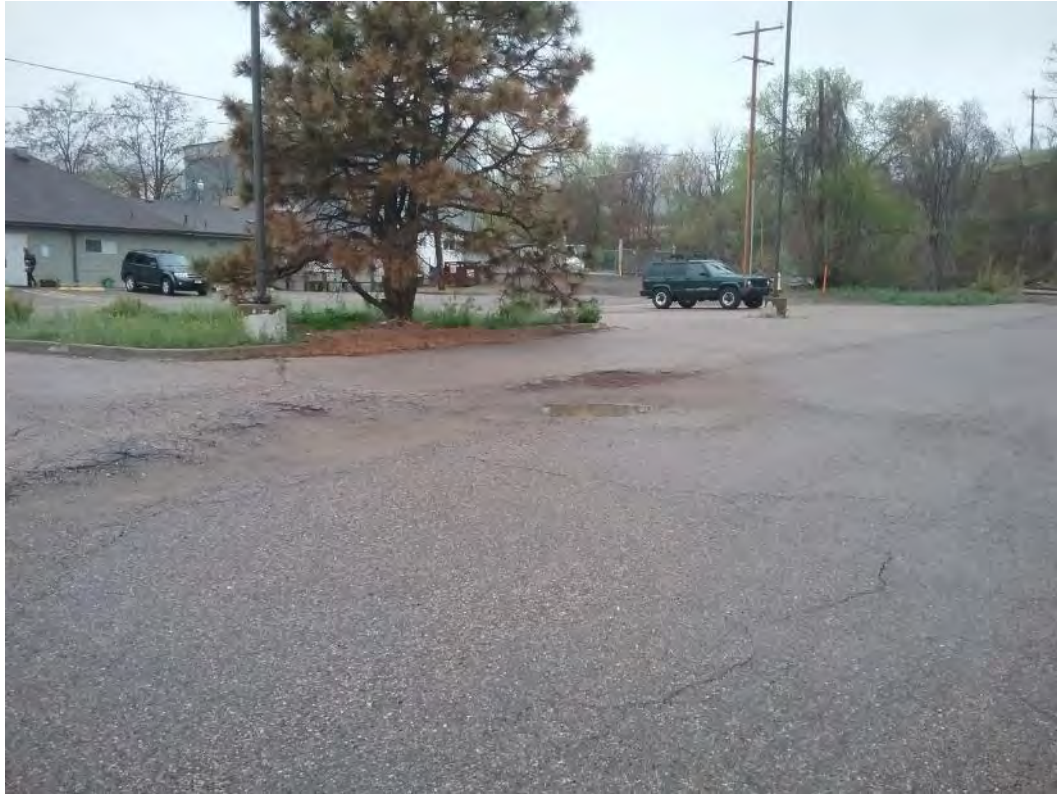
Photo 1-Area 1

1. A portion of the asphalt in the parking lot appears to have deteriorated several inches below the original finished grade and is experiencing ponding of stormwater runoff (Photo 1).
2. Several cracks were observed in the asphalt and aggregate was exposed at the surface (Photo 2).
3. Curb and gutter around landscaped islands in the parking lot were observed to be severely damaged and cracked. Vegetation was growing through cracks in the curb and gutter and asphalt (Photo 3).
4. Portions of the parking lot did not appear to properly drain as areas of ponding were observed during the site visit (Photo 4).

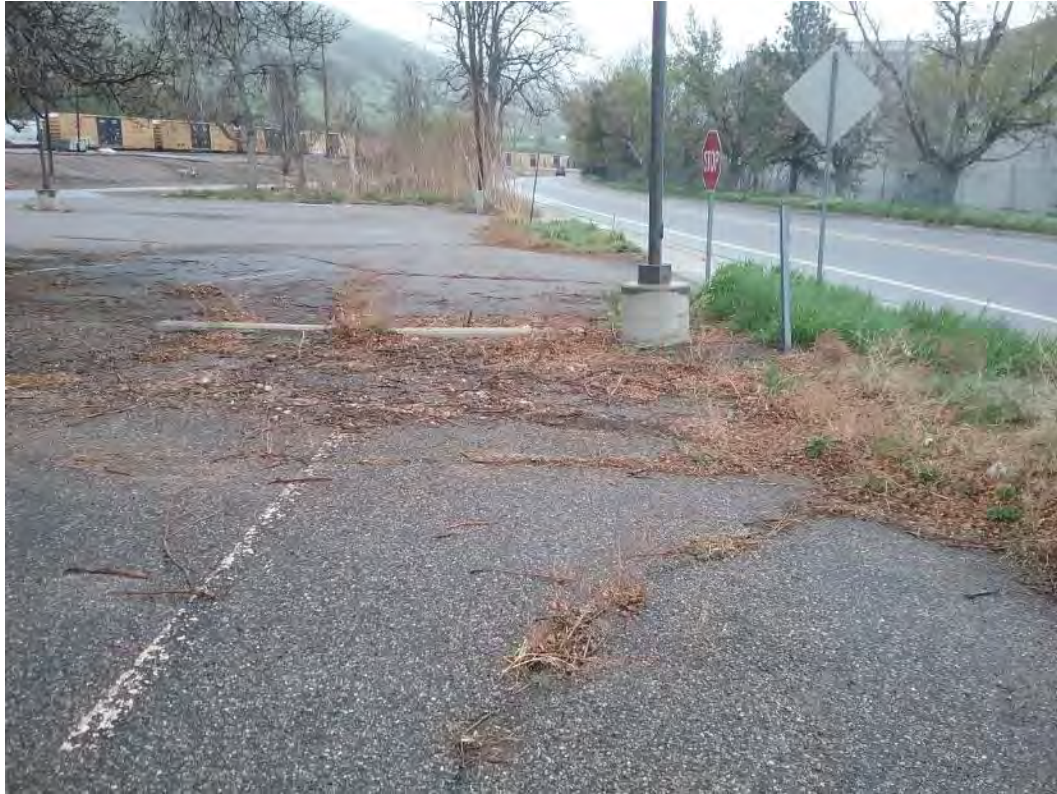
Photo 12-Area 4

1. The asphalt within Area 4 appears to be in poor condition as cracks were observed in several locations and vegetation was growing in the cracks (Photo 12).
2. The parking lot did not have curb and gutter to separate landscaping and pavement (Photo 13).
3. The asphalt within Area 4 appears to be deteriorating as exposed aggregate and loose gravel were observed on the surface of the asphalt (Photo 14).

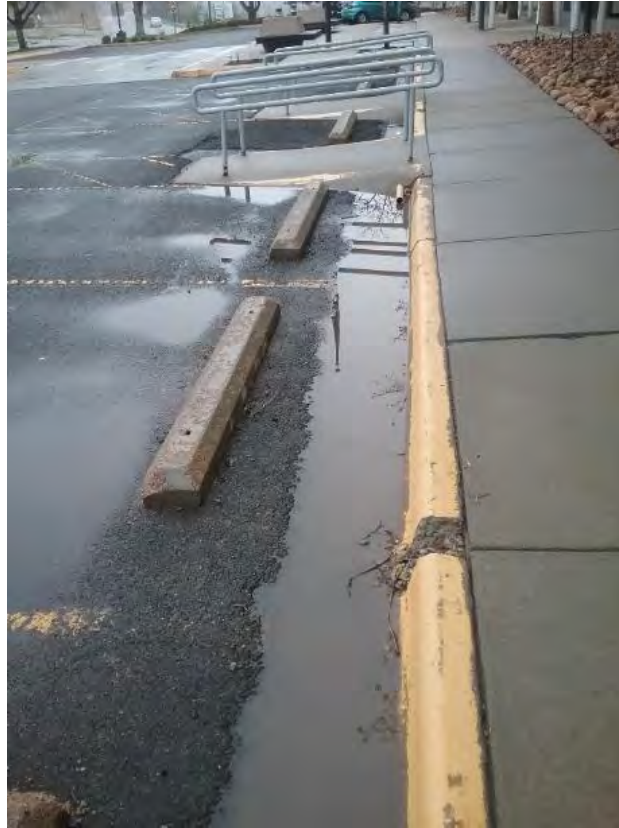
Photo 16-Area 5

2. Curb and gutter appeared to be damaged in locations within the parking lot on the north side of the building (Photo 16).
3. Ponding was observed in areas of the parking lot on the north side of the building due to grading issues and an ineffective drainage pipe used as a culvert (Photos 17 and 18).
