Council Memorandum

Re: 311 10th Street Building Feasibility Study Review

Golden Civic Center: Feasibility Study

Final Due Diligence Report

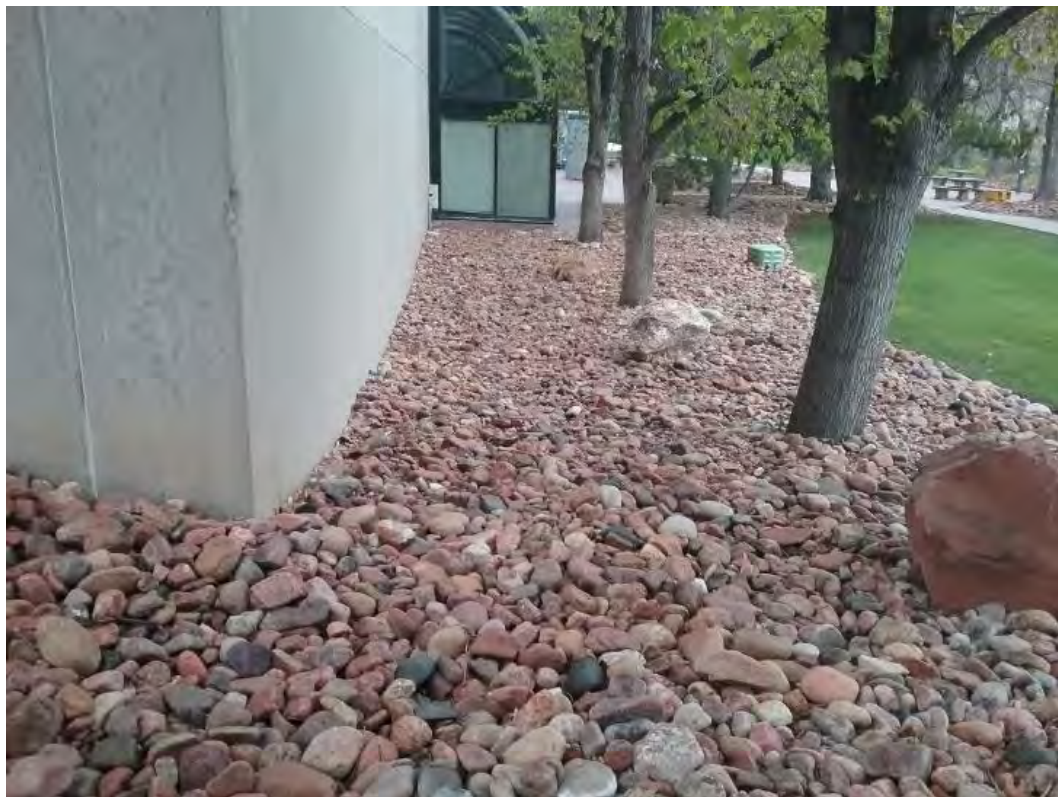
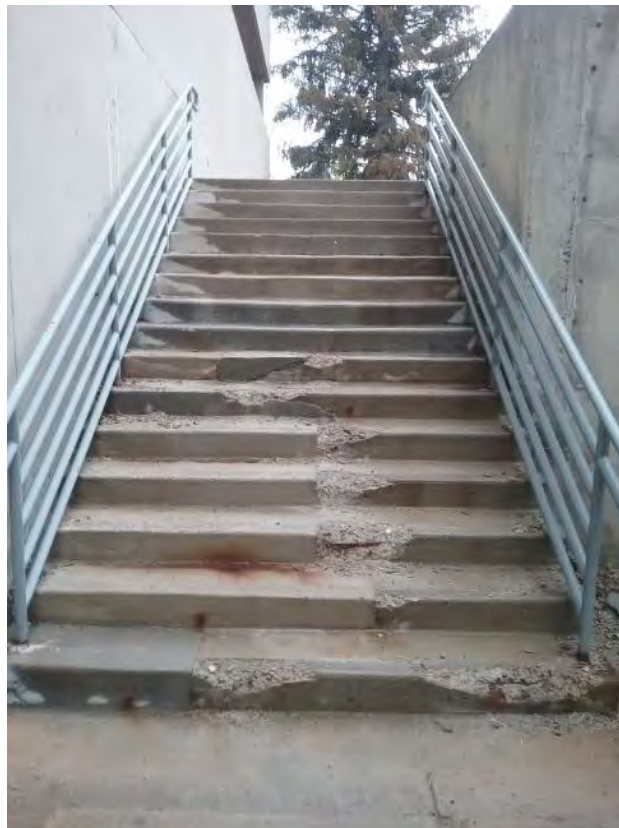
6. The landscaping adjacent to the north, west, and south sides of the building did not appear to have sufficient slopes to effectively convey runoff away from the building (Photo 21 and 22).

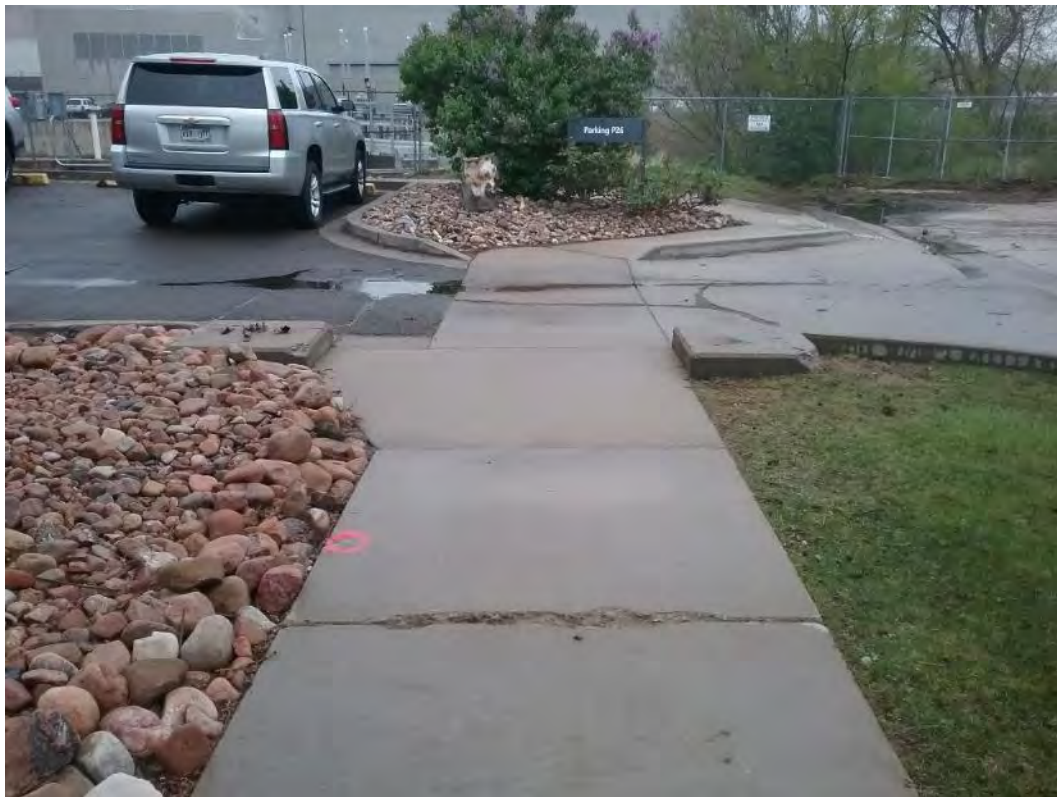
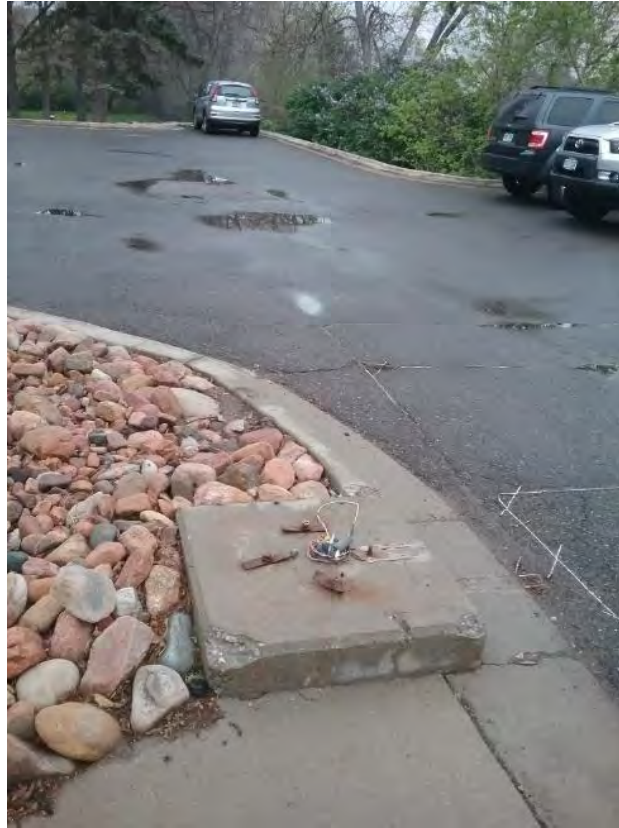
9. The sidewalk and concrete pavement on the south side of the site at the Archer Street dead end was observed to be cracking and ponding (Photos 25 and 26).

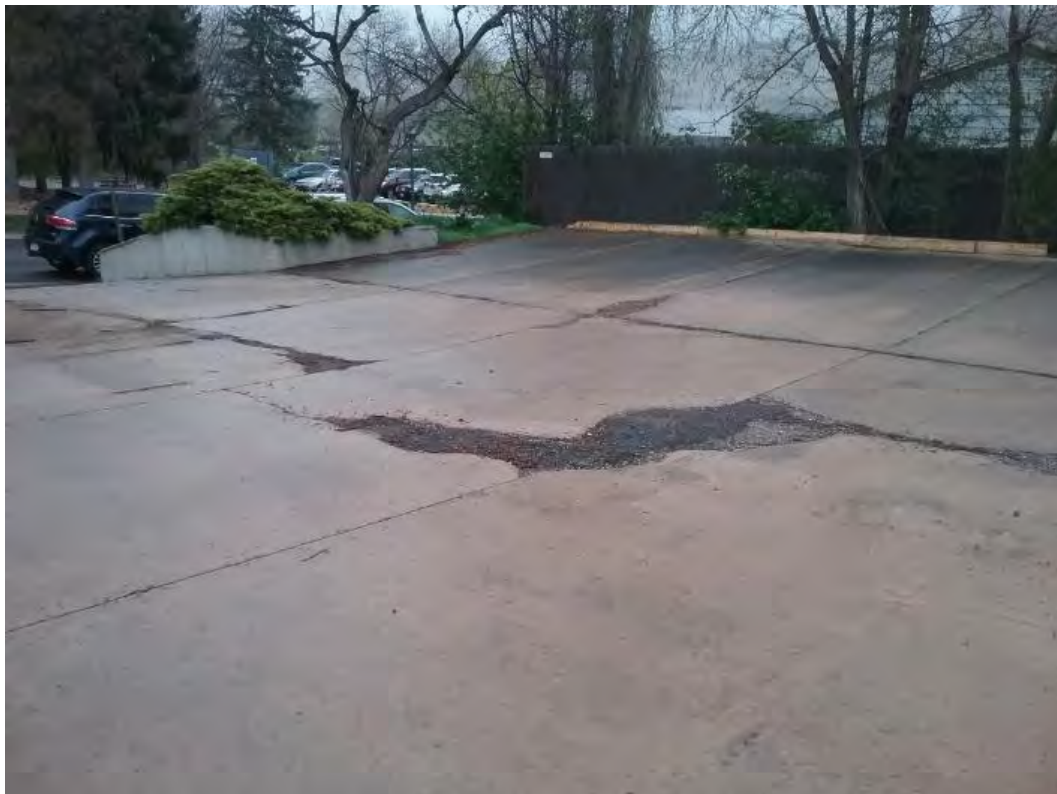
Photo 29-Area 5

13. The concrete parking lot on the west side of the site appears to be in fair condition and drains the majority of the runoff to Archer Street. Minor cracking and vegetation growing through the joints were observed in the parking lot (Photo 29).

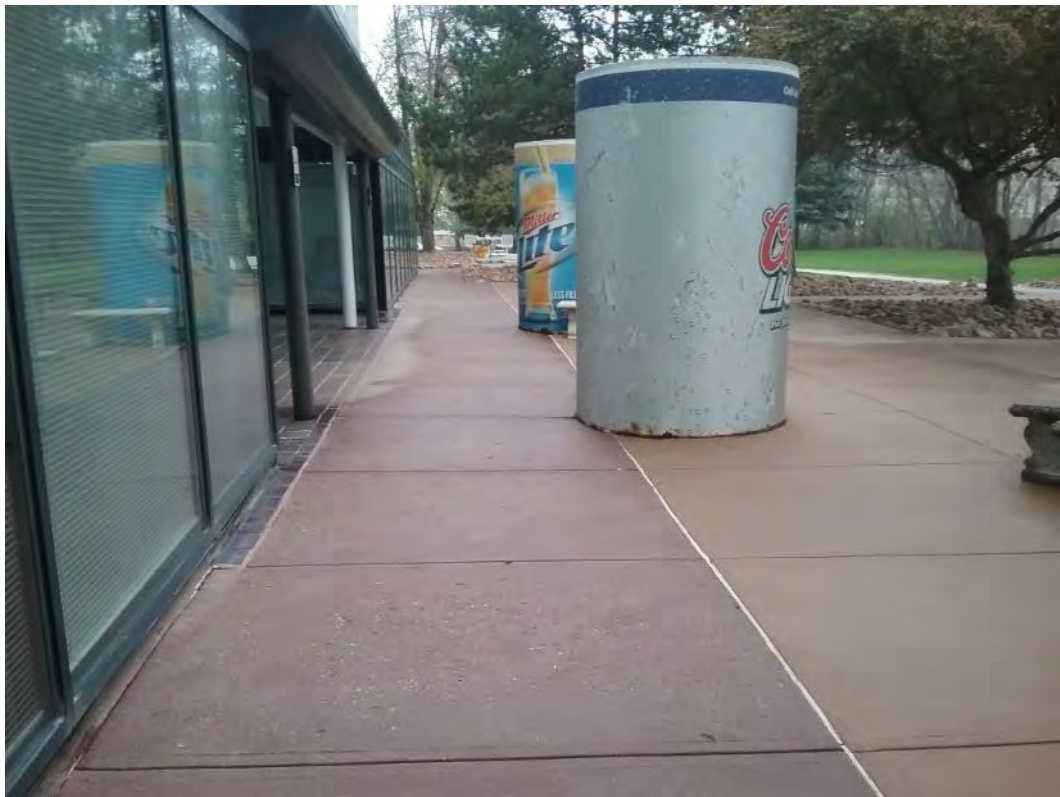
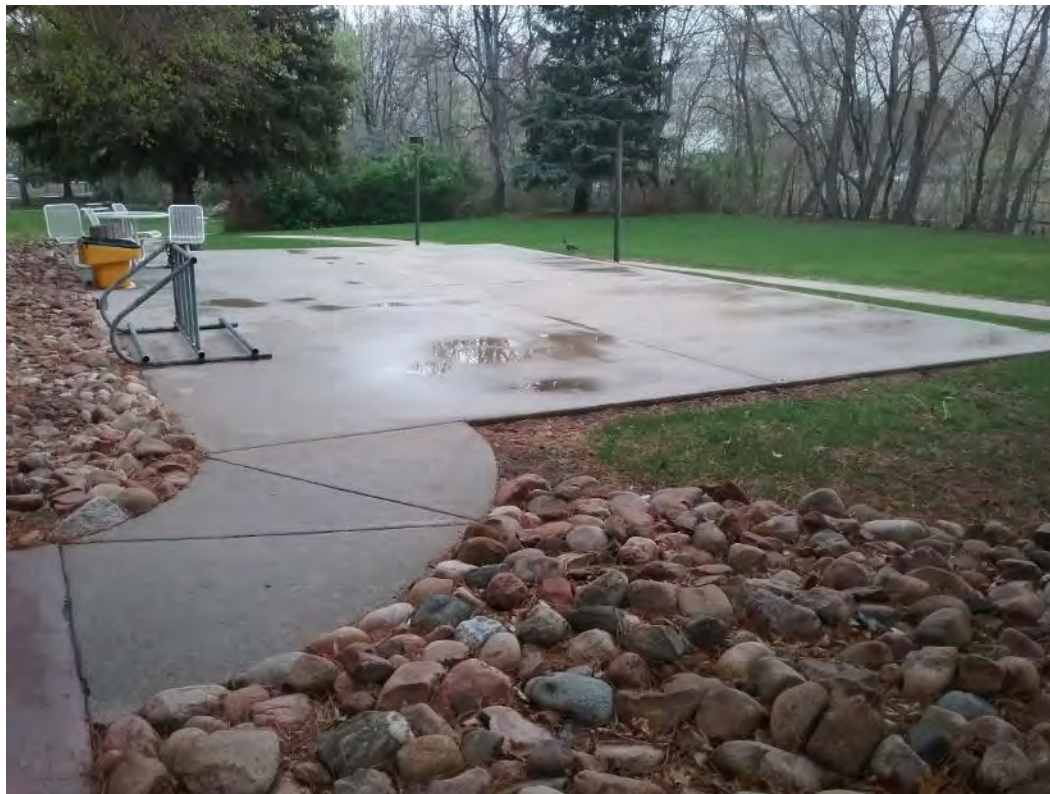
15. The concrete plaza on the south side of the building appears to be in good condition and draining away from the building (Photos 31 and 32).
16. Ponding was observed on the concrete patio on the south side of the building (Photo 33).

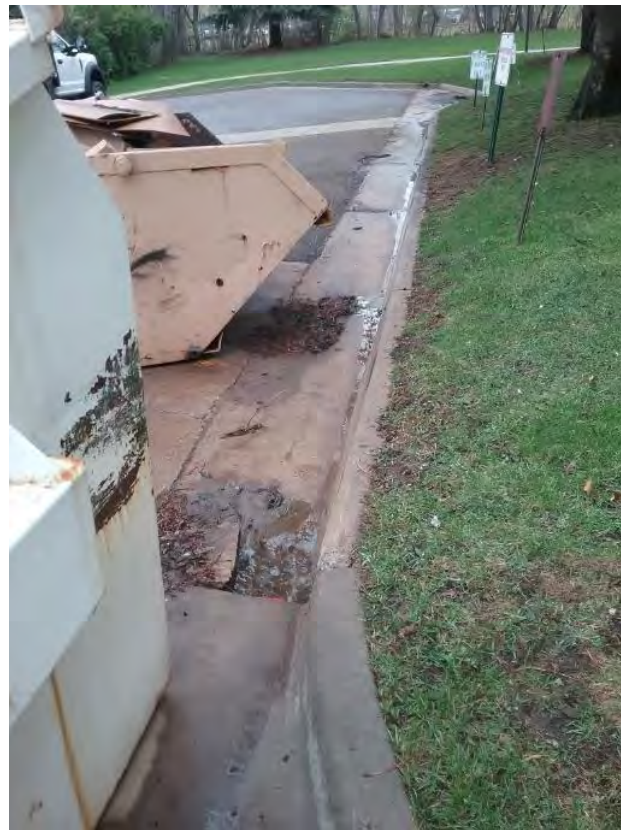
Photo 37-Area 5

20. The pavement at the loading dock appeared to be in good condition. A fairly steep slope was observed at the south end of loading dock connection to Vasquez Street (Photo 37).

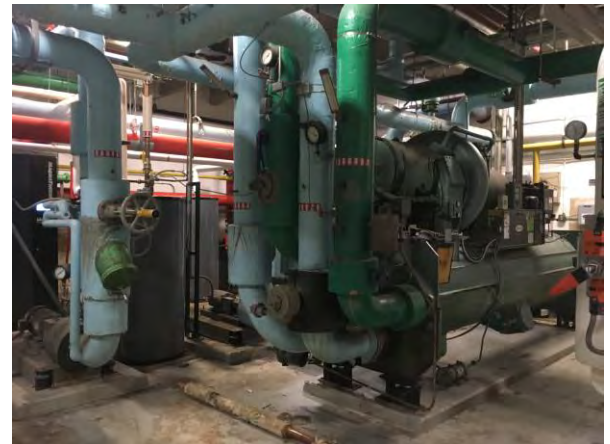
Fig. M-5 – 2011 Carrier chiller in operation.

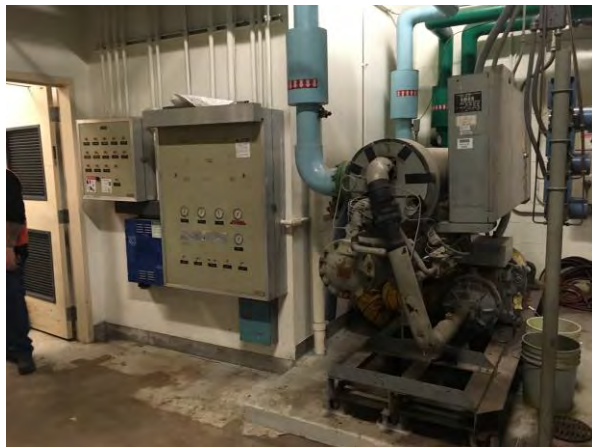
Fig. M-6 – Older Carrier chilled described as backup, not in operation.

Although the cooling plant is currently running sufficiently utilizing a single chiller, the backup chiller is estimated to be past its equipment life expectancy. If the primary chiller has an unexpected failure, and the backup chiller cannot reliably operate, this could leave the building without cooling for possibly an extended period of time while repairs are made. It is therefore recommended that the older Carrier chiller be replaced, and the two chillers operate lead/lag, distributing run-time between them. It might also be prudent to remove the abandoned chiller at this time.

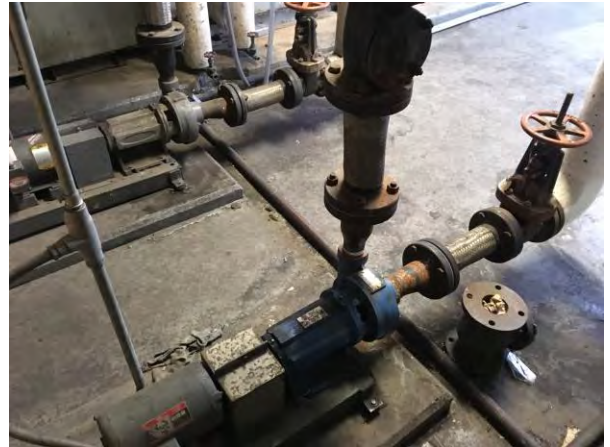
Fig. M-12 – Two heating water coil circulation pumps for two large penthouse air handling units.

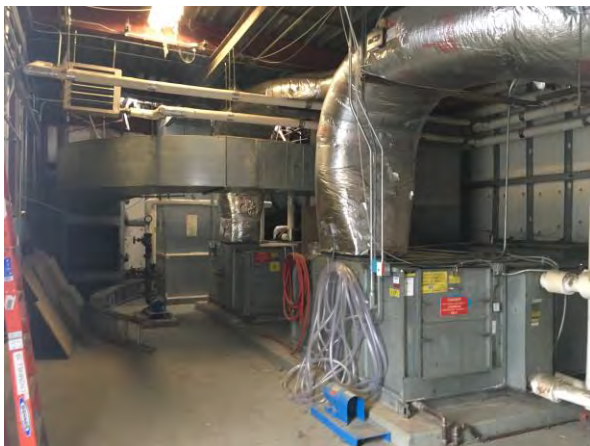
Fig. M-13 – Two (2) smaller penthouse air handling units serving perimeter induction units.

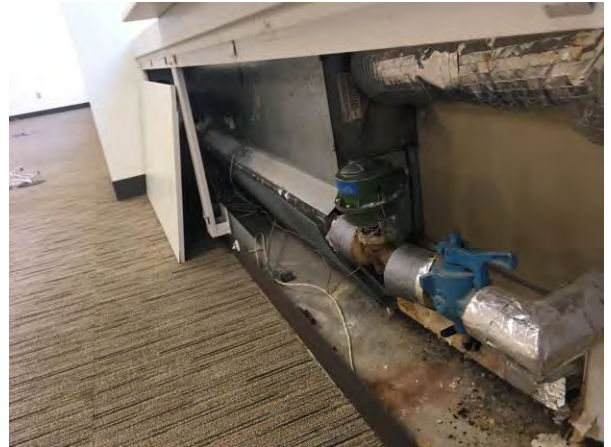
Fig. M-16 – Inside casing of typical perimeter induction unit.

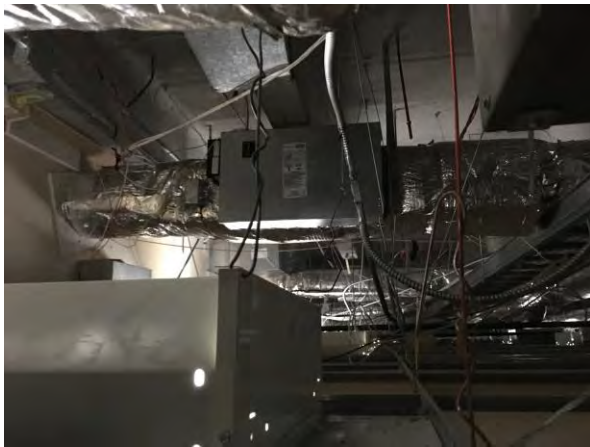
It was discovered on the third floor, that some offices along the west exterior had supplemental electric duct heaters installed, reportedly to address comfort issues. Although tile ceilings are typical throughout the building, there is an area on the west side of the fourth floor that was renovated to include an open-to-structure ceiling with exposed mechanical infrastructure.

Fig. M-17 – Electric duct heater serving third floor west perimeter offices

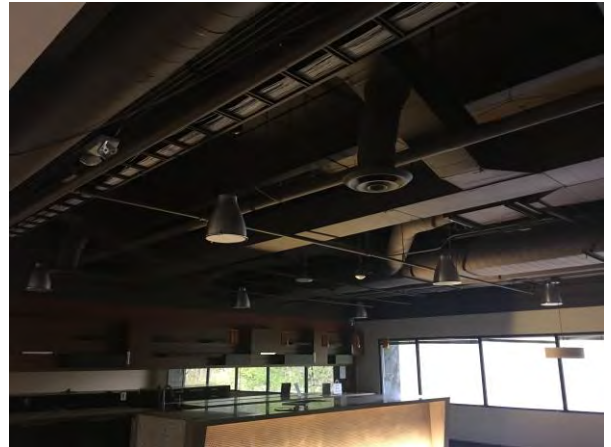
Fig. M-18 – Exposed mechanical infrastructure on fourth floor.

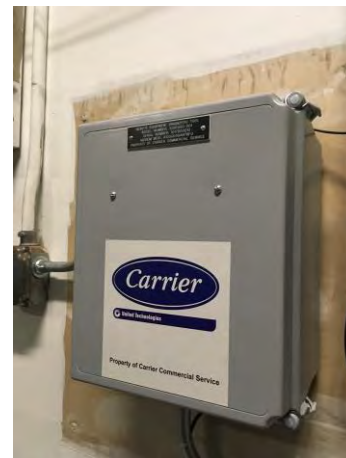
Fig. M-22 –Carrier control panel for newer chiller.

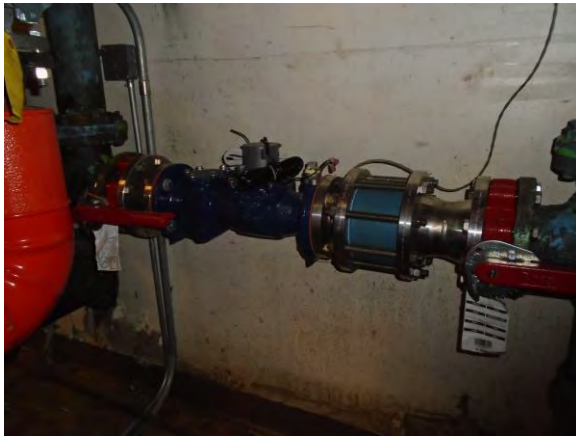
Fig. P-1 – 3" water meter at water entry

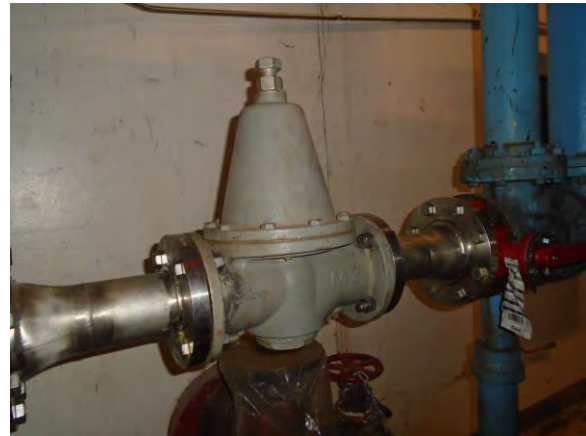
Fig. P-2 – Pressure Reducing Valve

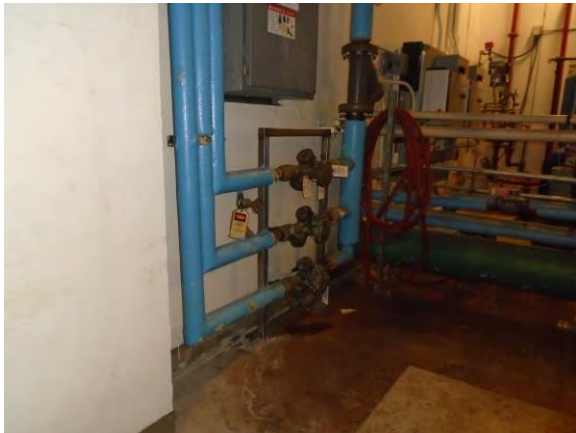
Fig. P-3 – (3) reduced pressure backflow preventors off main line

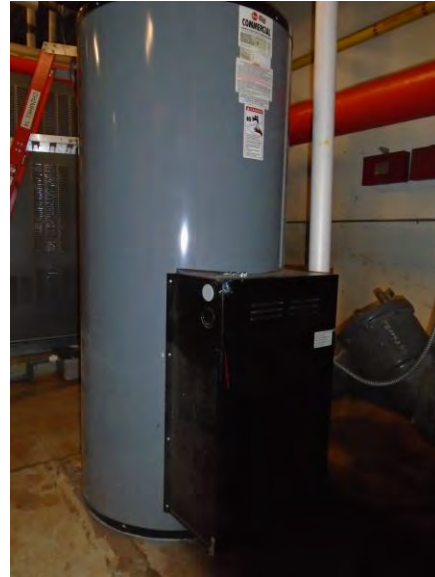
Fig. P-5 – Domestic hot water booster heater and storage tank

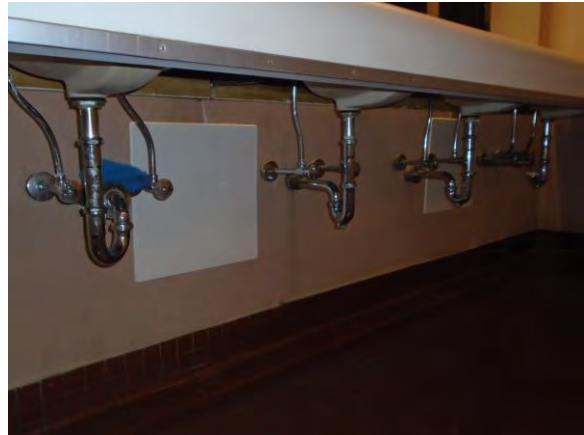
The core restrooms are in fair to poor condition. The restrooms are operable, but there are signs that the lavatories in each of the restrooms has issues with waste line draining. Hot water was present at the lavatories tested. The Women's restroom consisted of five (5) water closets and (4) lavatories. The Men's restroom consisted of (3) water closets, (2) urinals, and (4) lavatories. The water closets are wall mounted flush valve style. There are floor drains in each restroom for ease of cleaning. The restrooms were not checked for full ADA compliance however, the lack of insulation under the sink to protect a person from the hot water line and drain line is not present.

Fig. P-8 – Typical undercounter at lavatories with access doors

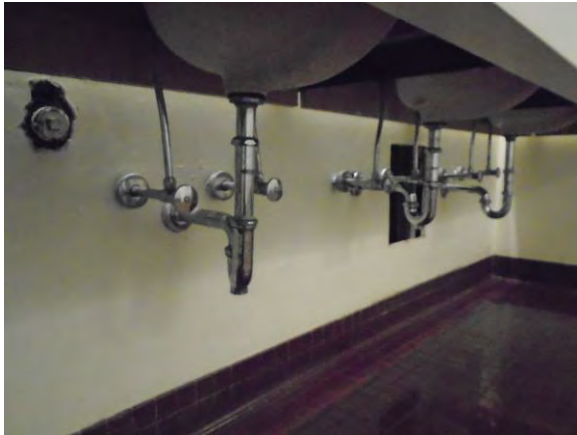
The main sanitary line exits the building to the south in the middle of the building and according to the original drawings is a 6" sanitary main connection. In the core restrooms at the lavatories, there appears to be issues with the lines. In each of the core restrooms, both Men's and Women's, there were holes and/or access panels under the lavatories indicating that the lines need to be accessed on a regular basis.

Fig. P-28 – Typical access openings under lavatories in restrooms

It is recommended that the sanitary line be scoped with a camera to verify if there are any issues with the integrity of the pipe for long term use. Based on site conversations, the main sanitary line is in good condition.

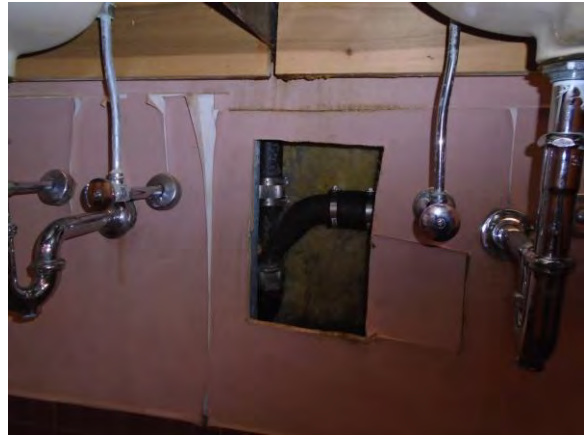
Fig. P-29 – Another example of access opening under lavatories

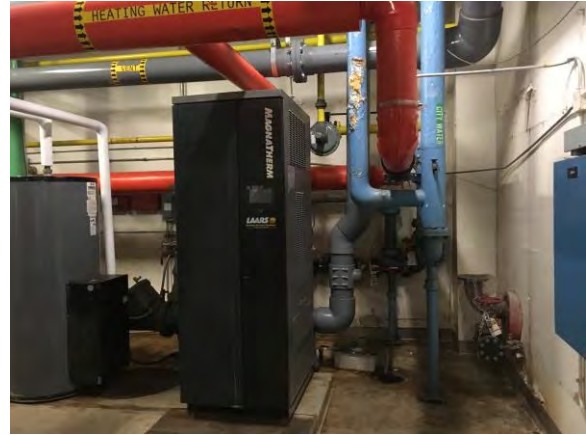
Fig. P-32 – Gas regulator (in back) in mechanical room

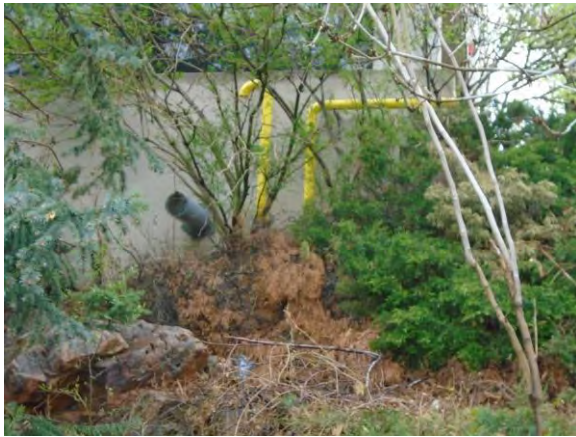
Fig. P-33 – Natural gas vent from regulator in mechanical room

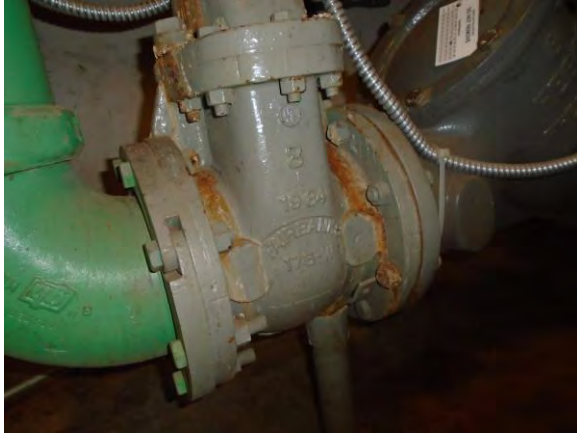
Fig. F-1 – Fire Entry main 8" shut-off valve

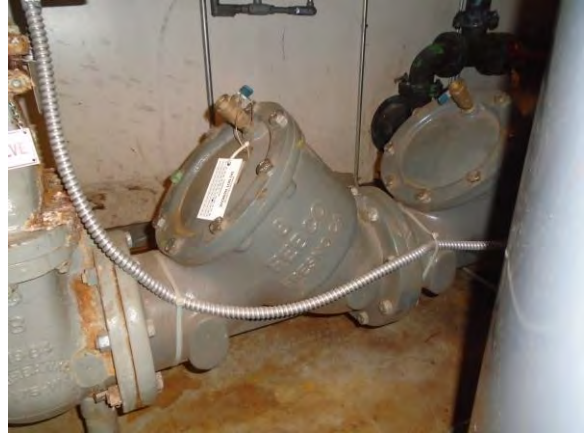
Fig. F-2 – 8" double check backflow preventor on fire line

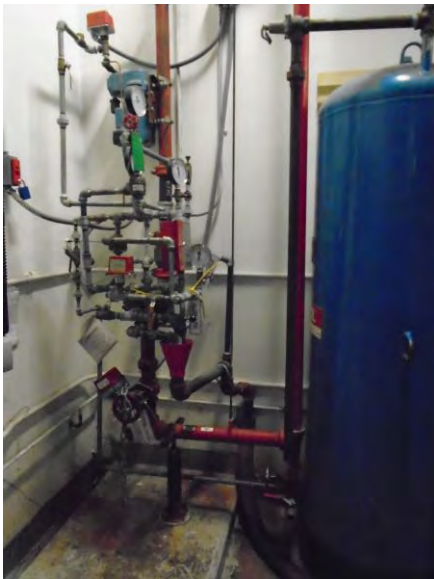
Fig. F-3 – Dry pipe valve assembly for dock sprinklers
Located in mechanical room

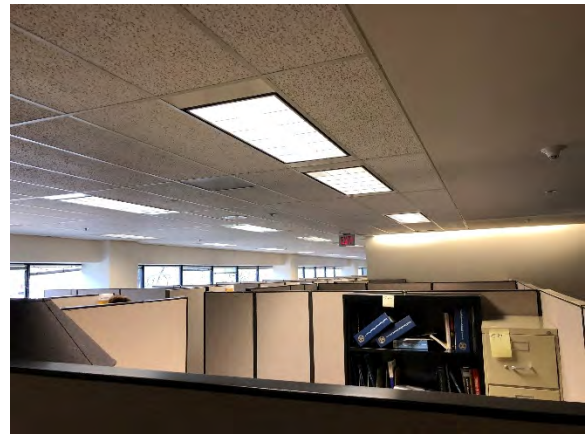
Photo #8: Typical Office Lighting

Most of the existing lighting in the office spaces appear to be 3-lamp, T8 luminaires and are controlled by a building lighting control relay panel. Additional accent lighting throughout the other spaces in the building are non-LED lamps and either have local control or are also controlled by the building lighting control relay panel. It is anticipated that in order to comply with current energy codes, renovations to the building would require replacement of all fixtures with LED lamp fixtures and local control. The existing lighting control panels for overall building are in good condition and may potentially be reused. The main consideration for reuse would be for whether existing circuiting would be required to be maintained, or if future use determines control characteristics that are outside of the current system capabilities.
