CITY OF GOLDEN

Public Art Assessment – 2020

October 2, 2020

Prepared by
Alison Leard
Pacific Coast Conservation
2334 Colorado Blvd
Denver, CO 80207
310-383-4710
www.pacificcoastconservation.com

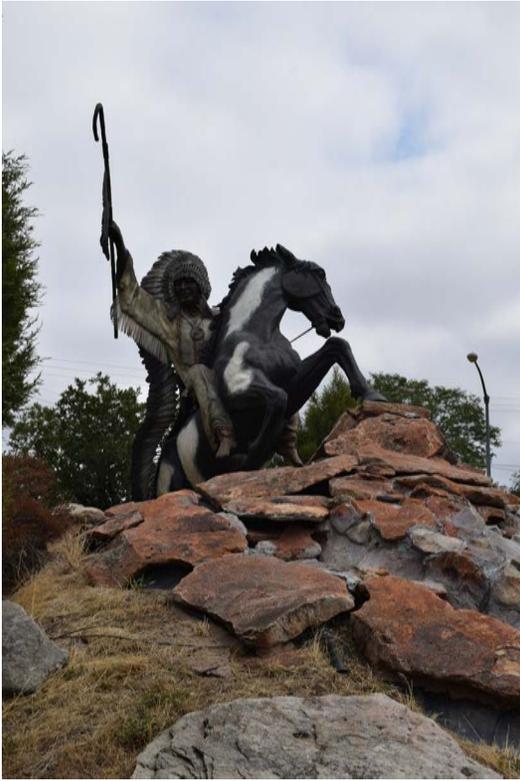
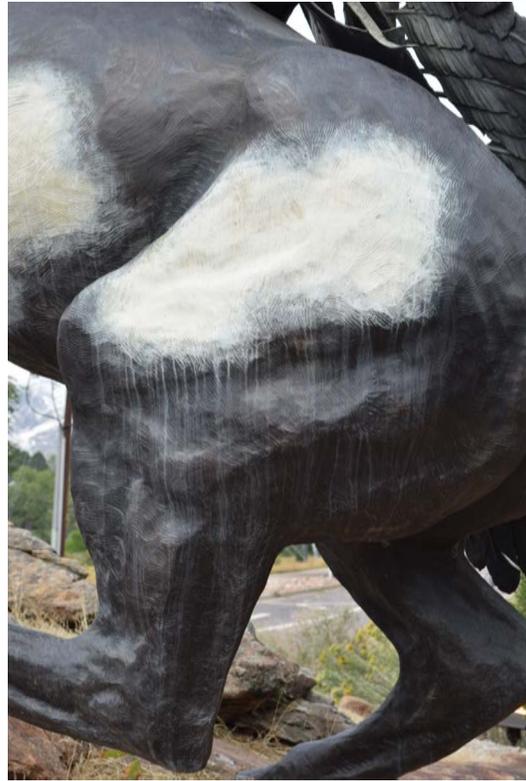
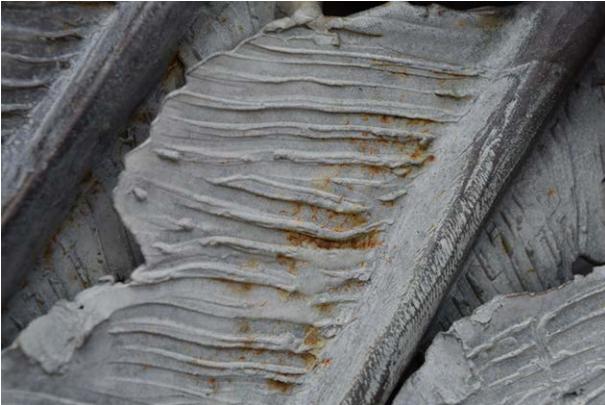
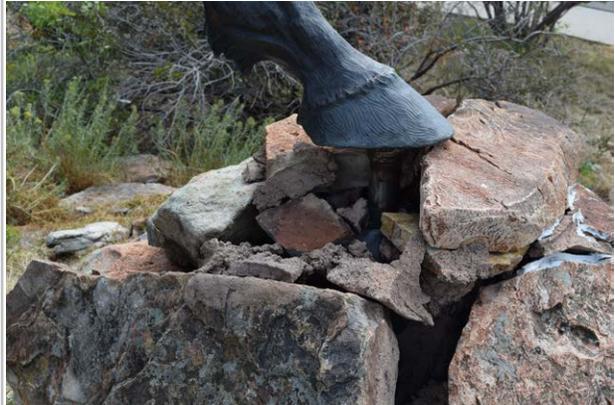
The surface is in fair condition. There are failed surfaces throughout the piece, failed clear coating and paint overall and corrosion in areas where the underlying metal is exposed to the elements. Previous inpainting attempts are not well matched or sealed and are failing. There are scratches and abrasions overall. There is some marker graffiti and soiling in places. The sculpture appears to be in good structural condition, but there are two anchor like objects that are near that base that are cracked.

Wash in areas of soiling with a non-ionic detergent and water with a soft brush. Remove loose surface corrosion with a stiff brush. Rinse with water to clear loose material and soiling. In areas of corrosion or bare metal apply a cold wax coating. Buff when set with a soft brush.

Reach out to the artist to determine the original intent of the piece to develop an appropriate treatment for the failing surface coatings. Potential treatments include inpainting areas of loss, recoating the piece as a whole, or maintaining the metal and allowing the coatings to alter over time. Confirm purpose of anchors at base, replace if needed.
