2007 Vidler Tunnel Repairs

Flossie Vein Collapse Area

East Portal Rebuild

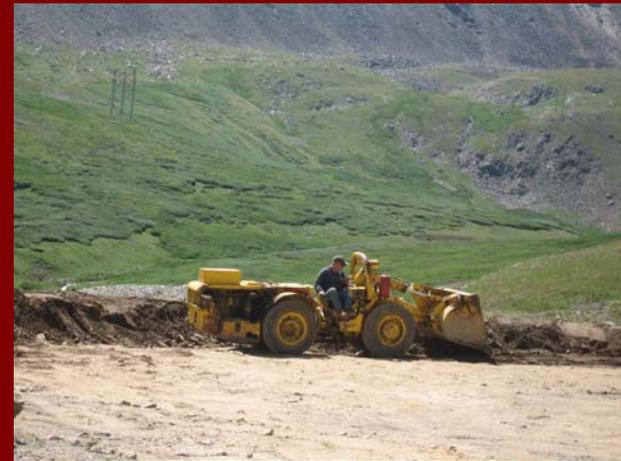
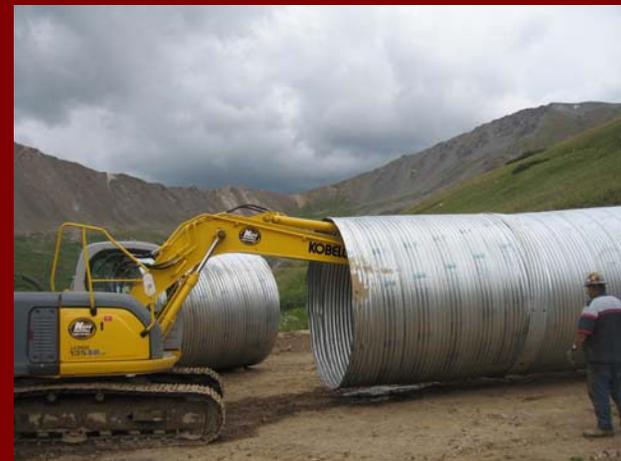
The time had come for much needed repair and Hayward – Baker began construction.

- There would be need for a one yard LHD, a medium size excavator, and a front end loader.

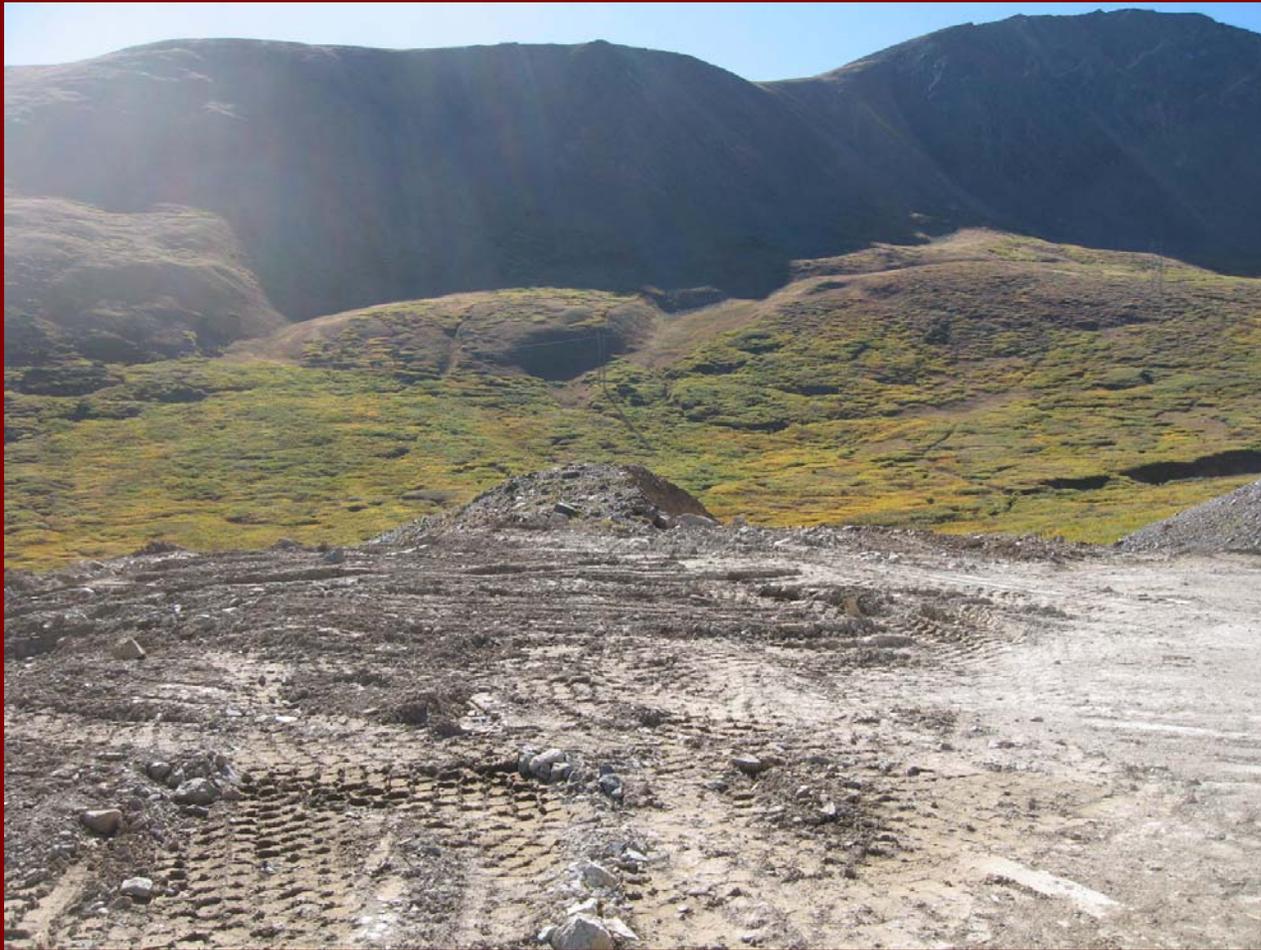
The area was cleaned up on September 21,
2007 and the Hayward – Baker crew went
home
