## Heritage Road *Roundabout Evaluation*

## Eagle Ridge Drive *Traffic Calming Evaluation*

January 2018

Engineering  
Spatial Data  
Advanced Technologies

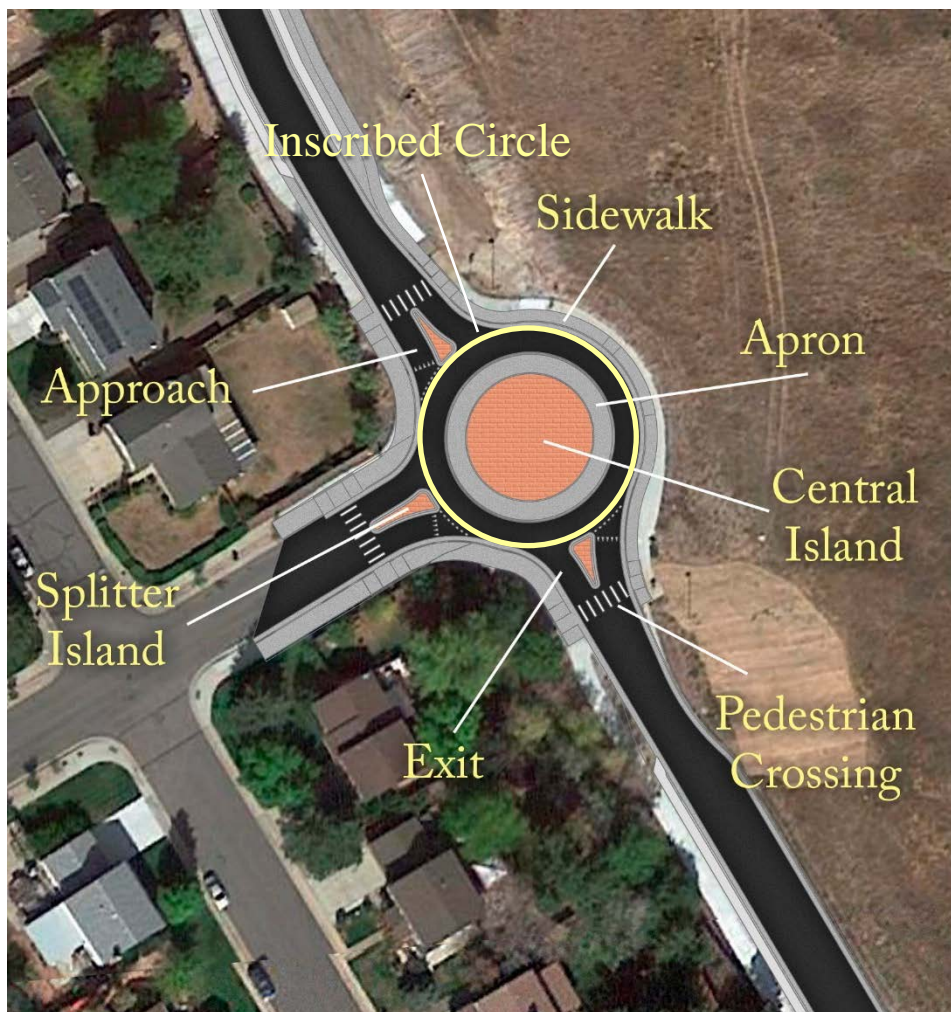
**Figure 2: Design Elements**

Figure 2 (using Kimball Ave as an example) provides a visual to help identify the location of the above-listed design elements.

- **Approach** alignment is recommended at Left or Center
- **Entry width** is recommended to be 14-16 feet for single-lane
  - Current entry width is *discouraged* at all three roundabouts

- Entry width is largest determinant of capacity
- Central island **apron width** is recommended to be 3-13 feet
  - Eagle Ridge Dr and Kimball Ave have a *recommended* 7.5-foot apron

- 4<sup>th</sup> Ave is entirely paved with no separate apron but still *acceptable*
- Central **island shape** is recommended to be circular
  - Eagle Ridge Dr roundabout is more of an oval shape but *acceptable*

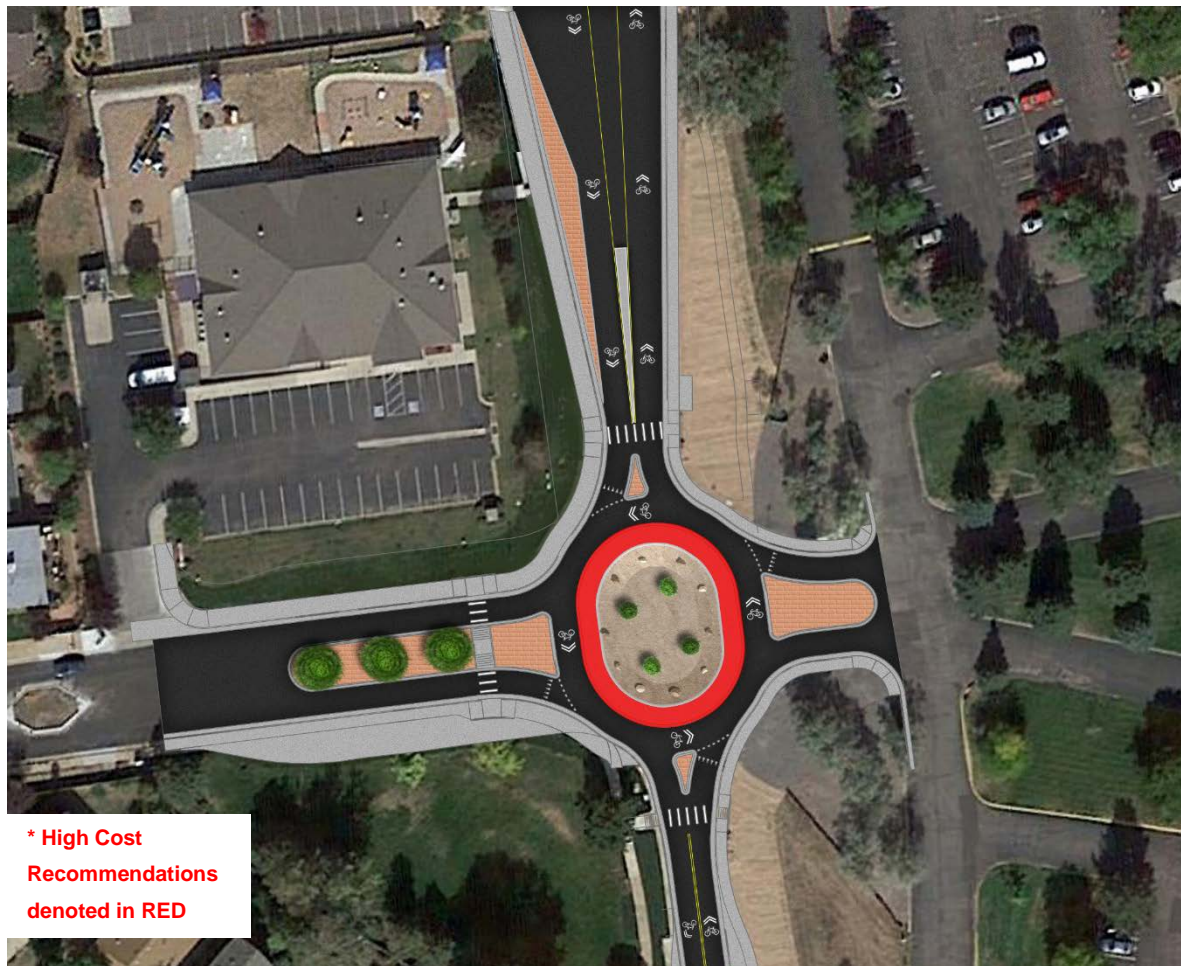
Figure 5: Eagle Ridge Dr – Final Recommendations

Eagle Ridge Dr – Final Recommendations	
High Cost*	Reduction of width/vertical on apron is recommended but will require further analysis on potential design, drainage, and reconstruction issues.
Low Cost	Remove boulders - Add tall grass within center island.
	Further refine single lane on the southbound approach with sharrows/striping.
	Strive to remove structures within sight distance triangles.
	Place consistent signage/pavement markings before, during, after roundabouts.
	Where applicable, paint markings delineate the bicycle entrance/exit from the roadway.
	Utilize sharrow pavement markings within the roundabout.

The **high-cost recommendations** generally include infrastructure modifications, such as reconstruction of the aprons at Eagle Ridge Dr and Kimball Ave, with curb relocations recommended at 4<sup>th</sup> Ave and Kimball Ave (*identified in red in*

*Figures 5-7*). The high-cost infrastructure recommendations were carefully considered with regard to potential secondary impacts (i.e. design considerations), as well as a qualitative cost-benefit analysis to ensure the expenditure of public funds will bring tangible improvements to the operations of the corridor. With all high-cost infrastructure recommendations, the need for further analysis is required to determine any drainage impacts and ROW needs, at the very least.

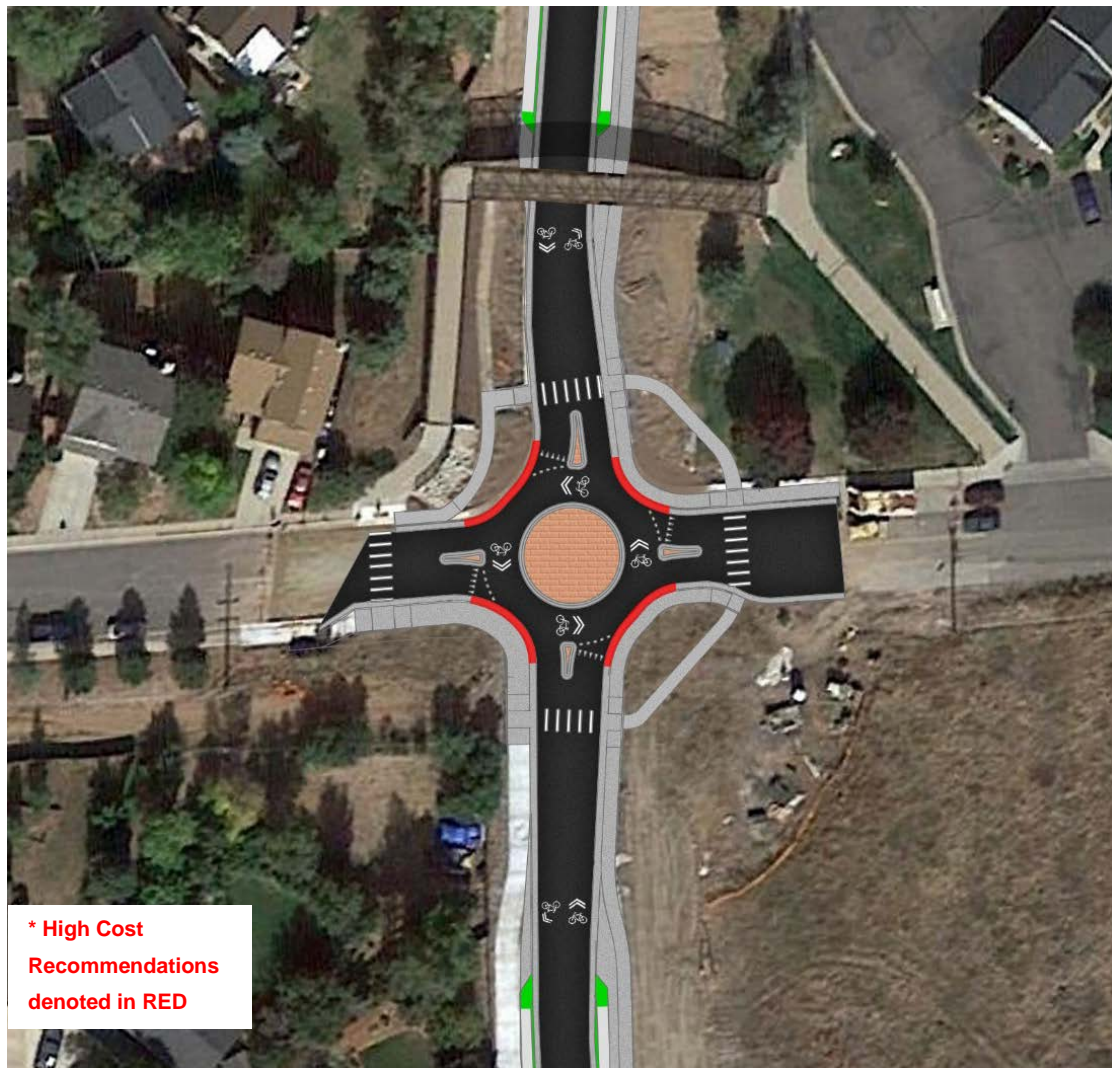
Figure 6: 4<sup>th</sup> Ave – Final Recommendations

4th Ave – Final Recommendations	
High Cost*	Relocate the outside curb line at the 3 corners where the sidewalk has been relocated, and also consider possibility of relocating sidewalk at the remaining corner as well. May require further analysis on potential design, drainage issues, and ROW issues.
Low Cost	Strive to remove structures within sight distance triangles.
	Place consistent signage/pavement markings before, during, after roundabouts.
	Where applicable, use pavement markings to delineate the bicycle entrance/exit from the roadway.
	Utilize sharrow pavement markings within the roundabout.

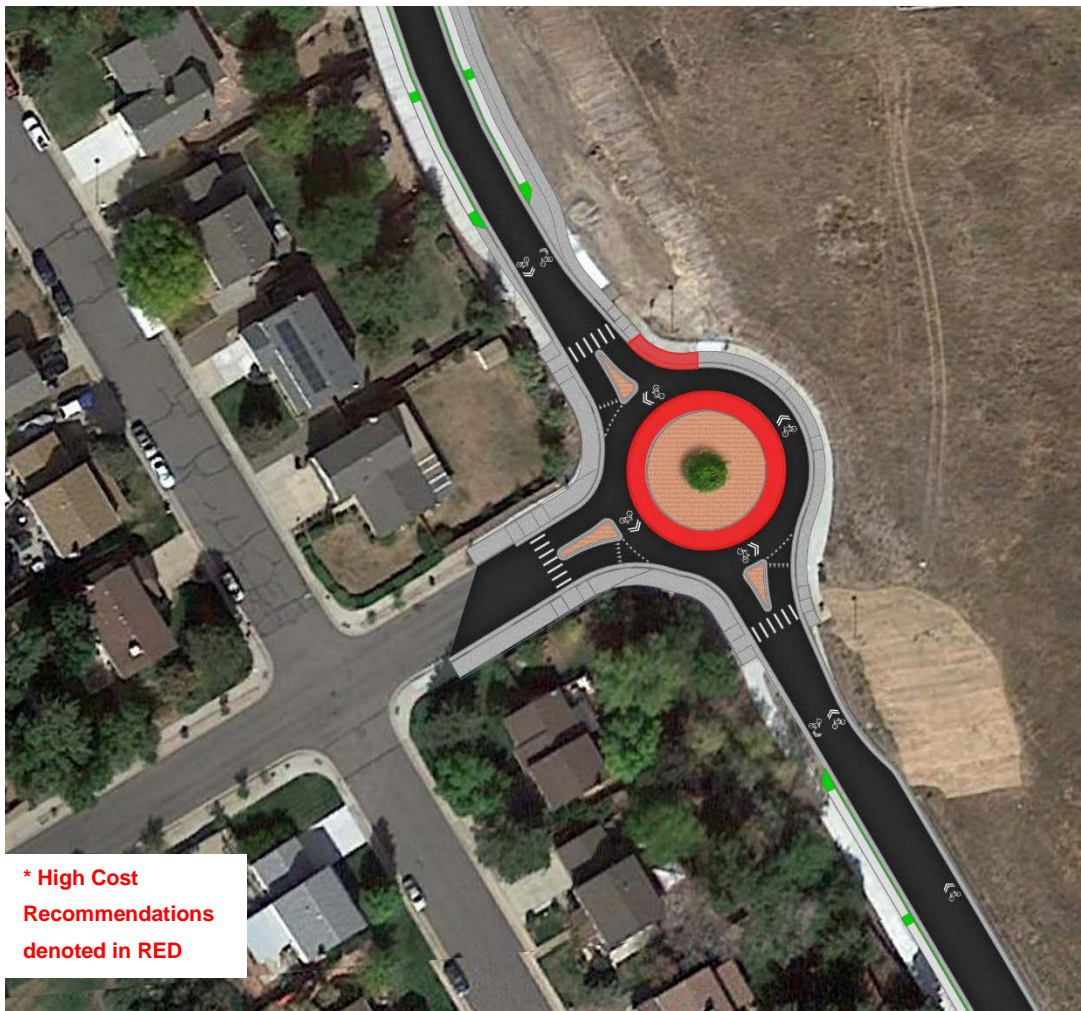
Figure 7: Kimball Ave – Final Recommendations

Kimball Ave – Final Recommendations	
High Cost*	Curb relocation recommended at the NB exit location but will require further analysis on potential design and ROW issues.
	Reduction of width/vertical of apron is recommended but will require further analysis on potential design, drainage, and reconstruction issues.
Low Cost	Place consistent signage/pavement markings before, during, after roundabouts.
	Where applicable, use pavement markings to delineate the bicycle entrance/exit from the roadway.
	Strive to remove structures within sight distance triangles.
	Utilize sharrow pavement markings within the roundabout.

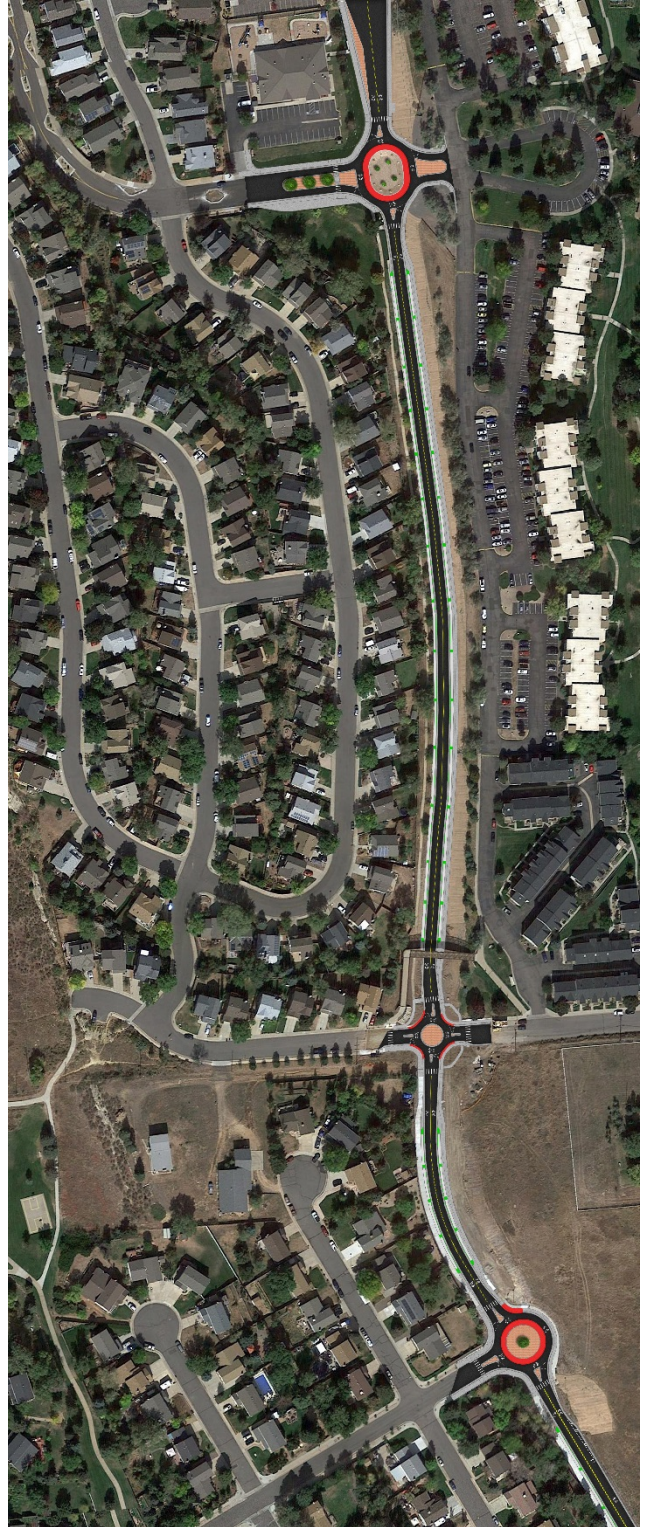
**Figure 9: Corridor-Wide – Final Recommendations**

Corridor-Wide – Final Recommendations	
Low Cost	Consolidate signage along corridor to improve sightlines and promote consistency at each roundabout.
	Green paint and pavement markings at decision points - enter/exit - and along bicycle facilities. Sharrow markings through the roundabout.
	Enhance existing crosswalk markings with enhanced paint and additional hashmarks in crosswalks.
	Add sharrow pavement markings north of Eagle Ridge Dr.
	Place low landscaping options between sidewalks and bicycle lanes and/or traffic lanes, where applicable.
	Recommend lane narrowing in the northbound direction and addition of sharrow pavement markings.
	<i>New Recommendation: Consider improved lighting</i>
	<i>New Recommendation: Improved maintenance of bicycle lanes by the City</i>
	<i>New Recommendation: Improved signage prior to entering Heritage to notify trucks and large vehicles of the presence of roundabouts</i>

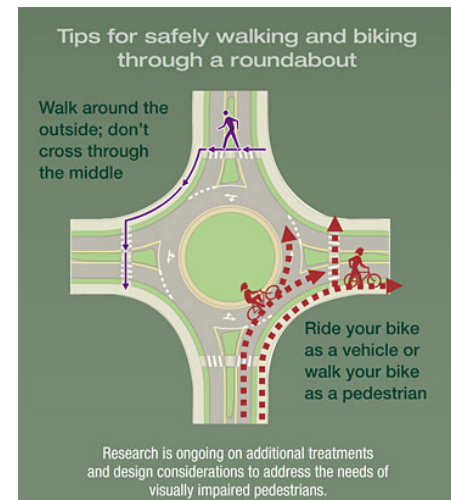
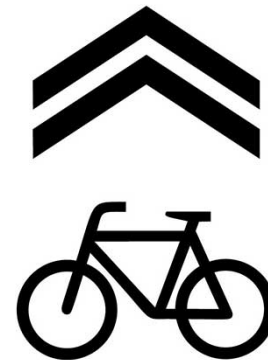
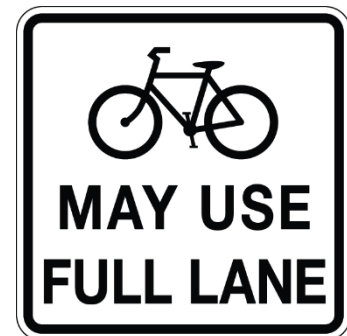
#### (1) Bicycle Ramps and Sidewalk Access

The movement of bicyclists through roundabouts must be considered from both a design and operations perspective. Design guides explicitly state that bicycle lanes are not to be provided through roundabouts (i.e. CDOT, AASHTO, and FHWA); rather, bicycle lanes must terminate 100' before the crosswalk or yield line at the entrance to the roundabouts, as indicated by the MUTCD.<sup>7</sup>

However, pathways should be provided for cyclists to navigate these intersections. According to the FHWA manual *Roundabouts: An Informational Guide*, bicyclists should have the option of traveling through the roundabout in the same manner as a vehicle or by dismounting and proceeding along the pedestrian route (i.e. the sidewalk).<sup>8</sup> To aid bicyclists and inform motorists, shared lane markings may be provided at the entrances to roundabouts and path options for cyclists should be clearly indicated through signage and/or pavement markings.<sup>9</sup>

To allow bicyclists to access sidewalks, ramps may be provided from the road surface to allow cyclists to access the sidewalk in a location other than the formal crosswalk. FHWA and CDOT indicate that sidewalks should be widened at roundabouts so that cyclists and pedestrians may use sidewalks

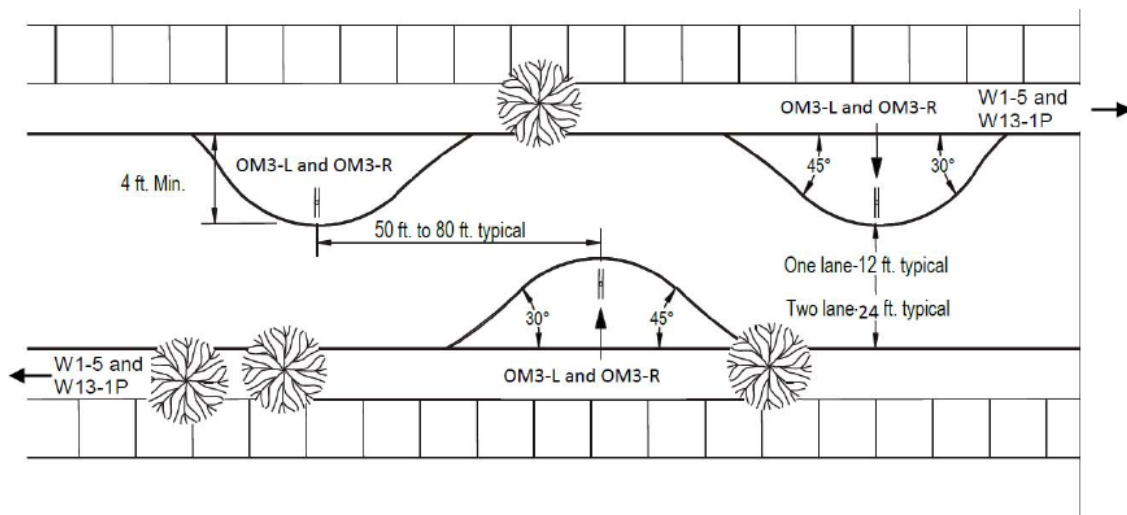
**Figure 8: Design Considerations for Chicanes, *Pennsylvania's Traffic Calming Handbook***

*Pennsylvania's Traffic Calming Handbook* calls for there to be 50-80' between the peaks of the chicanes (i.e. the most protruding point), with peaks extending at least 4' from the curb. The *Canadian Guide to Neighborhood Traffic Calming* calls for a 23' (7m) gap between chicane features located along the angled portion of the offset chicanes.<sup>15</sup> This is comparable to the gaps between the chicanes along Eagle Ridge Dr; however, the current paired design of the chicanes allows for higher speeds than other designs. The gap between the chicanes along Eagle Ridge Dr is also considerably longer than the recommended designs.

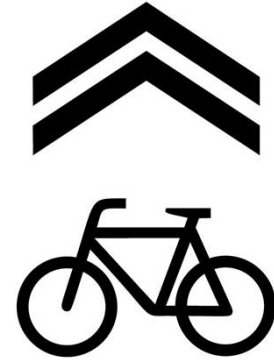
Given the potential speed differential between the chicanes, recommendations to improve operations include the addition of identifiers for the chicanes and medians, such as yellow paint along edges, vertical elements within chicanes/medians, and curb aprons. Yellow paint and vertical elements will increase visibility and curb aprons would allow emergency vehicles more flexibility to maneuver through the corridor as needed. Caution should be noted with the curb aprons, as they could increase speeds. Sharrows are recommended along the entire corridor to provide clarity to both the vehicle and bicyclists that the roadway is to be shared.

Also recommended is the removal of the two chicanes located closest to the intersections of Entrada and Somerset. The proximity of these chicanes makes it challenging to maneuver through the intersection, and in most cases the vehicles are already slowed by the actual turning movements at that location.

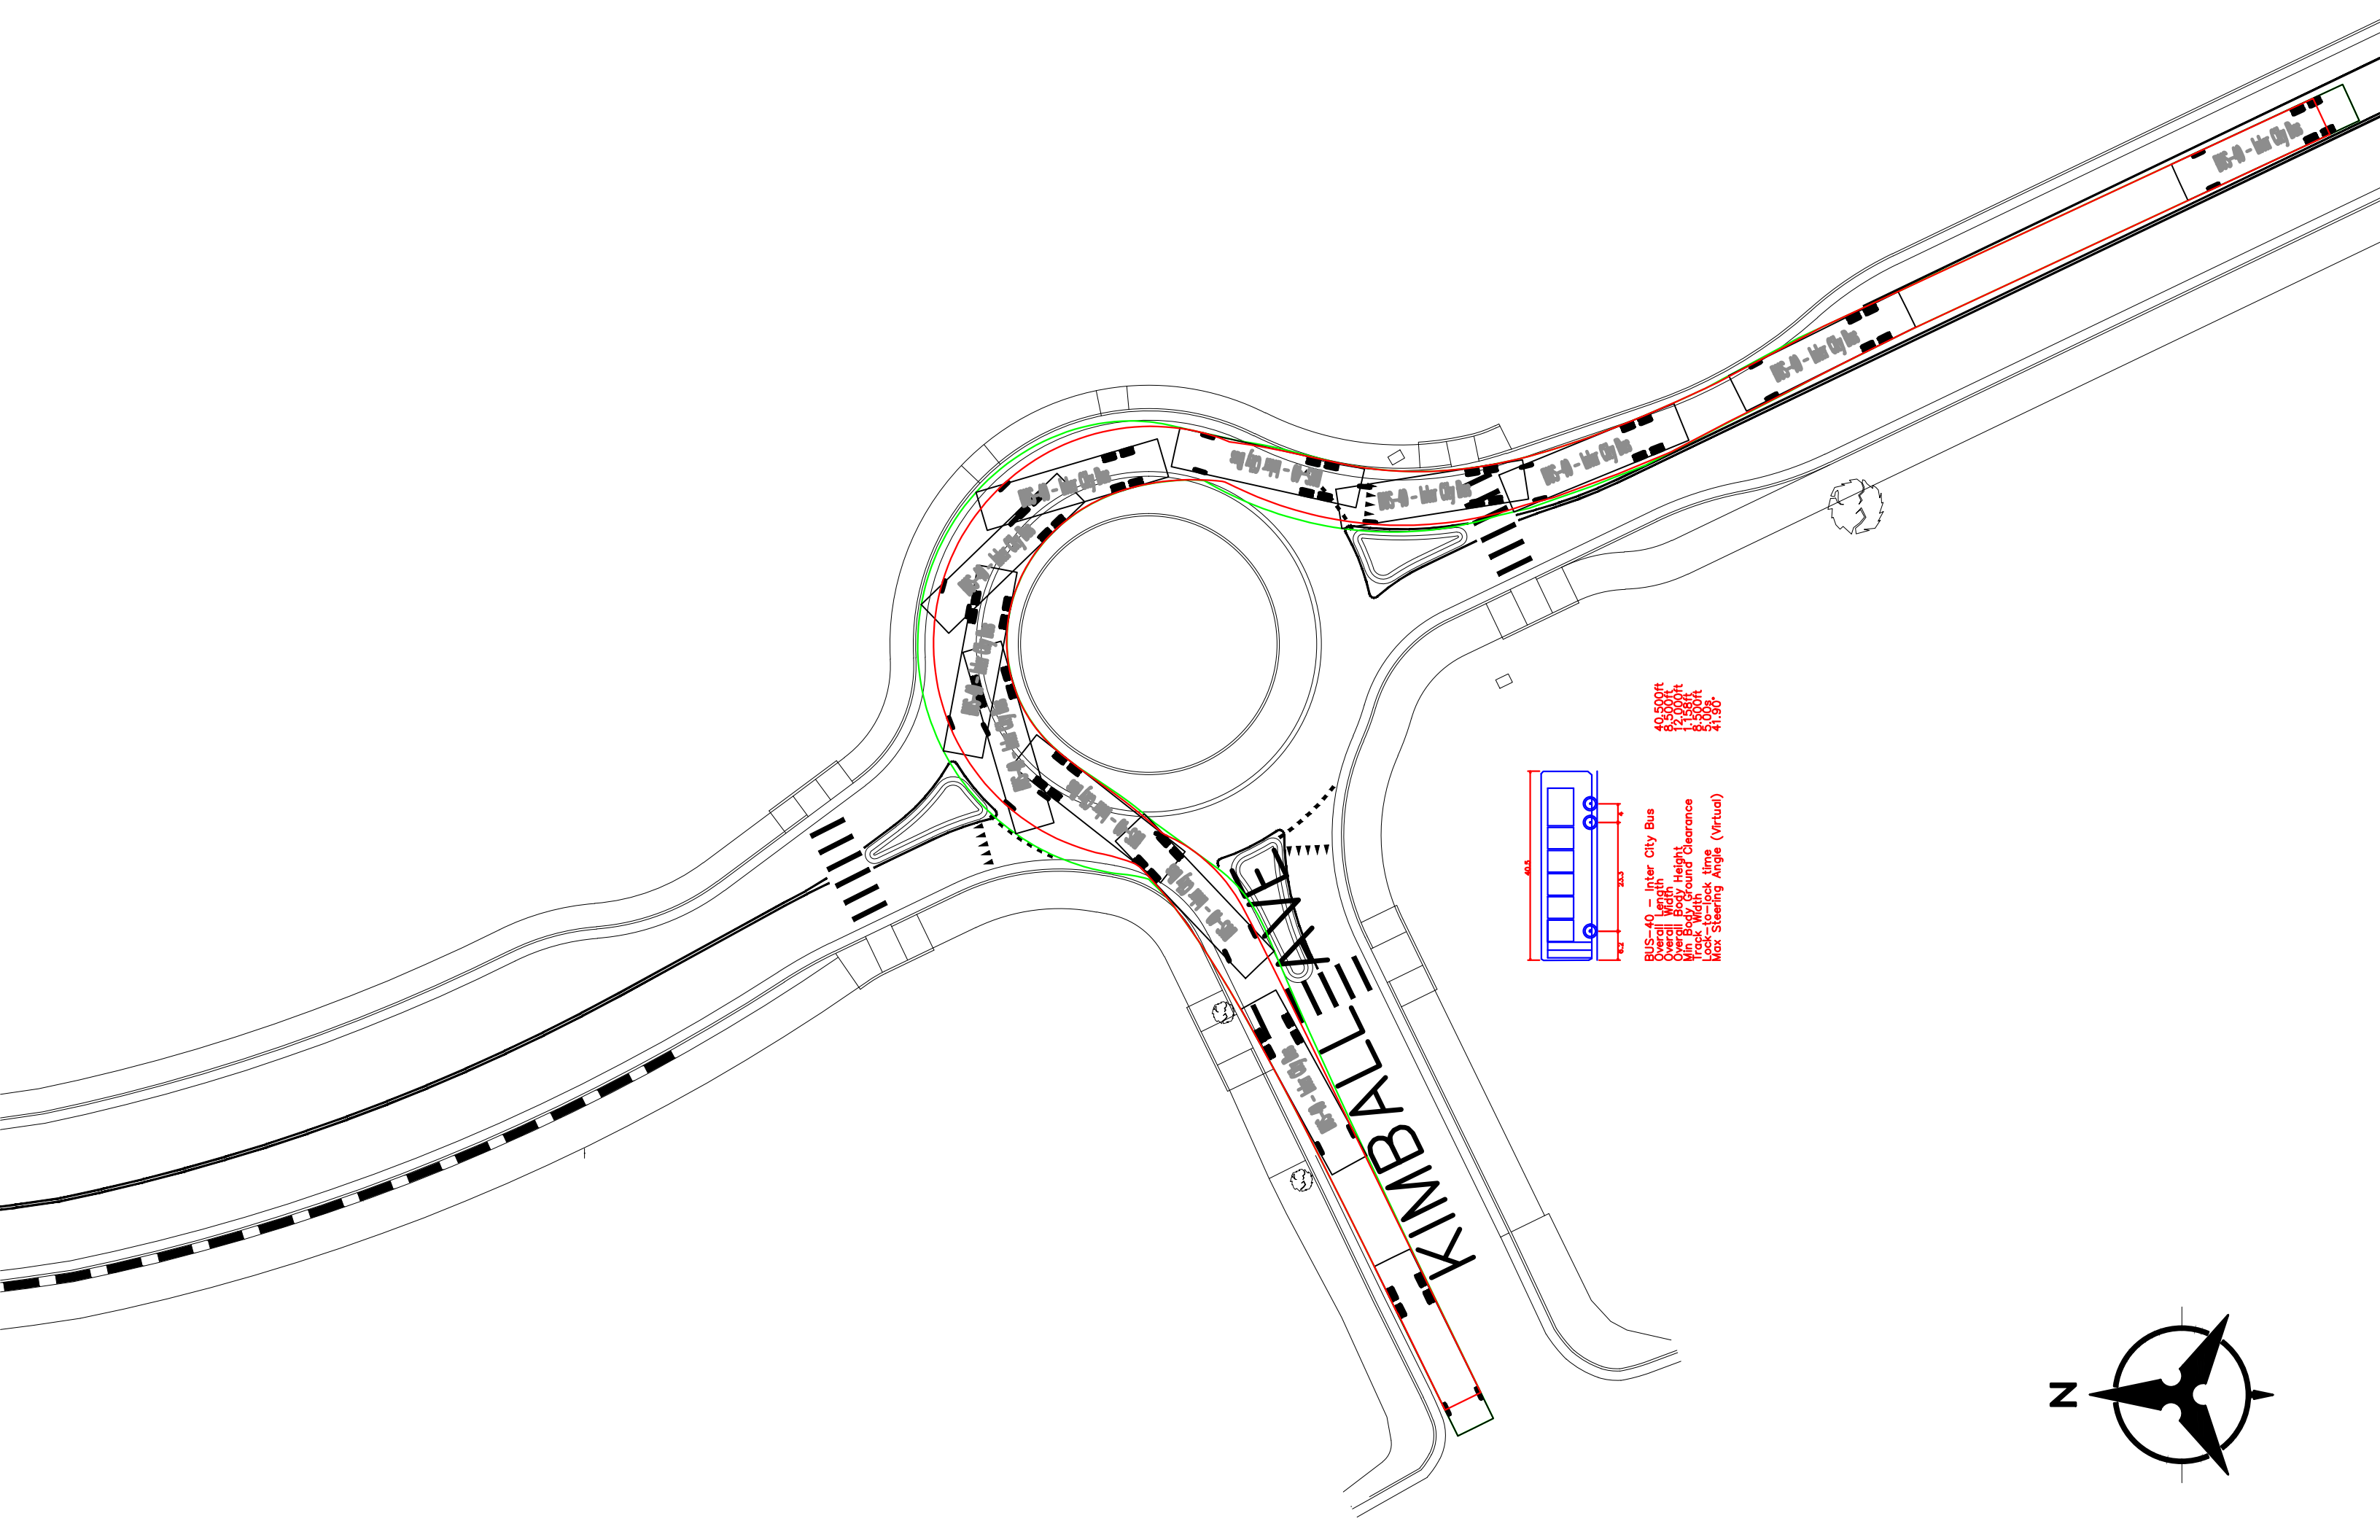
BUS-40 - Inter City Bus  
Overall Length 40.500ft  
Overall Width 25.300ft  
Overall Height 12.700ft  
Min Body Ground Clearance 1.158ft  
Track Width 8.500ft  
Lock-to-lock time 3.00s  
Max Steering Angle (Virtual) 41.90

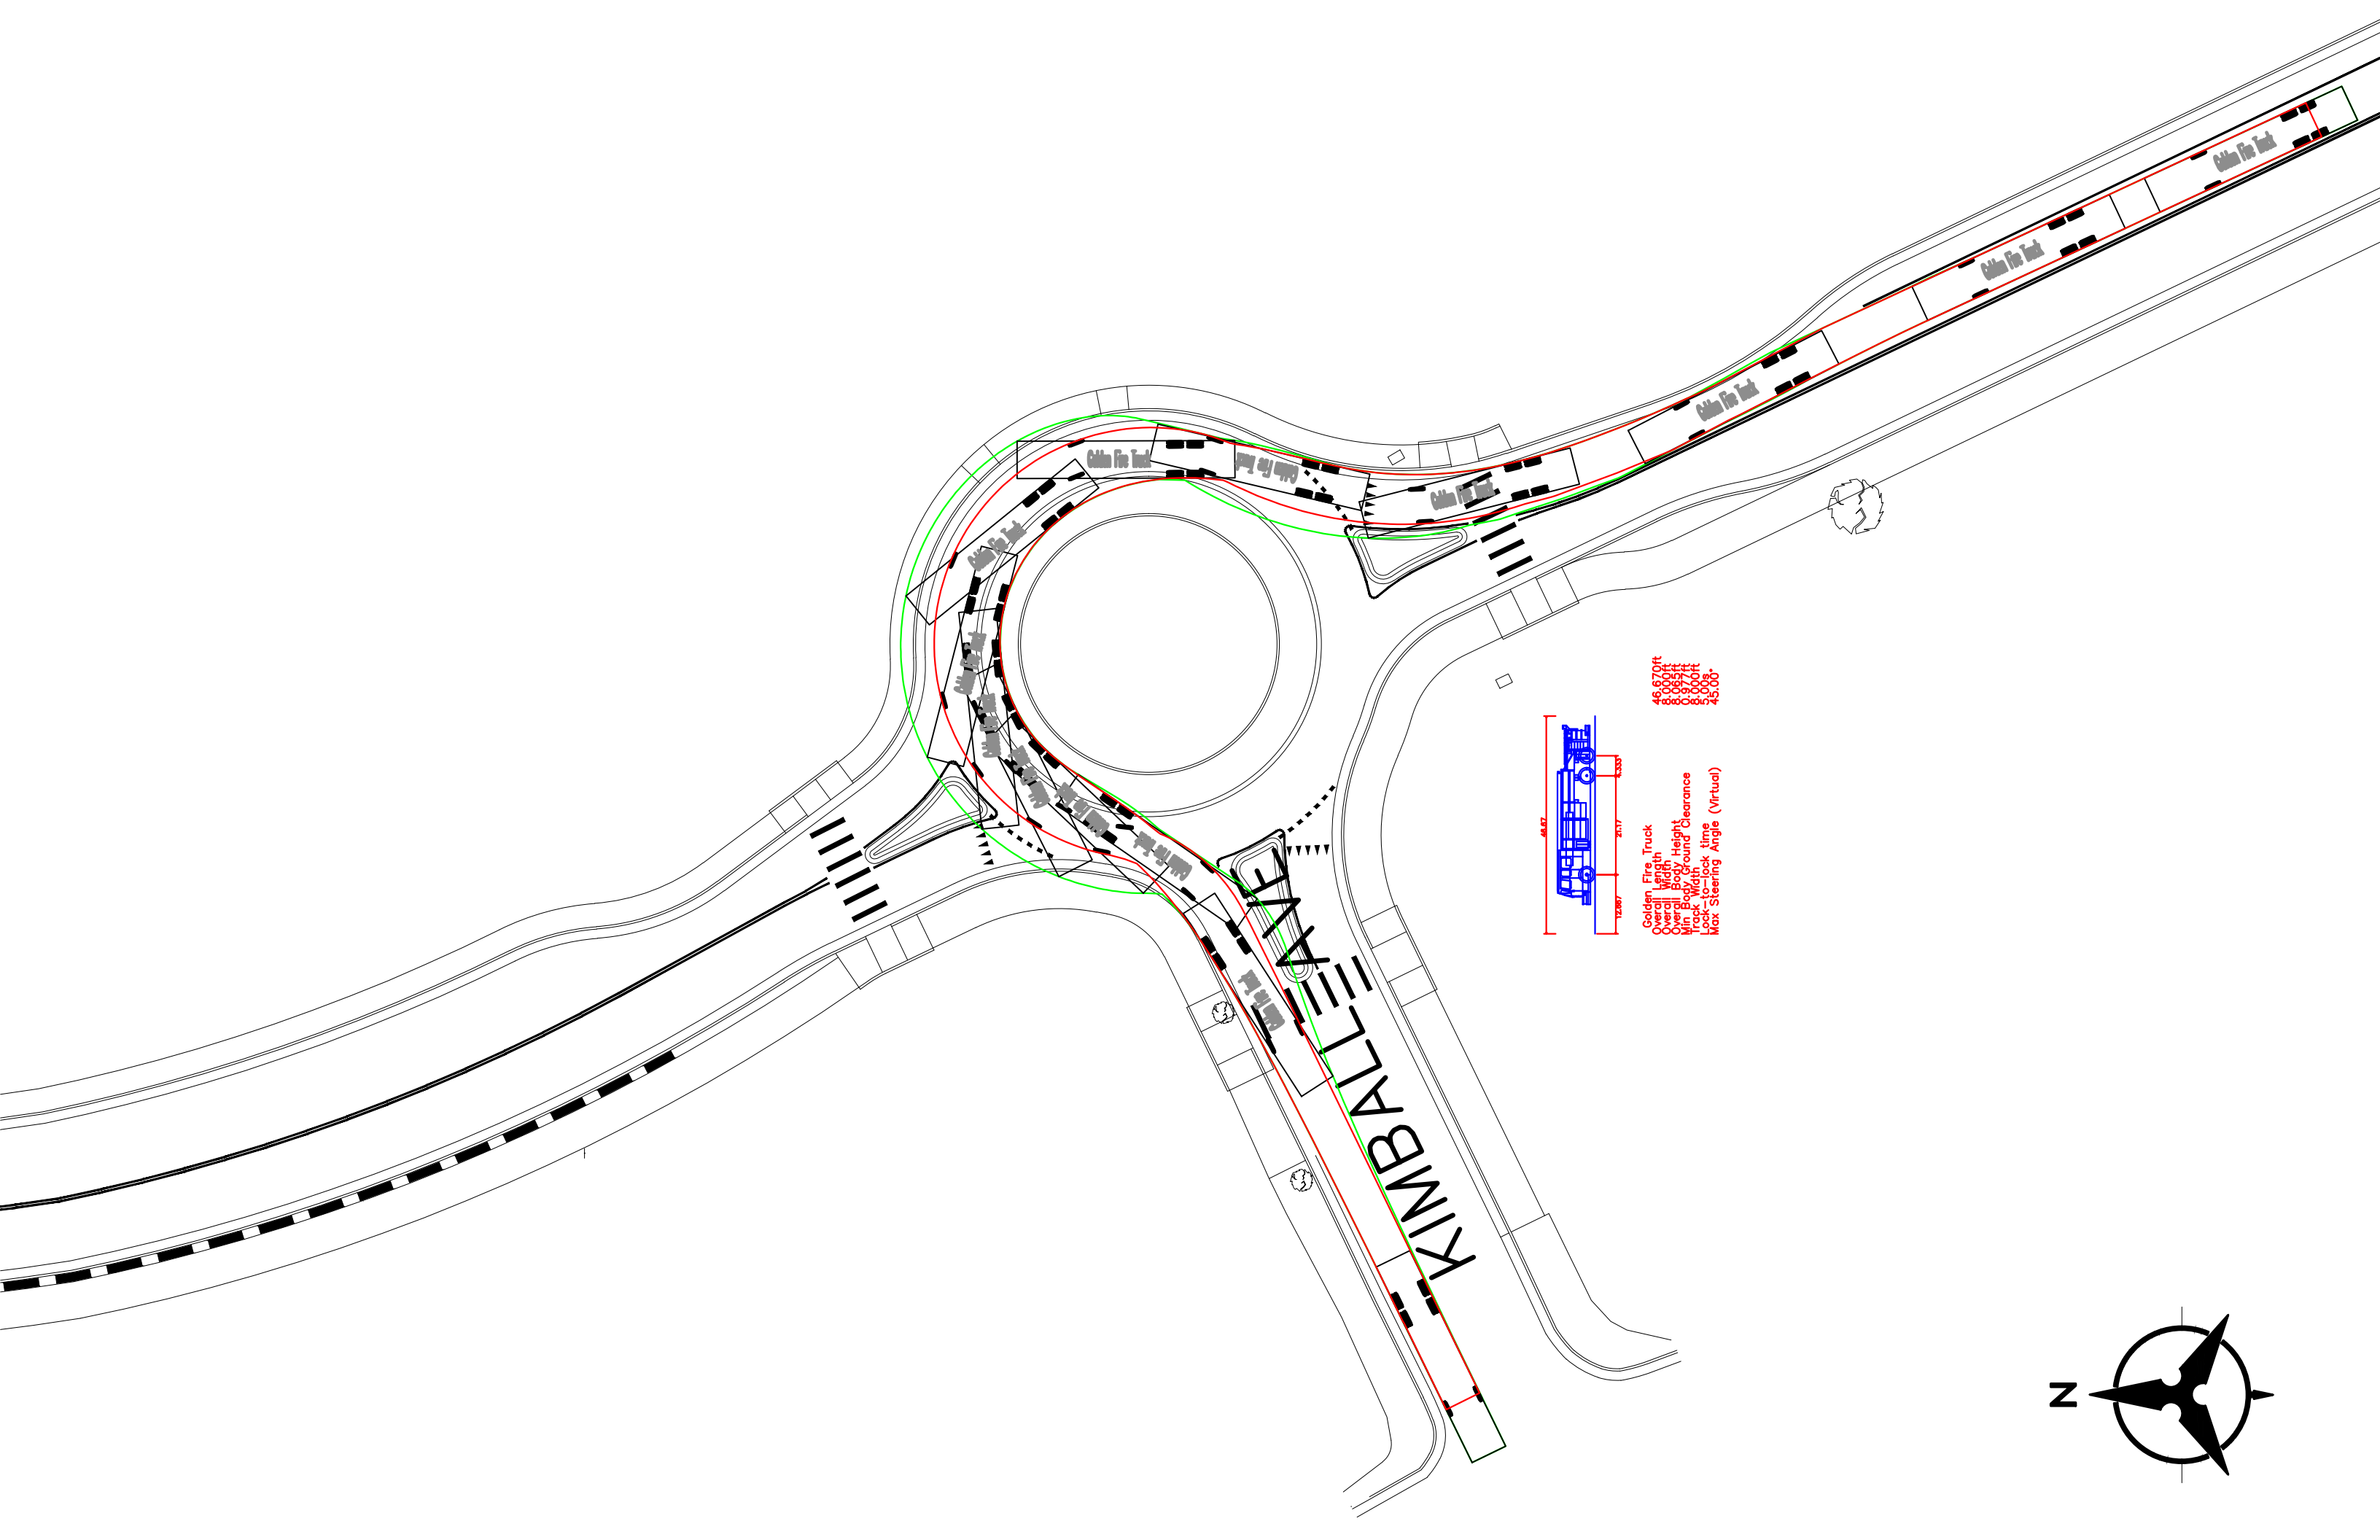
Golden Fire Truck  
Overall Length 46.670ft  
Overall Width 12.867ft  
Overall Body Height 8.060ft  
Min Body Ground Clearance 8.085ft  
Track Width 8.977ft  
Lock-to-lock time 8.060ft  
Max Steering Angle (Virtual) 45.00°
